**Alpha & Omega
Home Inspections, LLC**

CONFIDENTIAL INSPECTION REPORT

511 Elm St., Gastonia, NC

1/13/2007 9:00 am to 12:30 pm

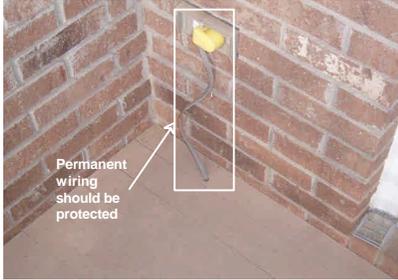
- 1.5 - Non-metallic sheathed cable was not protected from damage. We recommend all electric cables within 7 feet of the floor or ground be protected within walls or approved conduit to prevent accidental damage to the conductors.

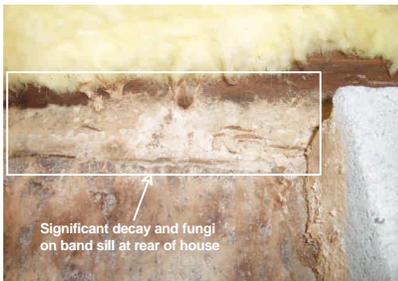
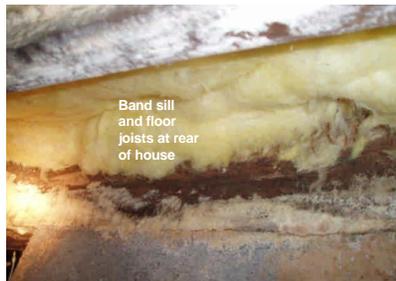
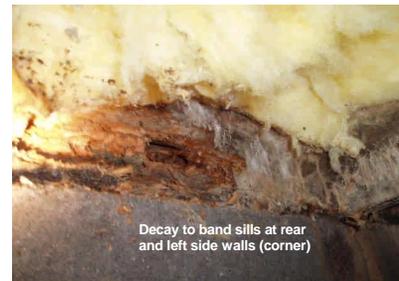
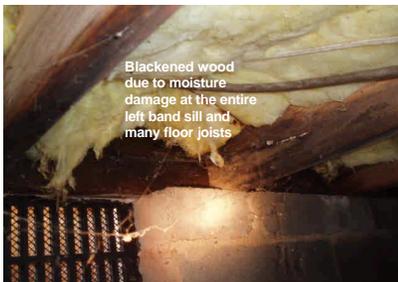
3.4 - Decay to the wood structures (band sill and/or floor joists and/or sub-floor and/or girders) at the perimeter of the crawl space was observed. Repair by a licensed general contractor is recommended. Note: it is important that the conditions that resulted in the decay be determined and corrected to prevent recurrence.

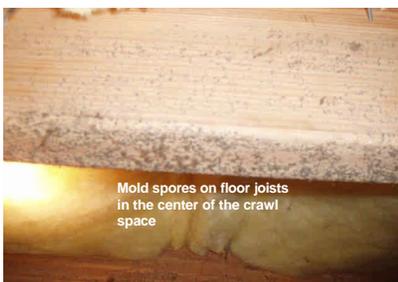
3.5 - There is a high moisture content in the wood structures inside the crawl space (28%+ moisture was measured in some areas). Wood will decay at moisture levels > 28% and will support fungi growth at levels in the low-20s. Moderate to heavy fungi was observed in many areas of the floor joists. Because of the issues with high moisture content in the wood structures that result in fungi growth, it is recommended that a qualified individual: 1) remediate (kill) the fungi growing in the crawl space, 2) take appropriate measures to eliminate the environment conducive to future fungi growth, 3) eliminate the environment that will cause the wood to decay. The services of a mold remediation specialist and/or a crawl space specialist should be considered to achieve the desired results. Options to reduce the moisture levels include, but are not limited to, elimination of water intrusion into the crawl space, increasing ventilation, installation of a vapor barrier or installation of a humidistat controlled fan. Here's useful information from the EPA about fungi: <http://www.epa.gov/mold/moldresources.html>

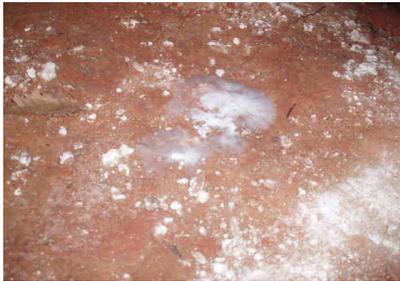
- 3.6 - Fungi exists on the floor of the crawl space. It is recommended that a qualified individual: 1) remediate (kill) the fungi growing in the crawl space, 2) take appropriate measures to eliminate the environment conducive to future fungi growth. The services of a mold remediation specialist and/or a crawl space specialist should be considered to achieve the desired results. Options to reduce the moisture levels include, but are not limited to, elimination of water intrusion into the crawl space, increasing ventilation, installation of a vapor barrier or installation of a humidistat controlled fan. Here's useful information from the EPA about fungi: <http://www.epa.gov/mold/moldresources.html>

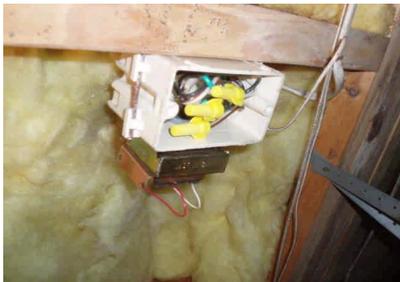
- 3.7 - There is an open electrical junction box within the crawlspace, which should be sealed so that any arcing or sparking would be contained within the box.

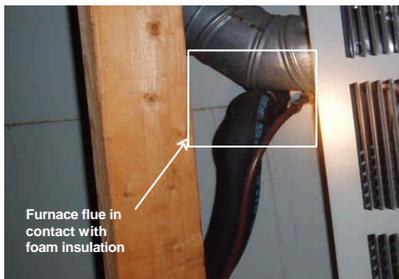
- 9.1 - The furnace exhaust flue was in contact with or too close to combustible materials. The manufacturer of the vent (a "B-vent") recommends a minimum 1" clearance from combustible materials. This construction defect is considered a fire hazard. We recommend that repairs meeting the manufacturers specifications be conducted for fire safety reasons.

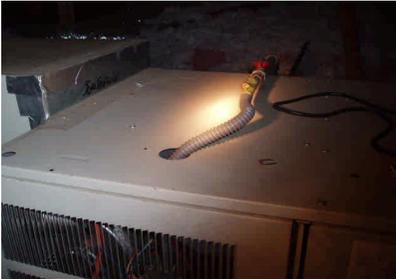
- 9.2 - A gas appliance connector passes through one or more HVAC cabinets; a practice which the manufacturer prohibits. The manufacturer of these devices states: "Do not conceal connector or run connector through enclosed outdoor BBQ pits, walls, partitions, floors or appliance panels."

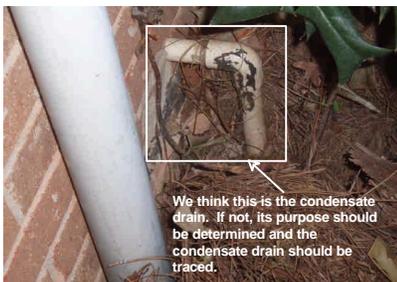
- 9.3 - The condensate drain(s) do not discharge sufficiently above grade. It will likely become clogged. Service to raise the condensate drain(s) is recommended.

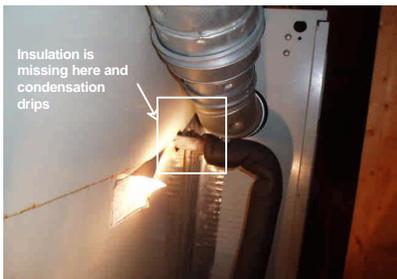
- 9.4 - Insulation is missing from the refrigerant line at the evaporator coil. The condition will allow condensation to form and drip, which may cause corrosion to the drip pan or other metal components or damage the ceiling or floor below. Insulation should be installed where missing.

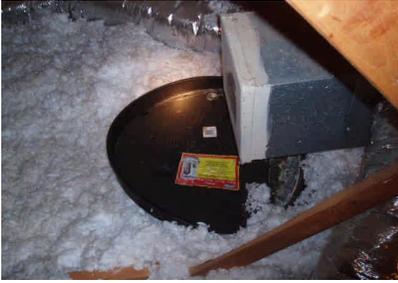
- 9.6 - A drain pan was beneath an HVAC duct for an unknown reason. There is evidence of water having been in the pan, but it was dry at the time of the inspection. We recommend that you monitor the system during periods of AC usage and if water leaks from the duct you should contact an HVAC contractor.
