# **Alpha & Omega Home Inspections, LLC**

## Confidential Inspection Report

**Property Address:**  
136 Anystreet St.  
MyTown SC

<b>Date:</b> 6/3/2010	<b>Time:</b> 02:15 PM	<b>Report ID:</b> 1912 House Sample
<b>Property:</b> 136 Anystreet St. MyTown SC	<b>Customer:</b>	<b>Real Estate Professional:</b>

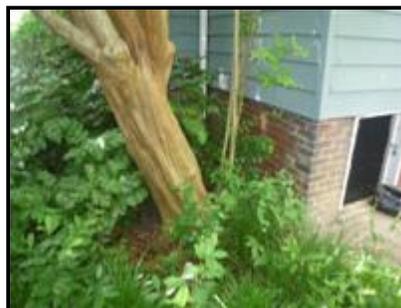
**1.0** (1) The roots of mature trees may have an adverse effect on the house, and you may wish to have the tree removed.

(2) Vegetation is in contact with the house roof. The vegetation should be trimmed to prevent damage to roof shingles. More about the hazards of trees close to the home can be read at [our website](#).

Vegetation is in contact with the house exterior, which may damage the siding and/or windows. Vegetation close to the foundation will limit ventilation of the crawl space, if present. The vegetation should be trimmed to prevent these issues.

Vines are overgrowing the house walls and although they are attractive they can introduce pests and rodents and accelerate deterioration of the brick and mortar. Therefore, you may wish to consider having them removed.

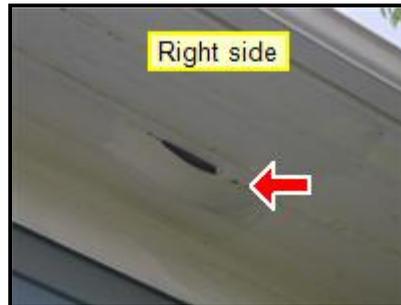
🔧 **1.4** The fascia board, soffits, and eaves are in a generally acceptable condition, but minor maintenance is needed to secure loose sections.

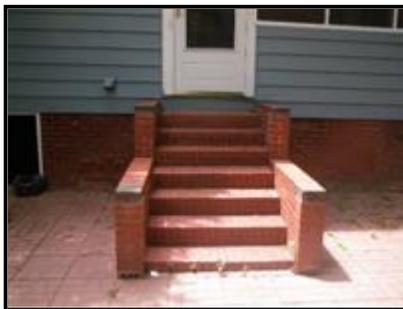
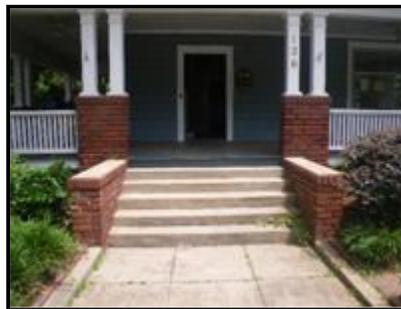
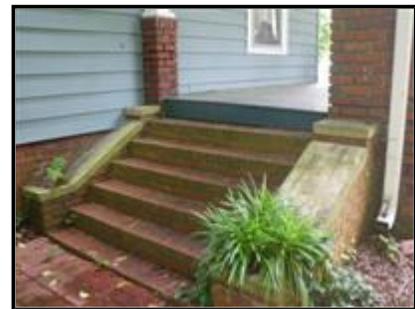
🔧 **1.5** As a safety precaution, we recommend installing handrails on steps that have four or more risers, and particularly if children or the elderly visit or occupy the property.

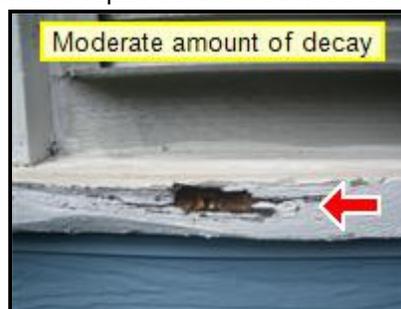
🔧 **1.7** (1) One window(s) or their components (frames, trim or sills) at the right side is deteriorated. The condition is conducive to allowing water infiltration and eventual decay to window components, and walls studs. We therefore recommend an evaluation and repair as deemed necessary by a licensed contractor.

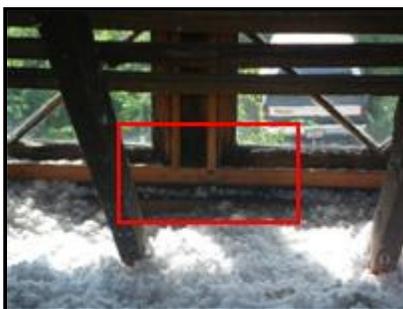
🔧 (2) Some of the wood framing around the attic windows was black, as if there may be a leak. The window was dry at the time of the inspection. We recommend an evaluation of them during a period of heavy or prolonged rain. *Note that it may be due to an old leak that has been repaired.*

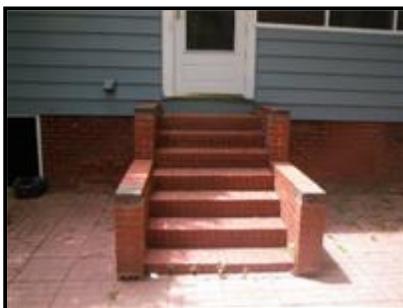
(2) The rear entry door opens over a step, or has no landing, and poses a fall hazard. According to today's commonly accepted construction standards, the width of each landing should not be less than the door served and every landing should have a minimum dimension of 36 inches measured in the direction of travel.

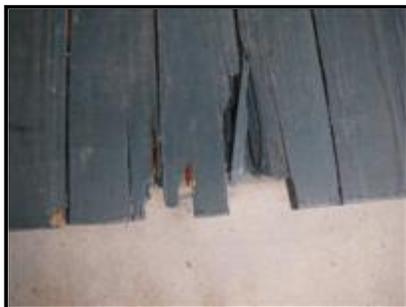
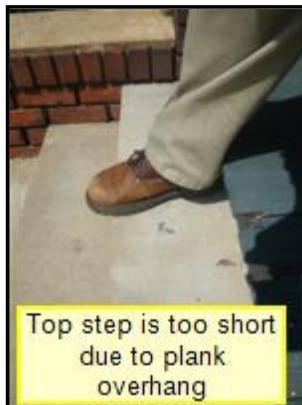
(2) Wood planks at the front porch steps are 'ragged' because they overhang too far and effectively reduce the top step tread depth to an unacceptably short length. We recommend service to repair and trim the porch planks and to ensure the porch steps have safe dimensions. (The minimum depth should be 10 inches. The greatest tread depth should not exceed the smallest by more than 3/8 inch.)

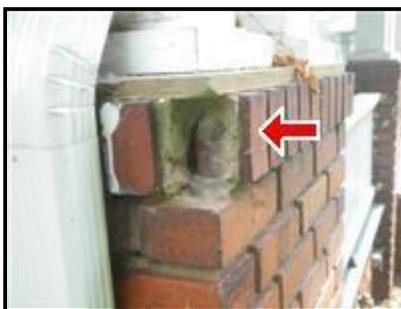
(4) The front porch post/pier has missing or loose bricks. Service by a masonry contractor is recommended.

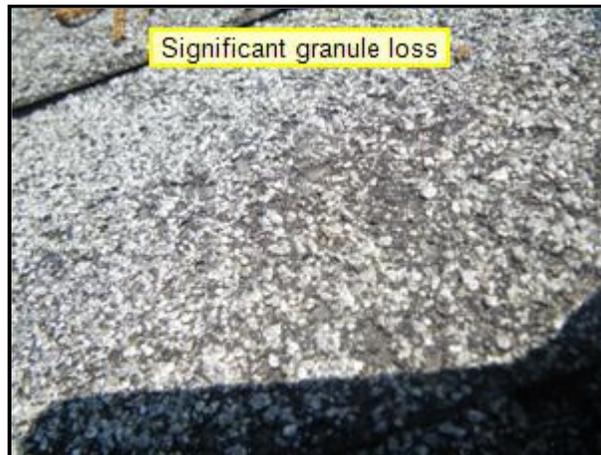
**2.0** (1) The roof is in a state of decomposition (loss of shingle granules, etc.), which means that the roof is in decline and susceptible to leaks. It will need to be maintained and closely monitored, because it is at or near the end of its serviceable life. We recommend an evaluation of the roof by a competent roofing contractor before the close of escrow because the cost of replacement may affect your valuation of the property.

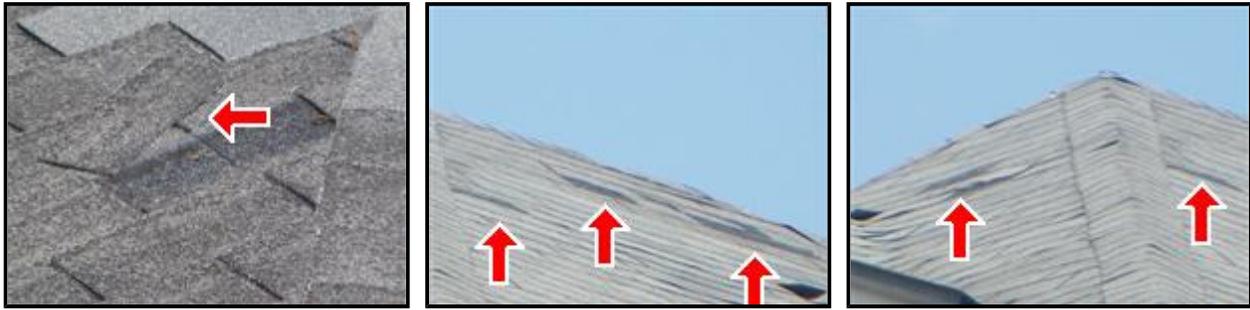
(2) One or more shingles or shingle tabs were missing or damaged at the front of home. A thorough evaluation of the roof and repair by a competent roofing contractor is recommended.

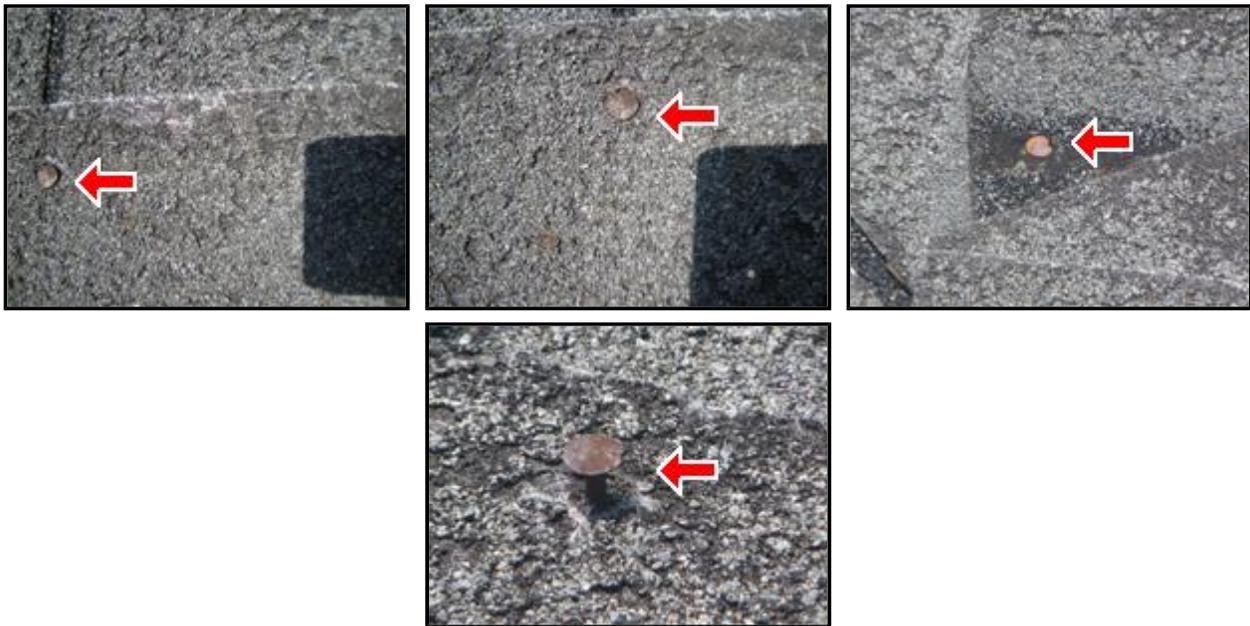
🔧 (4) Nail heads were observed at the front of home. This is indicative of an improper installation and/or poorly secured nails that have penetrated the shingles above them. An evaluation and repair by a competent roofing contractor is recommended to prevent future leaks.

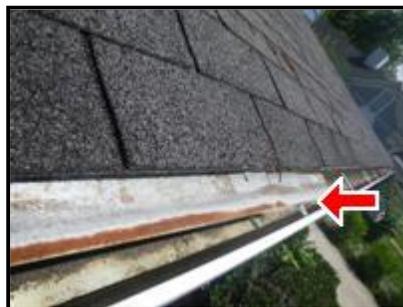
🔧 2.1 The drip edge flashing at the front of the home was loose.

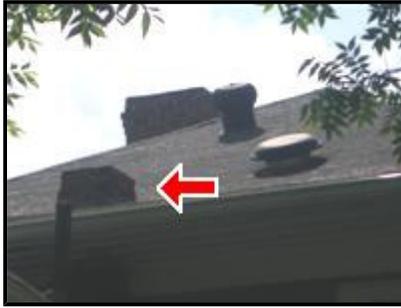
2.4 You may wish to have unused chimneys removed at the next re-roof to reduce the potential for roof leaks. FYI.

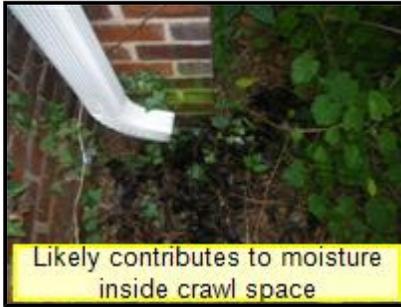
**2.5** (1) Every gutter downspout does not effectively discharge water 4 to 6 feet away from the house foundation. Although we rarely see it, we always recommend that downspout extensions be installed for the general welfare of the residence and its foundation.

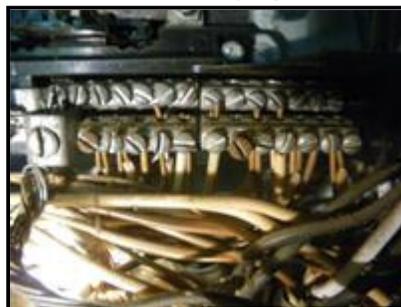
(3) A common defect exists in that one or more neutral wires are incorrectly connected under a single screw on the grounding or neutral bus bar at the main panel, and should be serviced. (Unless the manufacturer states otherwise, bus bars are only designed for one current carrying conductor per terminating screw.)

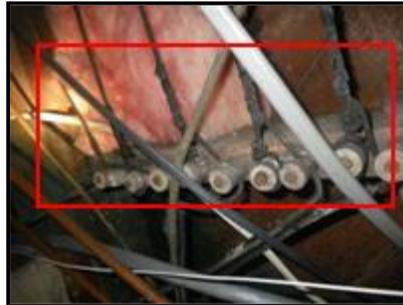
**3.4** (1) The residence was once wired with suspect knob-and-tube wiring, which was commonly installed prior to 1950. This system is ungrounded and over time the wire's insulation may become brittle and fall apart or wear thin, resulting in exposed conductors and a risk of shock and/or fire. The hazard is increased by covering it with insulation (a common practice), and incorrectly tapping new wiring into it. We tested many areas of the visible K&T wiring in the attic and crawl space and did not find any of it energized. Yet, we cannot guarantee that all the suspect knob-and-tube wiring throughout the house has been de-energized and replaced. We recommend that a qualified licensed electrician make that determination. Another recommendation is to remove all the unnecessary and de-energized wiring.

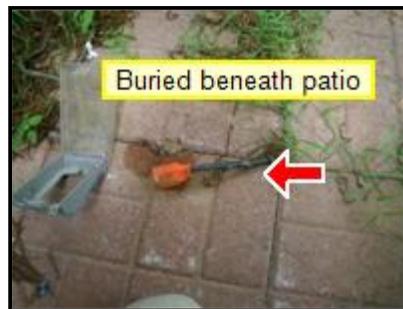
(2) At the exterior rear of the home an extension cord is used as permanent wiring, and needs to be replaced with permanent wiring.

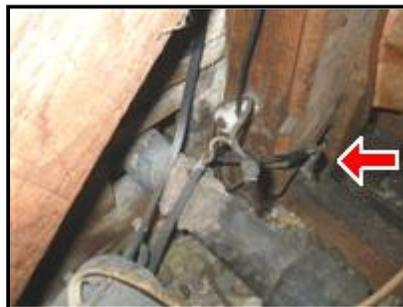
(3) One electrical connection(s) (in the attic or wall cavity adjacent to the upstairs bathroom) have been incorrectly made outside of junction boxes, which is a potential fire hazard. All such connections should be made within junction boxes in order to contain any arcing or sparking that could occur, a task that should be completed by a licensed electrician.

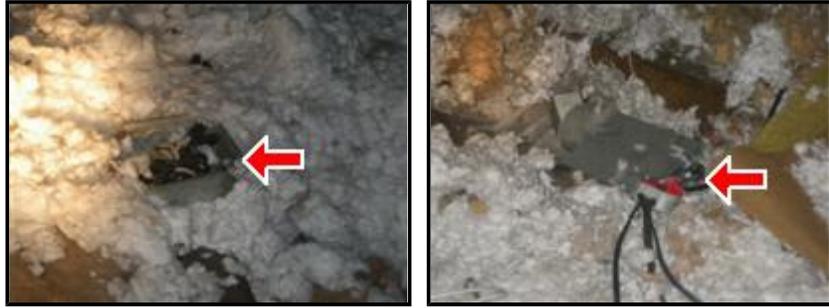
(4) Two open electrical junction box(s) were observed in the attic space which should be sealed to contain any arcing or sparking that might occur.

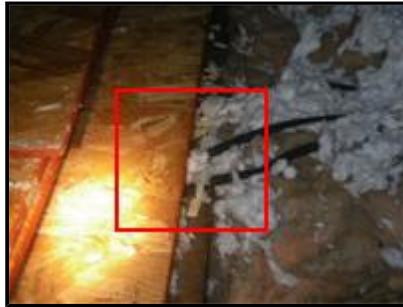
🔧 (5) Branch circuit wiring in the attic is susceptible to damage because it has been covered by floor decking. Abraded wires can be a shock or fire hazard. Service to re-route the wiring or remove the decking is recommended.

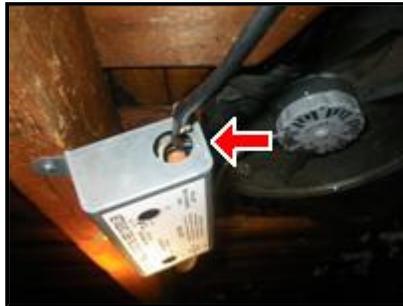
🔧 (6) No romex connector or strain relief bushing was provided to prevent a wire from making direct contact with the sharp edges of the junction box at the attic fan.

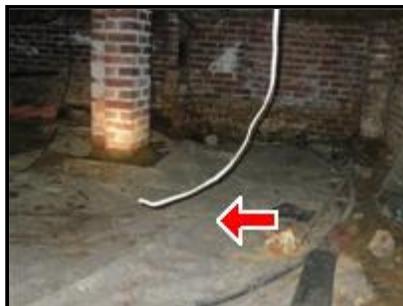
🔧 (8) A wire in the crawlspace has been improperly terminated. Removal or enclosing it in a junction box is recommended.

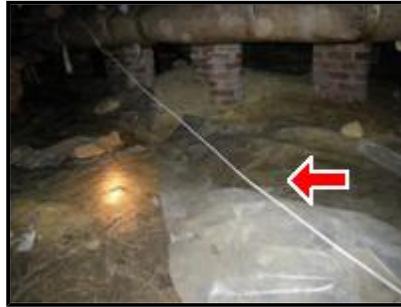
🔧 (9) In the crawl space, one or more electric cables was on the ground or dangled overhead. Electric cables

are required to be supported overhead every 4.5 feet.

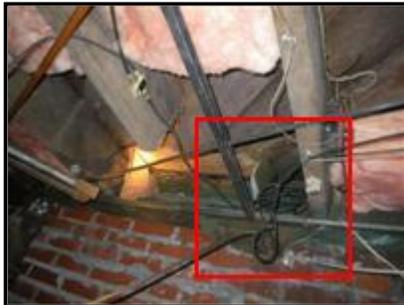
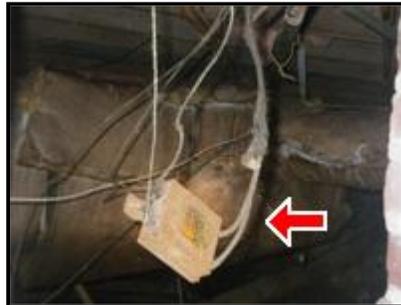
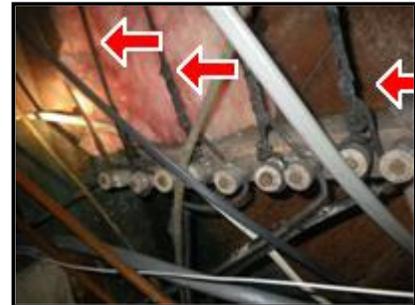
🔧 (10) Much of the original wiring and equipment has apparently been de-energized and replaced. However, most of it was left in place. Or recommendation is to remove all unnecessary wiring and equipment to eliminate any possibility of inadvertent energization.

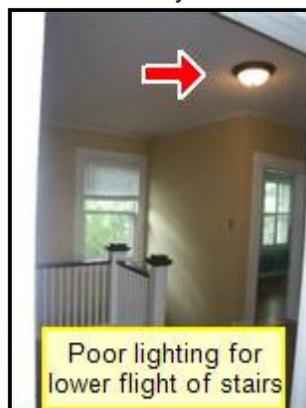
🔧 (17) We considered the stairway to have inadequate lighting. Today's commonly accepted construction standards specify that interior stairways should be provided with a means to adequately illuminate the stairs, including the landings and treads. While we did not take light measurements, our judgement is that the lighting was inadequate and suggest that it be improved for safety reasons.

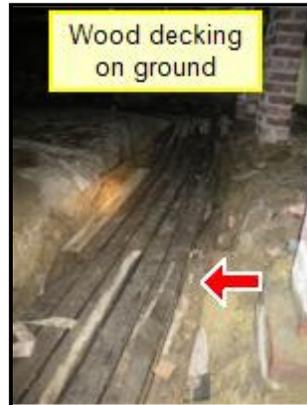
🔧 (3) Wood and/or other organic material was in the crawl space, which attracts wood destroying organisms. While we did not perform a pest control inspection, removal of all wood and similar materials from the crawl space is generally recommended.

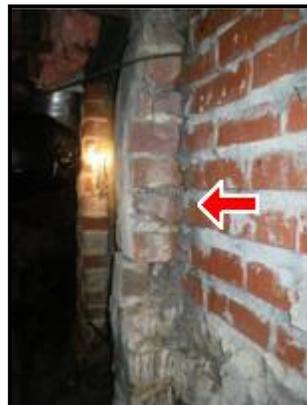
🔧 4.1 (1) One or more crawl space piers were cracked, leaning, or damaged. We recommend an evaluation and repair as deemed necessary by foundation specialist.

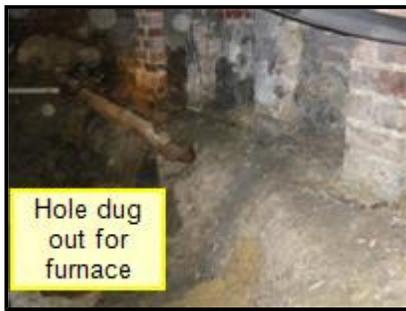
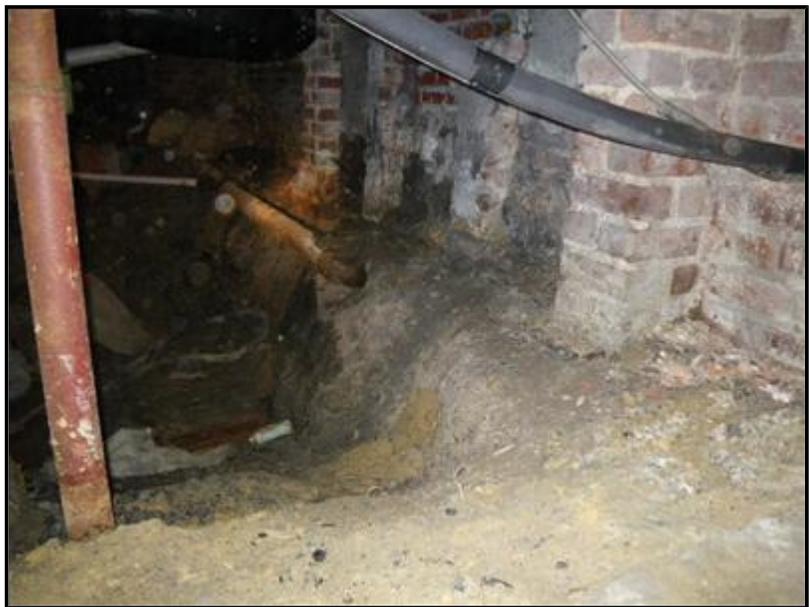
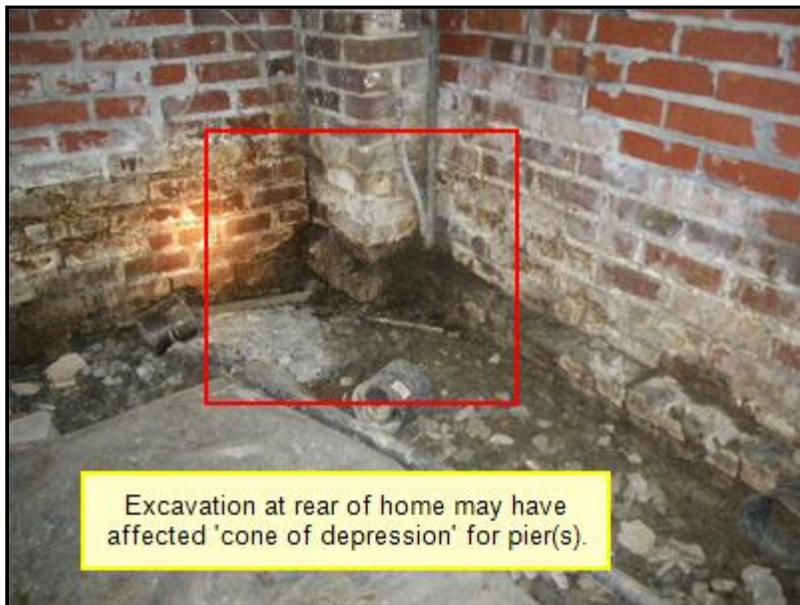
🔧 (2) The foundation footings have been undermined by trenching or soil excavation in one or more areas. An evaluation by a foundation specialist or structural engineer and repair as deemed necessary is recommended.

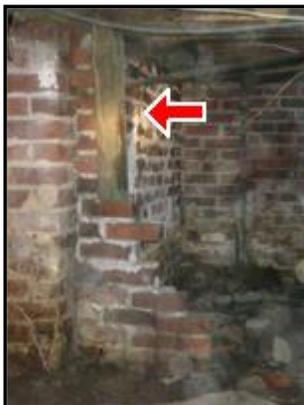
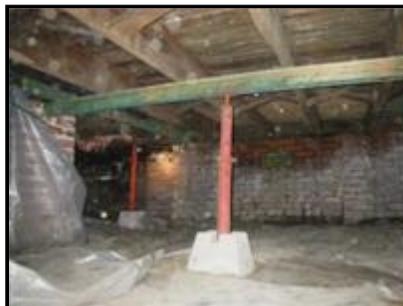
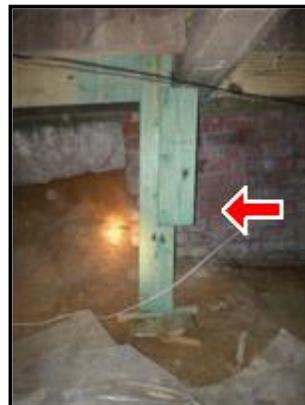
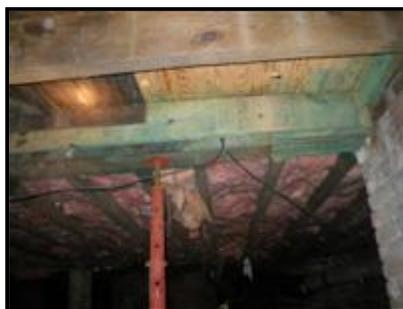
🔧 (3) Various portions of the floor structure was supported by various make-shift piers. Those floor supports exhibit poor workmanship are thought to be inadequate to provide permanent support to the floors. It is recommended that a competent and licensed general contractor or foundation specialist be consulted to provide a further evaluation of the adequacy of the floor supports and make necessary repairs.

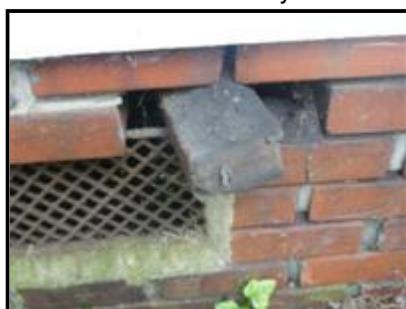
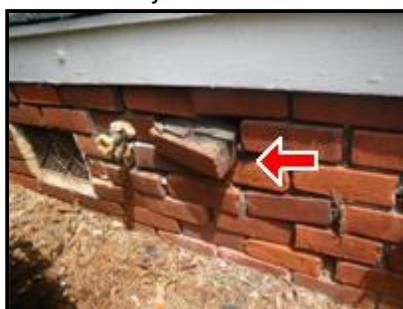
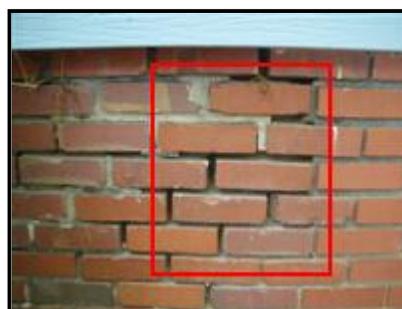
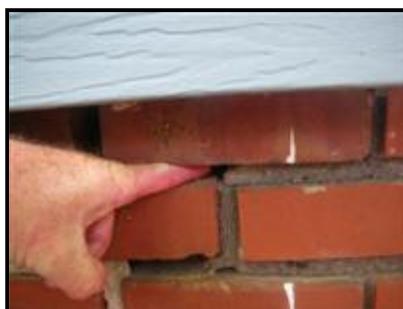
(2) The bricks that form the foundation wall are loose at the left side and front of the home. Service by a foundation or masonry contractor is recommended.

At the front of the home and rear of the home, mortar has deteriorated between the bricks that form the foundation wall. Service by a foundation or masonry contractor is recommended.

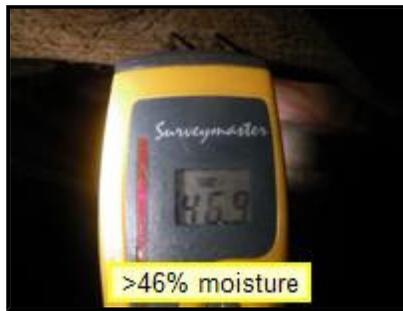
(2) Moisture content greater than 25% was measured in the wood structures. No decay or fungi was observed due to the moisture content, but wood will decay at moisture levels > 28% and will support fungi growth at levels in the low-20s. Options to reduce the moisture levels include, but are not limited to, increasing ventilation, installation of a vapor barrier, installation of a humidistat controlled fan, or total encapsulation of the crawlspace. You should consider the services of a crawlspace specialist to remedy this adverse condition.

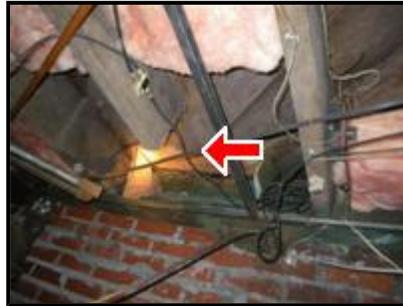
🔧 (3) A floor joist has been cut at the left side of the home. An evaluation and repair as deemed necessary by a licensed contractor is recommended.

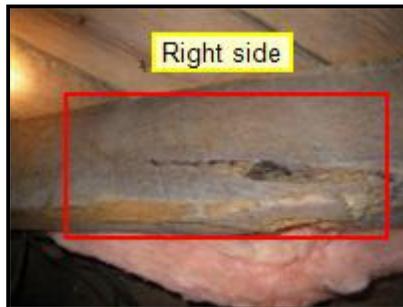
🔧 (4) A floor joist was split. An evaluation and repair as deemed necessary by a licensed contractor is recommended.

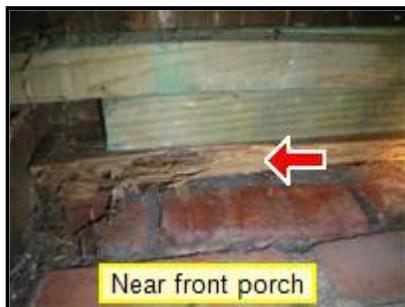
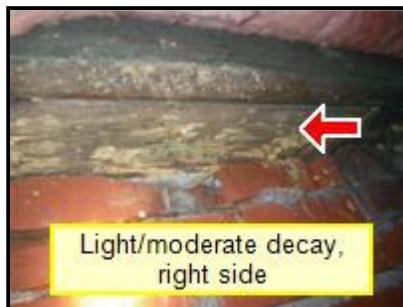
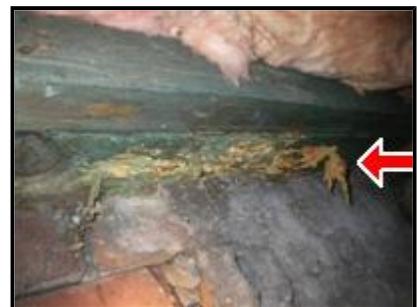
🔧 (5) Decay to a small section of the wood floor structures (band sill at the front of the home) inside the crawl space was observed. New wood was attached to the damaged band sill, when total replacement would have been the better option. Repair by a licensed general contractor is recommended.

Some decay to a small section of the wood floor structures (band sill at the right side of the home) inside the crawl space was observed. An evaluation by a licensed general contractor is recommended.

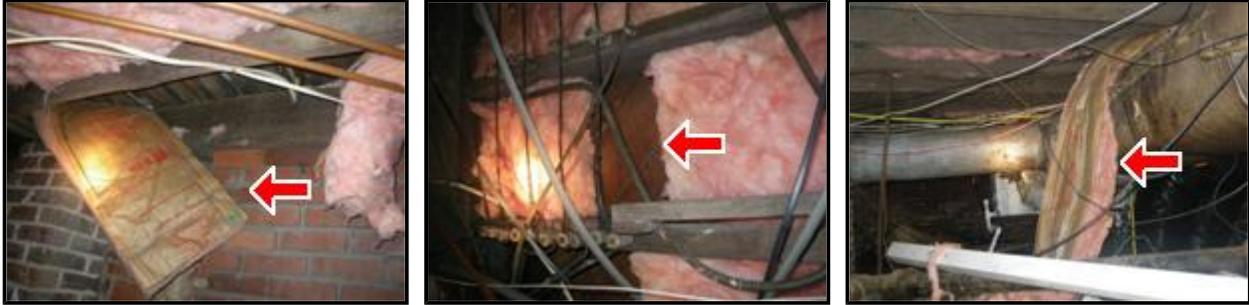
🔧 4.4 Some pieces of insulation are hanging or have fallen from between the floor joists. This does not have

any serious consequences, but negatively affects thermal efficiency and you may wish to have it serviced.

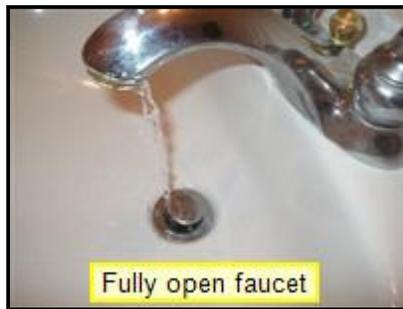
🔧 (2) Little to no water flow was present at the downstairs hall bathroom sink. We recommend that a licensed plumbing contractor evaluate the functional flow prior to the close of escrow, as the repair may be relatively simple or something more serious.

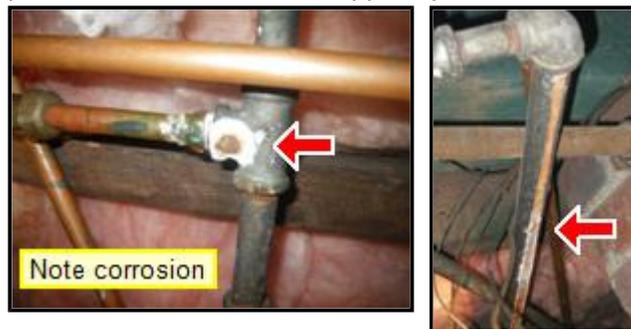
🔧 (4) Some of the potable water pipes within this residence galvanized, and are assumed to be original. By their nature, they will produce rusty looking water from time to time, and because the water volume in such pipes will gradually be reduced by a build-up of minerals within them, we do not fully endorse them. We recommend that you have a plumber evaluate them and apprise you of the cost of re-plumbing the home.

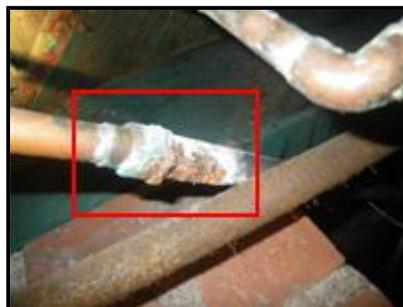
🔧 (5) A deteriorated or corroded plumbing fitting was observed near the rear left of the crawl space. While no visible leaks were observed, we believe the fitting is in danger of leaking at any time. Service by a licensed plumbing contractor is recommended.

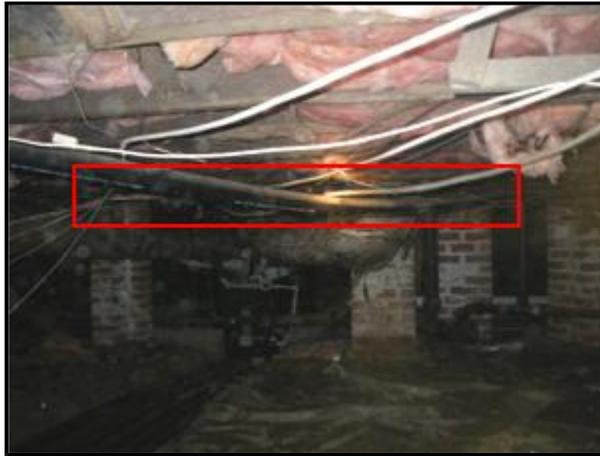
🔧 (4) A waste drain line flows uphill in the crawl space, which limits proper drainage. The minimum slope toward the sewer or septic system is 1/4" per foot. The maximum slope is 1/2" per foot. An evaluation by a licensed plumbing contractor is recommended.

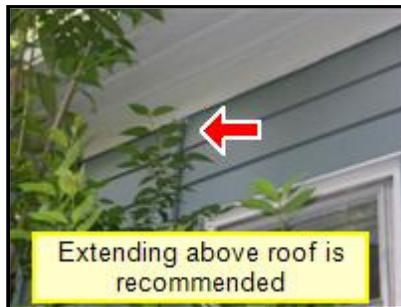
🔧 5.2 The plumbing waste drainage system appears to vent near an operable window. Vents are normally designed to vent outside the residence, and usually vent above the roof eave. Venting near a window may introduce odors into the home. We recommend that this method of venting be evaluated by a licensed plumbing contractor.

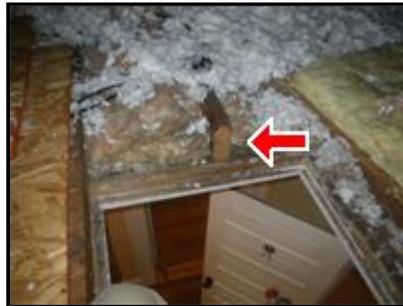
🔧 (2) A ceiling joist at the attic entrance has been cut and was not braced to compensate for the opening. Service by a licensed contractor is recommended.

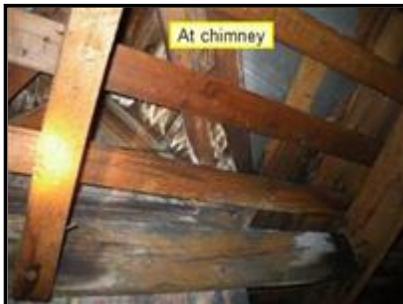
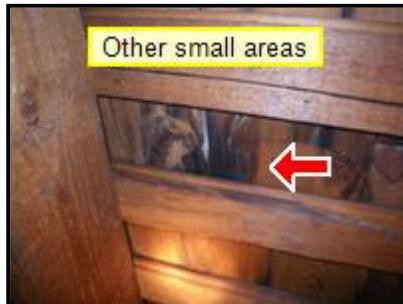
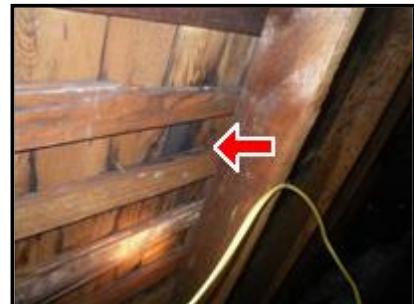
🔧 **7.6** Roof sheathing is water damaged around the chimney. Other areas had small portions that appeared to be water damaged. An active leak may exist and we recommend an evaluation and repair as deemed necessary by a competent roofing contractor unless the current owner can demonstrate that repairs have been performed. The areas were dry at the time of the inspection.

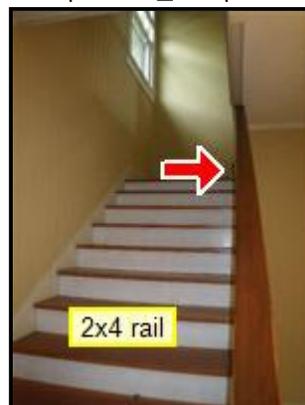
🔧 (4) The main stairs were not equipped with a standard, graspable, handrail. A standard handrail meeting today's standards is recommended for safety reasons. Information about proper stair railing and illustrations can be obtained here: [www.aohomeinspection.com/pdf/IRC\\_interpretation.pdf](http://www.aohomeinspection.com/pdf/IRC_interpretation.pdf). (See page 10.)
