**Alpha & Omega
Home Inspections, LLC**

CONFIDENTIAL INSPECTION REPORT

42 Oak St., Monroe, NC 28110

1/10/2007 1:45 pm to 5:20 pm

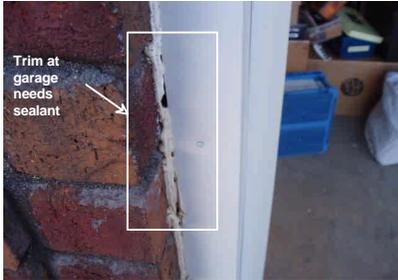
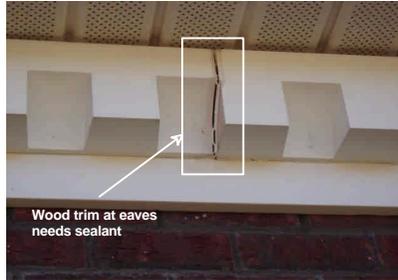
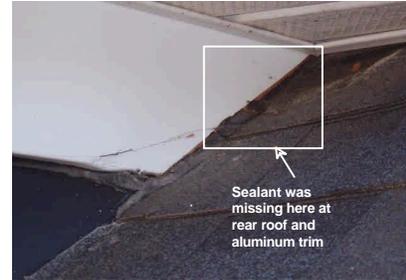
1.4 - The house trim needs sealant to prevent moisture intrusion.

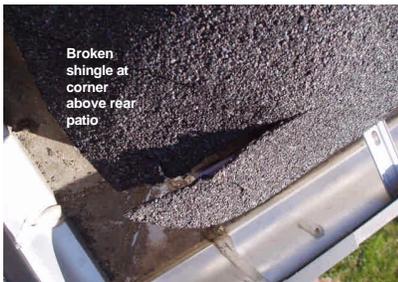
2.1 - Broken, cracked, or otherwise damaged shingles were observed. Evaluation and repair as deemed necessary by a licensed roofing contractor is recommended.

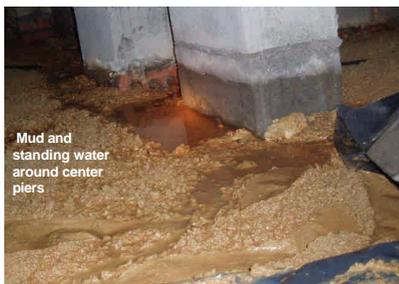
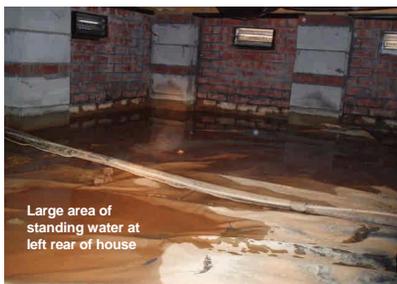
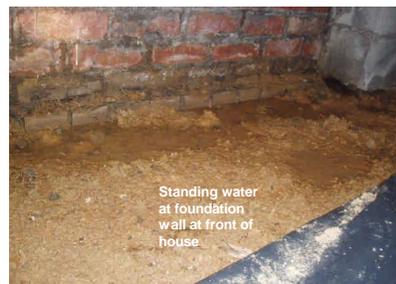
3.2 - Standing water and wet soil were observed in the crawl space in many areas. The exact entry point of the water could not be determined. Moisture can facilitate the growth of a variety of molds that can promote unhealthy conditions and excess humidity can cause decay to wood structures over time. Additionally, chronically moist conditions can cause foundation settlement or deterioration over time. We therefore recommend that you consult a grading or drainage contractor to correct this adverse condition. Observation of the crawl space during a period of heavy and prolonged rain is also recommended.

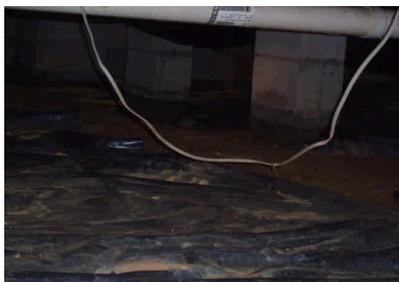
3.4 - In the crawl space, electric cables dangled overhead. Electric cables are required to be supported overhead every 4.5 feet.

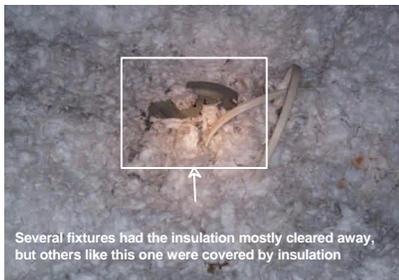
4.1 - We were unable to confirm that the recessed lights are designed to be installed in ceilings surrounded by insulation (IC rated). Recessed light fixtures that are installed in insulated ceilings can represent a fire hazard if they are not suitably rated for this application. Unfortunately, it is difficult to verify that the installation has been made correctly during a home inspection as the manufacturer's label is often inside the light fixture assembly. It is recommended that a licensed electrician be engaged to verify the safety of the system.

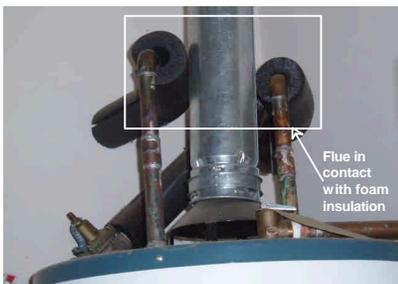
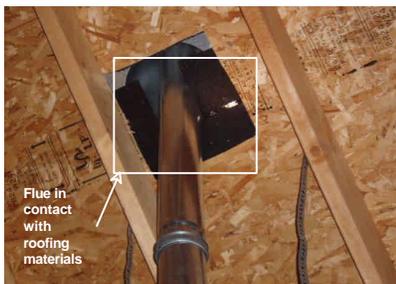
6.1 - The vent pipe is too close to combustible material, and should be serviced before the close of escrow. A single-walled vent pipe should be six inches away from any combustible material, and a double-walled vent pipe should be one inch away.

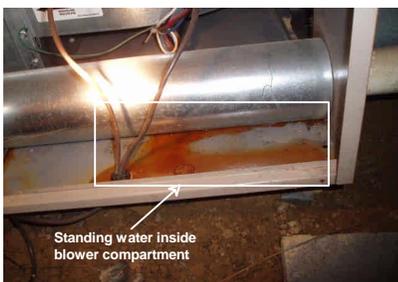
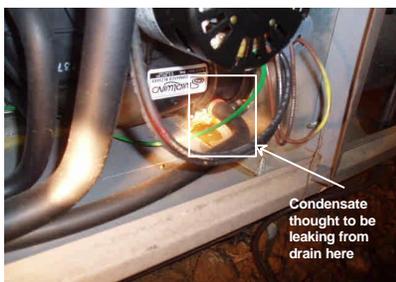
9.1 - The furnace condensate drain was leaking, which may indicate a clogged drain. Service by a licensed HVAC contractor is recommended.

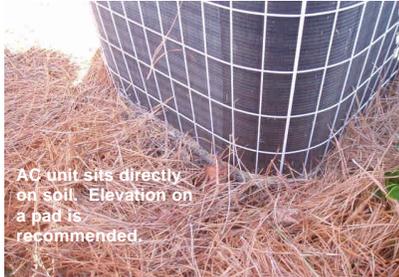
9.2 - The condensing coil was not elevated above the soil. Most manufacturers recommend an elevation of three inches above the surrounding soil to prevent corrosion.

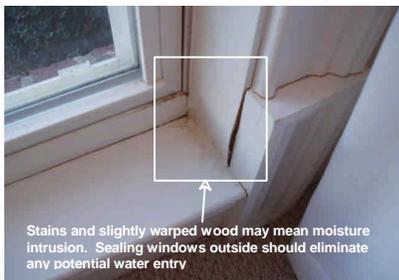
12.2 - Stains observed at the window may indicate moisture intrusion, but conditions were dry at the time of the inspection. We recommend that you monitor the area during periods of heavy an prolonged rain.
