Alpha & Omega Home Inspections, LLC

Confidential Inspection Report

634 Anystreet
MyTown SC

Date: 5/12/2010	Time: 04:40 PM	Report ID: Sample Report - 75 YO Home
Property: 634 Anystreet MyTown SC	Customer:	Real Estate Professional:

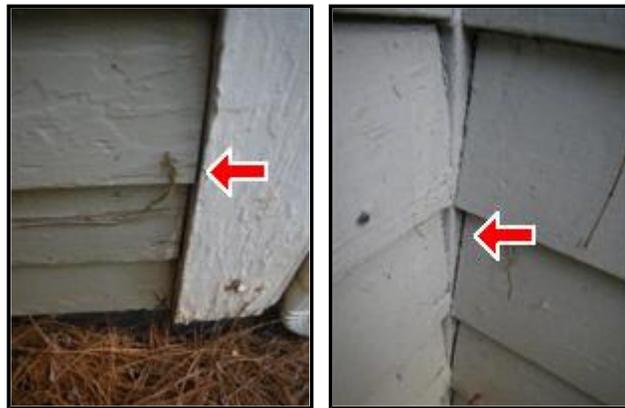
🔧 **1.3** One area(s) of the wall siding were not adequately sealed at butt end joints and where it meets the house trim. A thorough review of the siding by a licensed contractor and service to seal the openings is recommended. Failure to seal the joints may result in long-term deterioration of the siding or sheathing behind it.

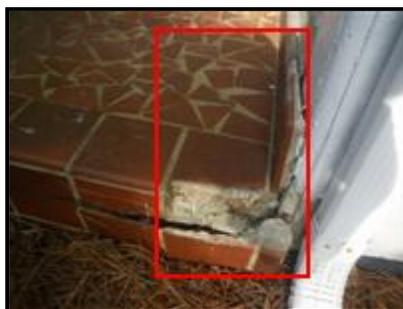
🔧 (2) Sections of the tile at the front porch are in poor condition and should be replaced by a specialist.

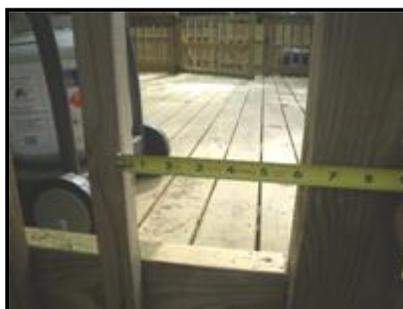
1.12 (1) The rear deck guardrail balusters do not conform to today's commonly accepted construction standards. The pickets should be spaced no more than four inches apart for child safety, and that is what we recommend if small children will be present.

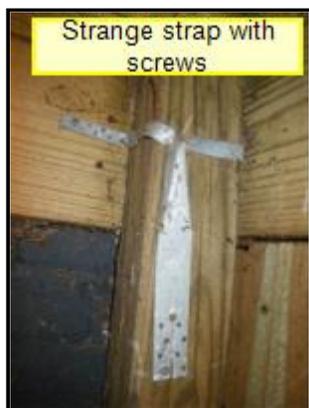
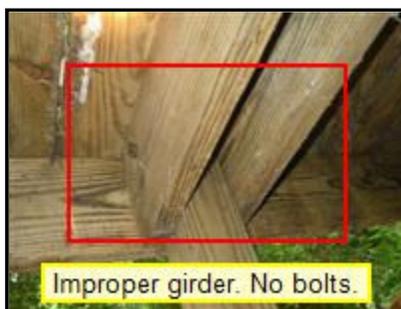
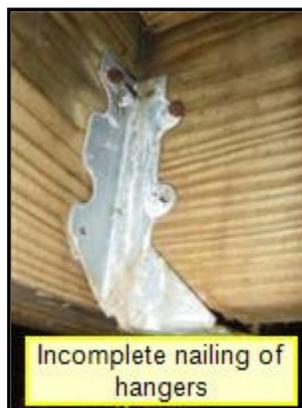
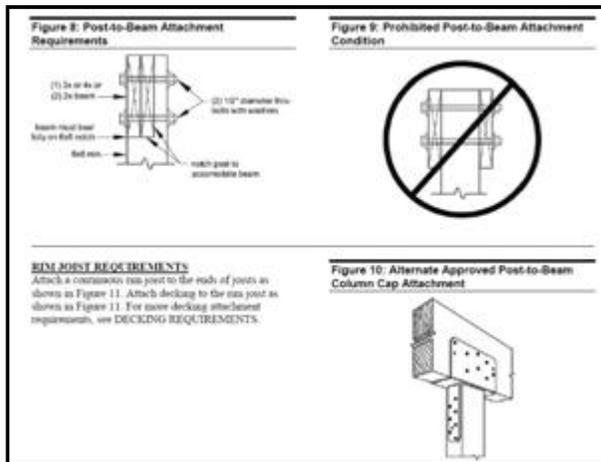
(2) There are components of the rear deck that are structurally unsound. We can elaborate on this issue, but the entire rear deck should be evaluated by a competent and licensed contractor and serviced accordingly.

The wood deck has atypical footings, spans, connections or rails, and could have been built without the benefit of a permit. We can elaborate on this issue, but you should request the permit from the sellers or have a specialist evaluate it.

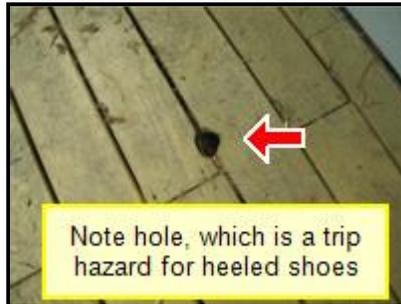
🔧 (4) The rear deck needs maintenance-type service such as sanding, pressure washing, sealing or painting, which will prolong the life of the structure.

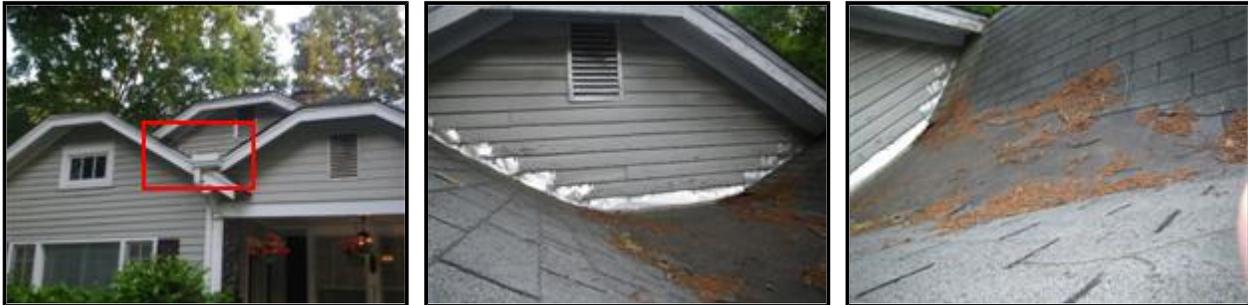
2.0 (1) The roof design is one that is susceptible to leaks. Water, snow, ice, tree debris may accumulate in this wide, nearly flat valley. FYI.

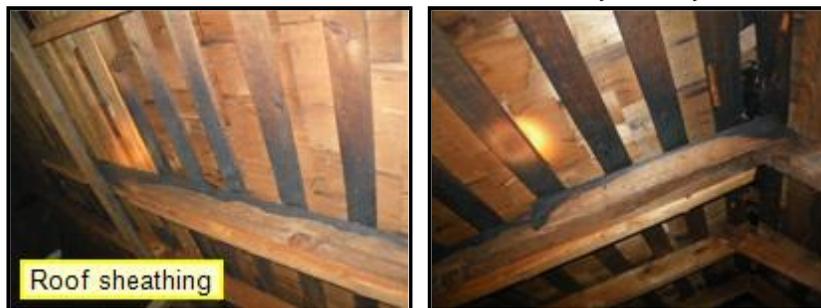
(2) The roof sheathing consists of 'skip planks'. The original cedar shakes are still installed. There was no plywood or OSB visible. On the next re-roof, the cedar shakes may have to be completely replaced with OSB, which will greatly increase the cost. You are advised to have the roof evaluated by a competent roofing contractor prior to the close of escrow because the cost of a re-roof may affect your evaluation of the property.

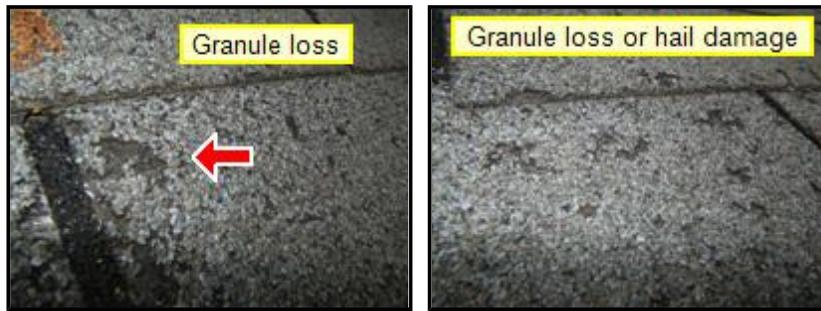
(4) The roof is in a stage of serious decomposition (loss of shingle granules, etc.), which means that the roof is susceptible to leaks. It is at the end of its serviceable life in our opinion. We recommend an evaluation of the roof by a competent roofing contractor before the close of escrow because the cost of replacement may affect your valuation of the property.

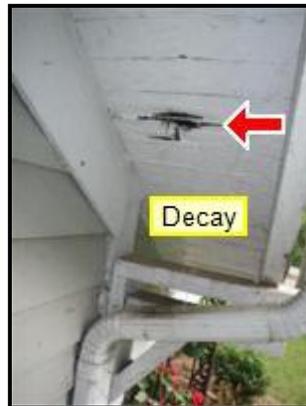
🔧 (5) A roof leak (or gutter overflow) at the front of the home, left of the porch, has caused damage to the roof sheathing. Service by a competent roofing contractor is recommended.

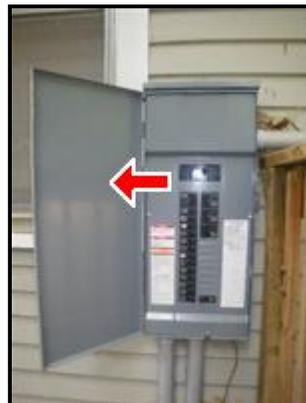
🔧 (2) The main panel cover would not effectively close so that the unit is water tight. The cover has been modified from the original design. The interior is therefore exposed to moisture. Service or replacement is recommended.

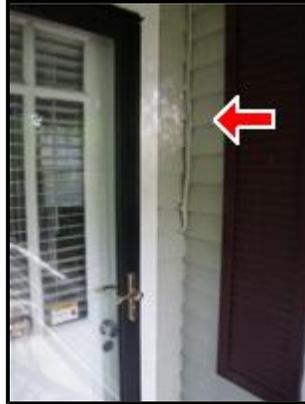
🔧 **3.4 (1)** Non-metallic sheathed cable, within 7 feet of the floor or ground surface at the main entry door, was not protected from damage. Installation in conduit or behind walls is recommended.

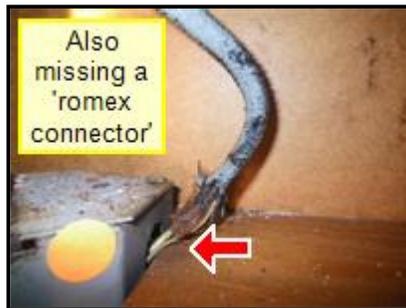
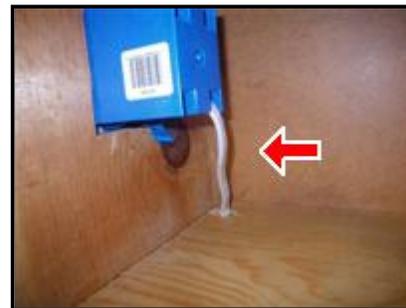
🔧 (2) Non-metallic sheathed cable in a kitchen cabinet was not protected from potential damage. Installation in conduit or behind walls is recommended.

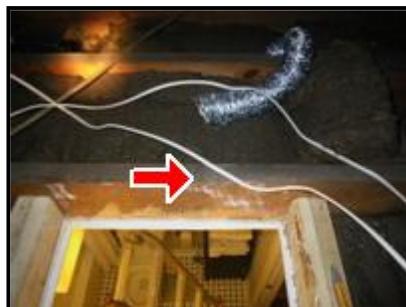
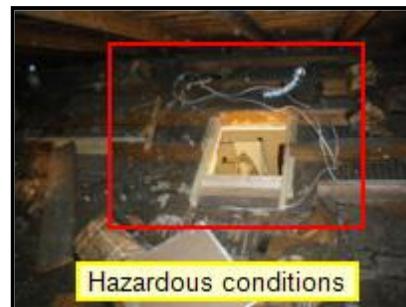
🔧 (3) There are unprotected electrical conductors within six feet of the attic access. Today's commonly accepted construction standards prohibit this practice and we recommend that they be relocated for safety reasons.

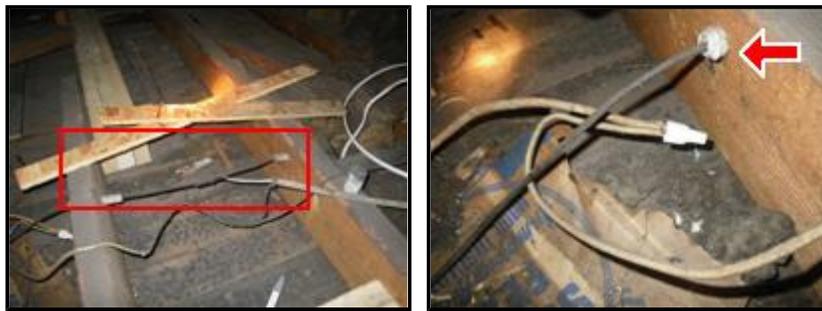
🔧 (4) The residence is wired with suspect knob-and-tube wiring, which was commonly installed prior to 1950. It is ungrounded and over time the wire's insulation may become brittle and fall apart or wear thin, resulting in exposed conductors and a risk of shock and/or fire. The hazard is increased by covering it with insulation (we observed this condition at this home), and incorrectly tapping new wiring into it. The wiring should be evaluated by a competent, licensed electrician and certified as being safe or replaced.

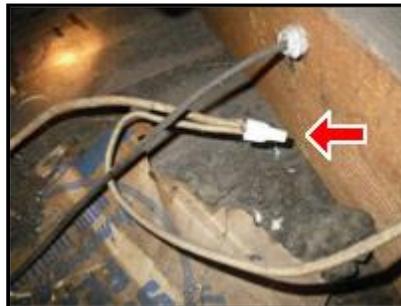
⚡ (5) Many electrical connection(s) in the attic have been incorrectly made outside of junction boxes, which is a potential fire hazard. All such connections should be made within junction boxes in order to contain any arcing or sparking that could occur, a task that should be completed by a licensed electrician.

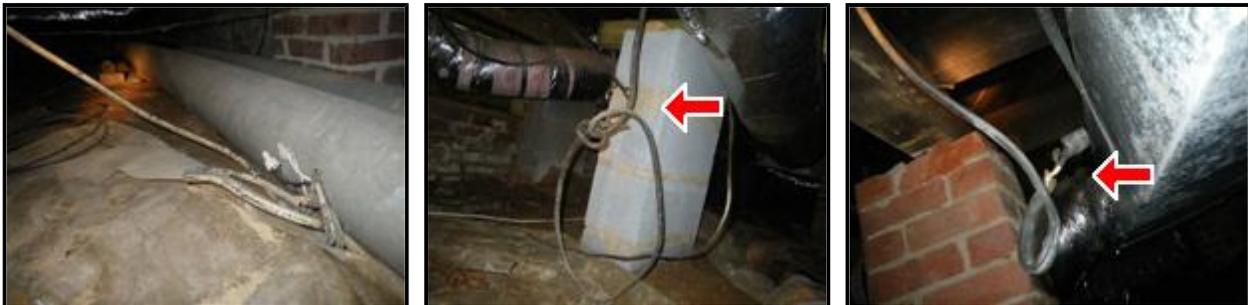
⚡ (7) Many wires in the crawlspace has been improperly terminated. Removal or enclosing it in a junction box is recommended. We realize that much of the house has been re-wired, but we cannot determine that all the dangling wires are not capable of being energized by the flipping of a certain switch or breaker. Common practice is to remove old wiring or terminate it properly for safety reasons and to remove all doubt about which systems are potentially live.

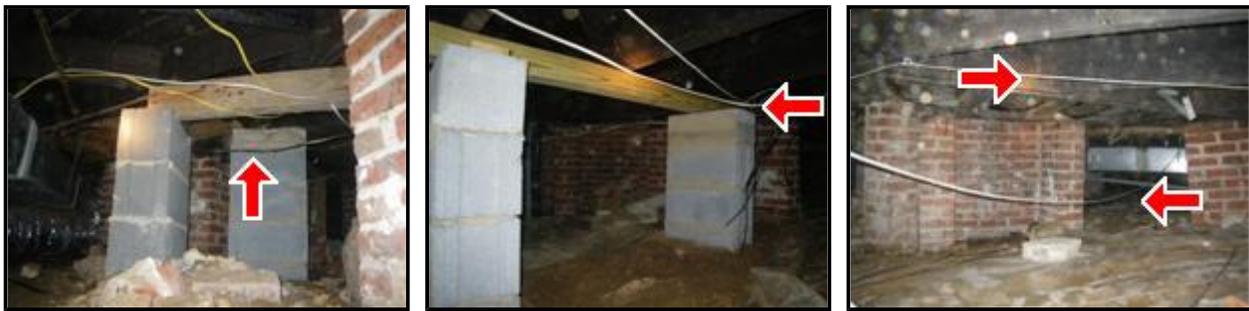
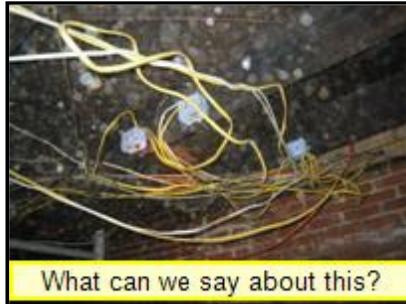
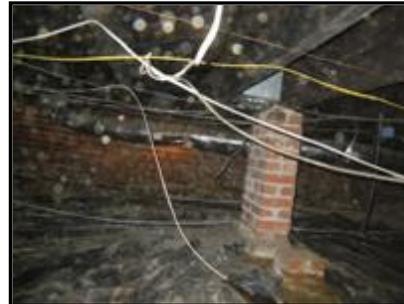
⚡ (8) In the crawl space, many electric cables dangled overhead. Electric cables are required to be supported overhead every 4.5 feet.

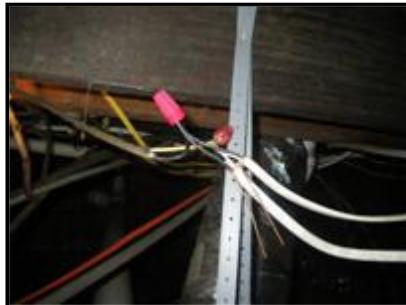
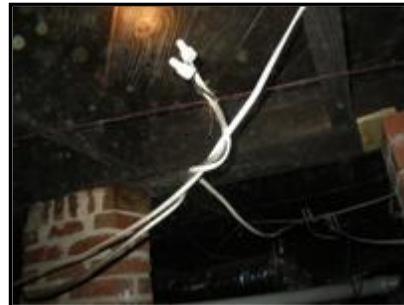
🔧 (9) Several electrical connection(s) in the crawlspace have been incorrectly made outside of junction boxes, which is a potential fire hazard. All such connections should be made within junction boxes in order to contain any arcing or sparking that could occur, a task that should be completed by a licensed electrician.

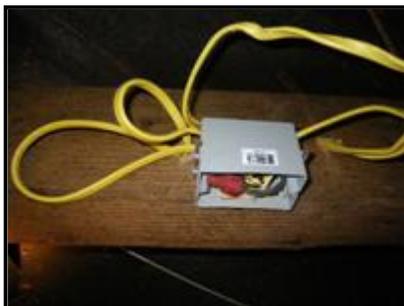
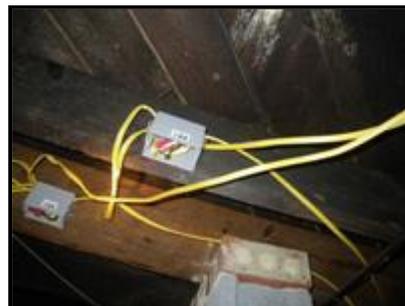
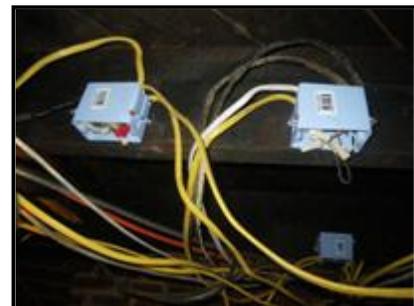
🔧 (10) Many open electrical junction box(s) were observed in the crawlspace which should be sealed to contain any arcing or sparking that might occur.

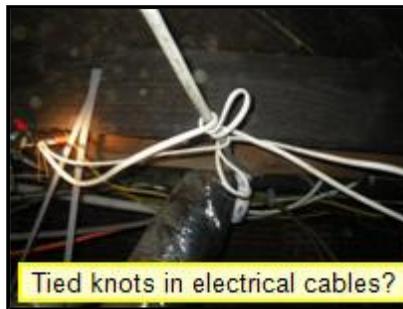
🔧 (11) **The quality and condition of the electrical work that was recently performed in this house is among the worst we have ever encountered.** It is difficult for us to imagine that this work was performed by a licensed electrician. We therefore recommend that a competent and licensed electrician perform a review of the entire house and make repairs as deemed necessary.

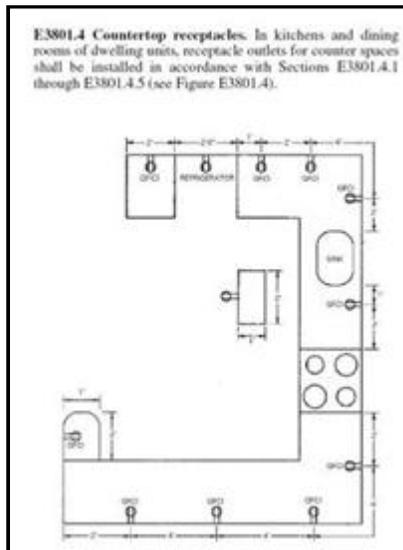
(2) There are not as many outlets serving the kitchen counters (at the sink area) as would be required by current standards, and you may wish to consult an electrician about the possibility of adding more.

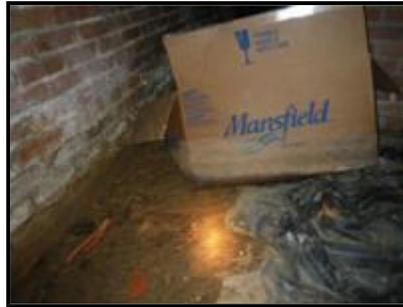
🔧 (3) Wood and/or other organic material was in the crawl space, which attracts wood destroying organisms. While we did not perform a pest control inspection, removal of all wood and similar materials from the crawl space is generally recommended.

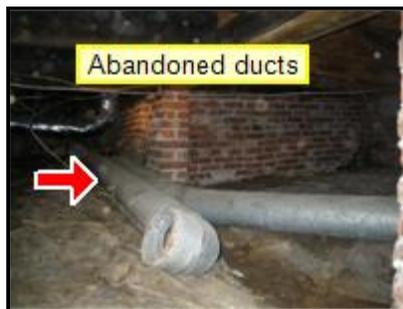
🔧 (4) Debris was in the crawl space in quantities that may provide a haven for rodents or other pests. While we did not perform a pest control inspection, removal of all debris and similar materials from the crawl space is generally recommended.

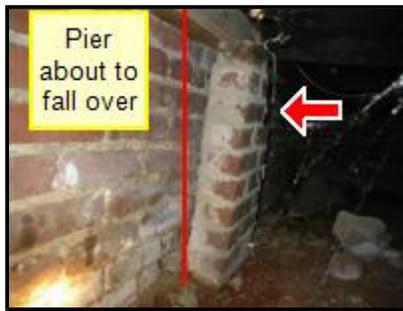
🔧 **4.1** (1) Even with the addition of new piers, other piers were leaning or deteriorated that have not been effectively reinforced by new piers. An evaluation of the house piers by a licensed engineer or foundation specialist and repair as deemed necessary by a general contractor is recommended.

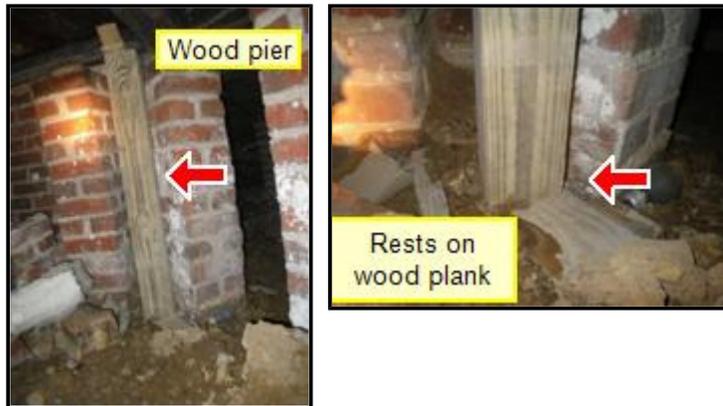
🔧 (2) A portion of the floor structure was supported by various make-shift piers. Those floor supports exhibit poor workmanship are thought to be inadequate to provide permanent support to the floors. It is recommended that a competent and licensed general contractor or foundation specialist be consulted to provide a further evaluation of the adequacy of the floor supports and make necessary repairs.

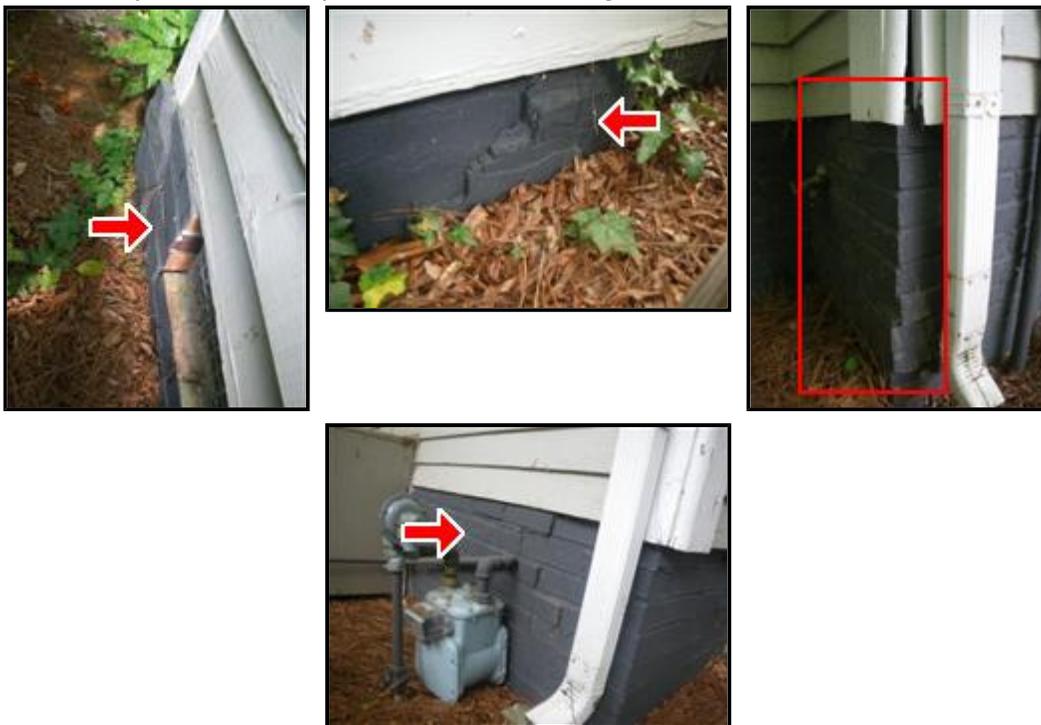
🔧 4.2 (1) There are pressure bulges in the foundation wall at the front of the home and along the left side that should be evaluated by a foundation specialist or structural engineer.

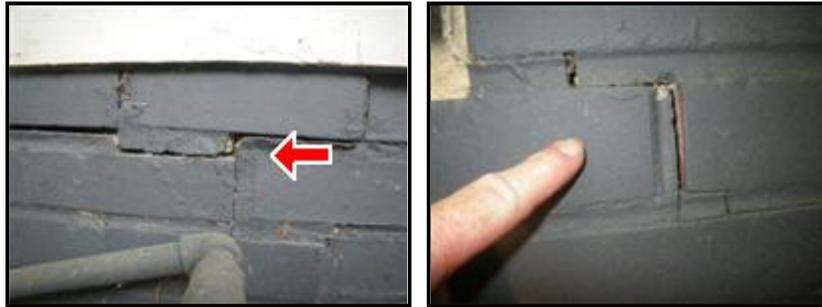
🔧 (2) There is a visible crack in the foundation a the right side. The crack was open and of measurable width

at the time of the inspection. A crack in the foundation indicates a deficiency. Cracks can change seasonally and progress over the life of the home. The crack may or may not penetrate through the foundation footing. A professionally engineer should be consulted to evaluate the foundation and determine extent of necessary repairs.

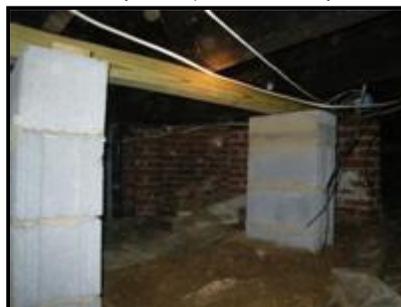
(3) Extensive repairs and new wood (piers, joist, beams, etc.) were observed in various areas. You should ensure the repairs were performed by licensed contractors with the benefit of a permit and you may want to view the condition for yourself. If you cannot confirm the work was performed by a licensed contractor with the benefit of permits, then we recommend that you have a licensed contractor evaluate the work and current condition. Note: generally speaking, structural repairs (band sill replacement, etc.) requires a permit.

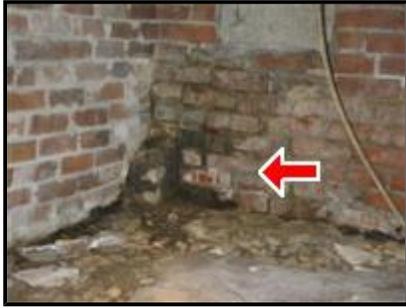
(2) There is efflorescence on the foundation wall in the crawl space at the front of the home which confirms a chronic moisture penetration condition that has activated minerals that form a white powdery formation of salt crystals. Therefore, you should consult a grading and drainage contractor or a licensed general contractor with experience in crawl space drainage and moisture to determine the extent of the concerns and necessary repairs.

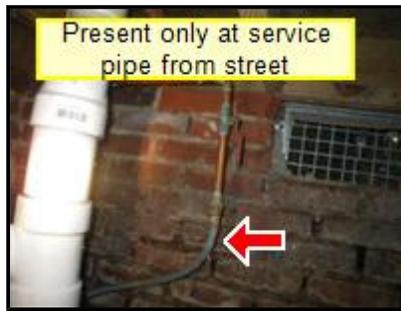
5.0 (1) The water supply pipes include Polybutylene plastic (PB). Polybutylene has been used in this area for many years, but has had a higher than normal failure rate, and is no longer being widely used. Copper and brass fittings used in later years may have reduced the failure rate. There is also a current theory that chemicals in municipal water systems react with the piping and resins in the fittings, weakening the pipes and joints. Heat may also cause the pipes to deteriorate and burst. The manufacturers have settled a class action lawsuit alleging manufacturing defects with this plumbing system containing plastic or metal insert fittings (including copper and brass). For more information about PB, see <http://www.pbpipe.com> and other Internet resources. We recommend that you do your own research on this type of plumbing system and rely on the evaluation and advice of a licensed plumbing contractor prior to the close of escrow.

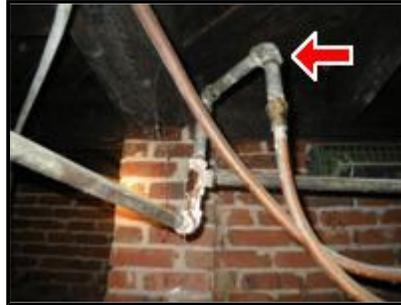
🔧 (3) Some or all of the potable water pipes within this residence galvanized, and are assumed to be original. By their nature, they will produce rusty looking water from time to time, and because the water volume in such pipes will gradually be reduced by a build-up of minerals within them, we do not fully endorse them. We recommend that you have a plumber evaluate them and apprise you of the cost of re-plumbing the home.

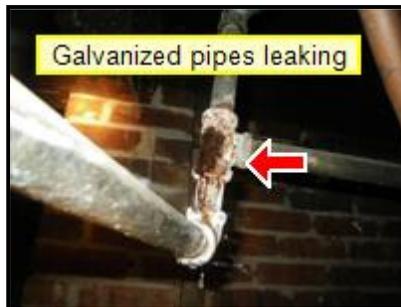
🔧 (4) There is a water supply pipe leak in the crawl space, which should be repaired by a licensed plumber within the contingency period, or before the close of escrow. This is particularly important because leaks can lead to the growth of molds and fungi, which can have an adverse influence on health.

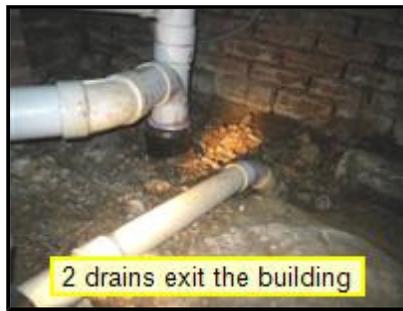
🔧 **5.3** What is apparently a laundry drain exits the house separately. It was common to discharge a laundry drain separately when septic systems were in use, but it would not be permitted by today's standards. You may wish to consult with a licensed plumbing contractor about the acceptability and ramifications of this method of waste water disposal and/or have it traced.

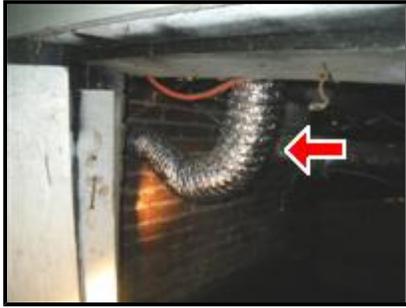
🔧 **5.11** The dryer vent in the crawlspace was corrugated, flexible ducting. Today's commonly accepted standards specify that corrugated ducts may be used only within the first 8 feet and may not be concealed within construction. The concealed ducts should be rigid metal ducts or equivalent, without screws, vented to the exterior of the home. This is recommended for fire safety reasons.

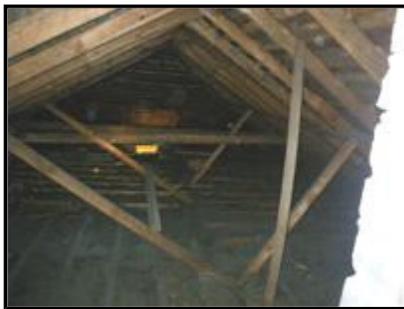
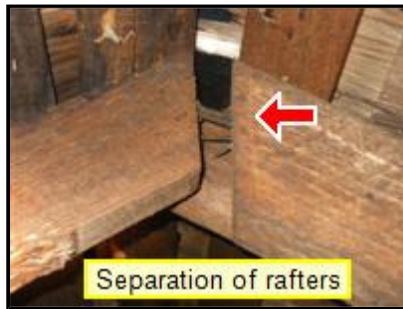
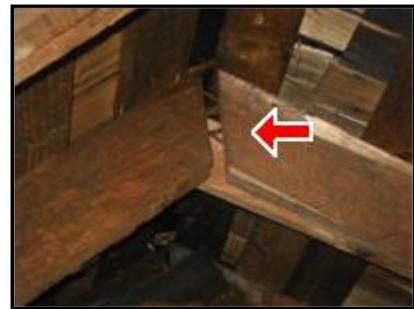
(3) A 'jumble' of miscellaneous, loose braces is all that provides support to the attic. The rafters have spread at the roof peak. An evaluation and service by a licensed and competent general contractor is recommended.

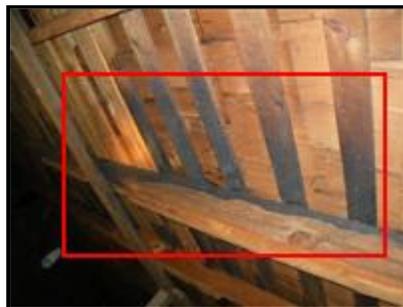
🔧 (4) Components of the roof framing have been scorched or charred. You should request information about this from the sellers, and if the charred framing has not been evaluated by an engineer it should be.

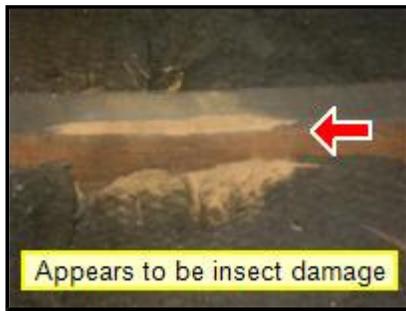
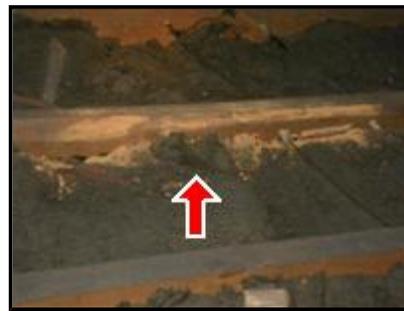
🔧 (5) While we are not trained or licensed to perform a pest control inspection, signs of previous or current activity by wood destroying organisms were observed in the attic and you should obtain a pest control inspection prior to close of escrow. Additionally, we recommend that a licensed general contractor evaluate the affected attic framing and make repairs as deemed necessary.

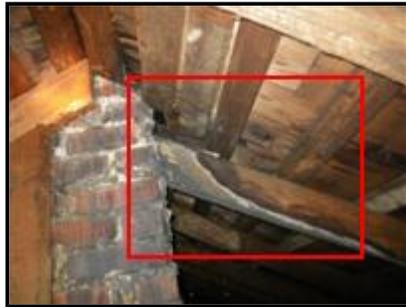
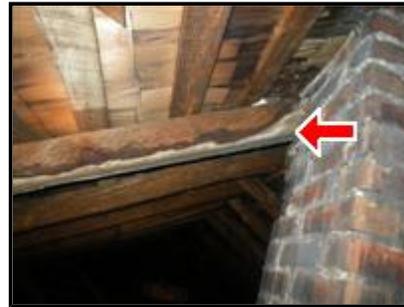
7.6 Roof sheathing is water damaged around the chimney. An active leak may exist and we recommend an evaluation and repair as deemed necessary by a competent roofing contractor unless the current owner can demonstrate that repairs have been performed. The areas were dry at the time of the inspection.
