Alpha & Omega Home Inspections, LLC

Confidential Inspection Report

Property Address:
8403 Anystreet
MyTown NC

Date: 3/22/2010	Time: 09:00 AM	Report ID: Sample Report - Million Dollar Home
Property: 8403 Anystreet MyTown NC	Customer:	Real Estate Professional:

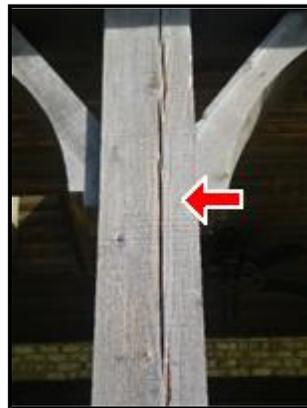
🔧 **1.2** Wood posts at the rear of the home exhibit "checking", which is a natural splitting of the wood. The checking itself is not a structural concern, however the openings should be treated with weather preservative to prevent deterioration and decay.

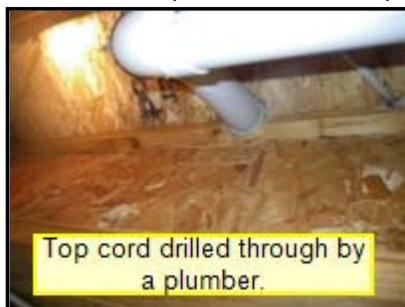
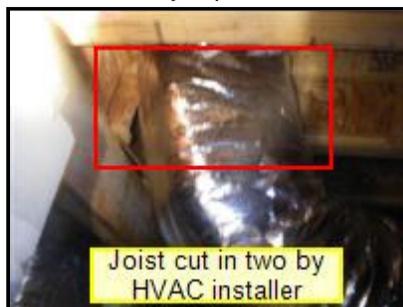
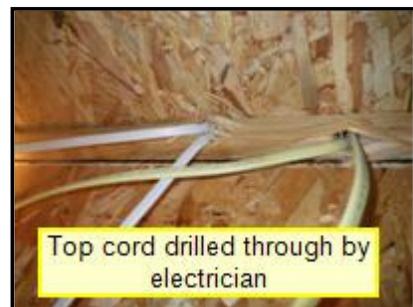
🔧 **1.3** (1) Engineered joists have been cut, drilled, or altered in one or more locations (right rear of home, right front of home, left front of home). Manufactured I-joists are highly engineered components. For this reason, field modifications such as notching, drilling, or tapering should be avoided and never done without a thorough understanding of their affects on the structural integrity of the member. Any modification should comply with the manufacturer's specifications. (Notching or drilling through the top or bottom cord is never permitted.) Accordingly, we recommend that a competent licensed general contractor review the modifications, the manufacturer's specifications, and perform necessary repairs.

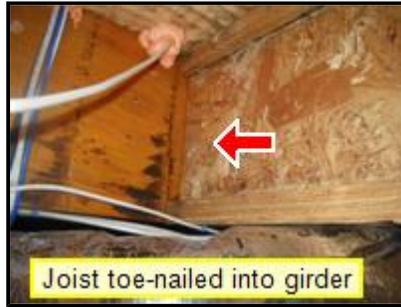
🔧 (2) Engineered I-joists are inadequately supported in the crawlspace. There is no ledger board or joist

hanger supporting three joists at the right rear of the home. They are simply toe-nailed into the adjoining girder. Repair by a licensed contractor is recommended.

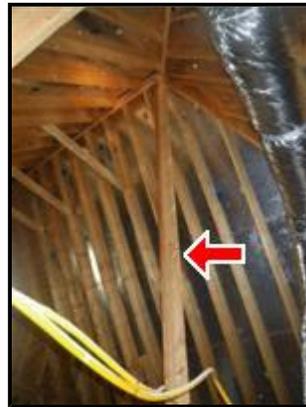
(2) An attic brace was very loose near the furnace. Service by a competent and licensed contractor is recommended.

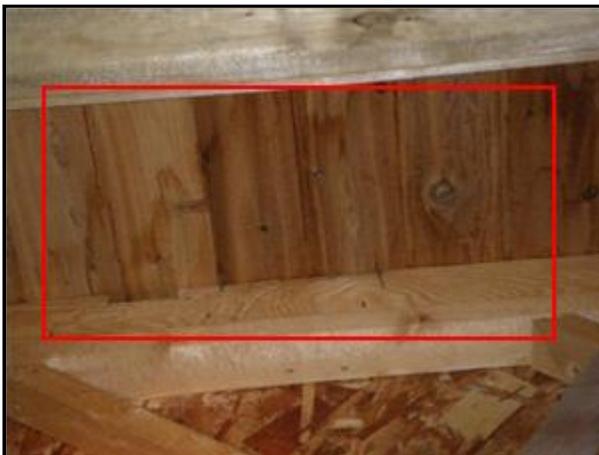
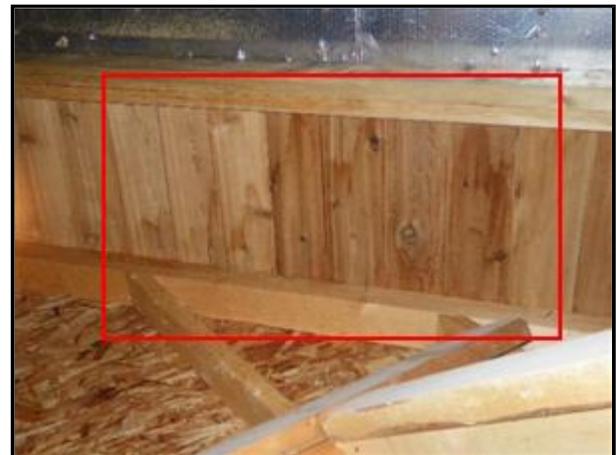
(3) At the front of the home, the very peak, there is a possible roof leak. We observed roof sheathing that was lightly stained. The stains may only be sap, but they more closely resemble water stains. We recommend an evaluation by a competent roofing contractor and/or observation during a period of heavy or prolonged rain.

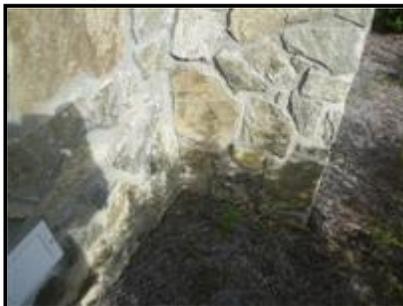
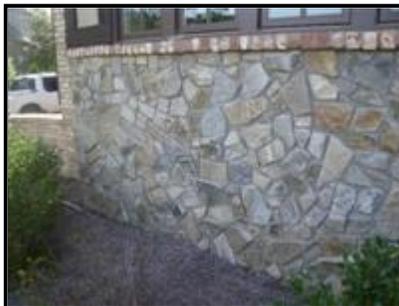
🔧 (2) The stone wall had no visible weep screeds. Stone walls are porous. If water were to penetrate behind the wall, there should be an exit point (a weep screed). While the absence of weep screeds is extremely common and builders will argue about the need for it, we believe the lack of a weep screed violates today's commonly accepted construction standards for stucco installation (and this type of wall covering is essentially stucco with rocks placed in it). The potential consequences could be trapped moisture behind the wall and long-term failure of the wood wall structure behind the stone, which may not be revealed until years in the future. We suggest that you obtain an independent evaluation of the installation methods by a licensed general contractor with experience in this siding installation and the applicable codes that govern its installation.

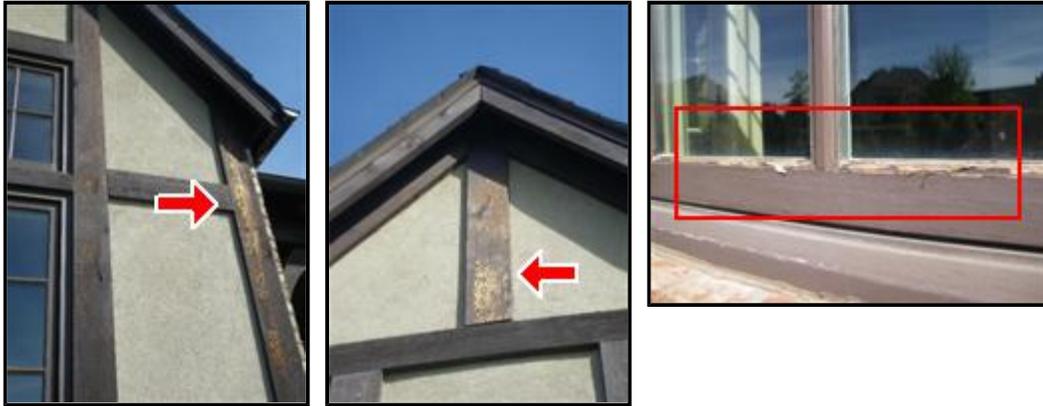
🔧 (5) Sections of the windows and house trim need paint or stain at the rear of the home. Bare wood was exposed to the elements. Failure to coat these areas will result in deterioration to the wood.

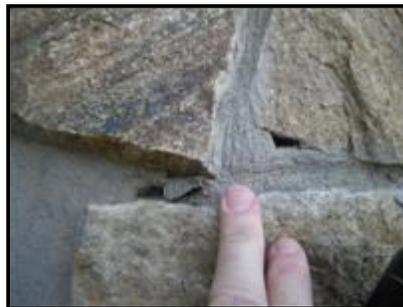
🔧 (7) Portions of the stone wall need mortar to fill voids between the stones. Failure to completely fill the voids may result in water entry behind the wall and subsequent structural damage.

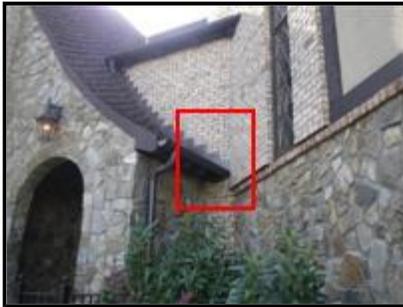
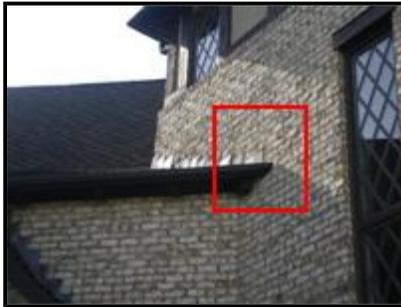
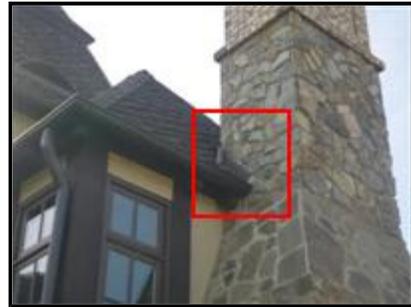
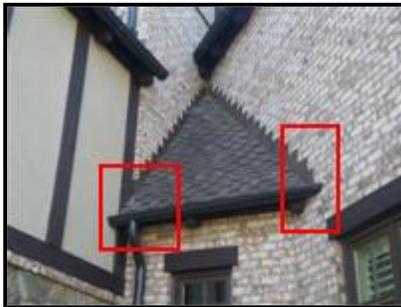
**3.1** (1) Kickout flashing may be necessary but was not observed at many roof to wall transitions to divert water away from the wall system and back onto the roof or gutter. Failure to properly manage water flow at these critical transitions may lead to water entry into the wall system, which will cause serious structural damage. An evaluation and repair as deemed necessary by a competent roofing contractor is recommended. A reference document is attached for your information.

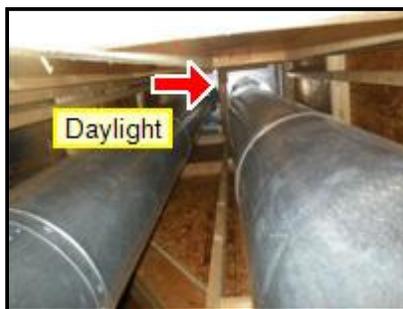
(2) Daylight can be seen around one of the chimney flues. Evidence of water entry into the attic was present (insulation that had been previously wet.) The flashing is apparently loose, incorrectly installed, or damaged. Service by a competent roofing contractor is recommended.

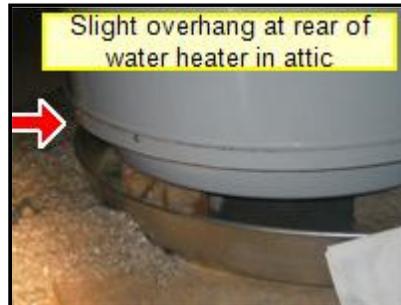
🔧 (2) The drip pan may not be positioned correctly to catch any leaks that may occur at the water heater. Leaks may damage the house structure below and cause damage. An evaluation and service as deemed necessary by a licensed plumbing contractor is recommended.

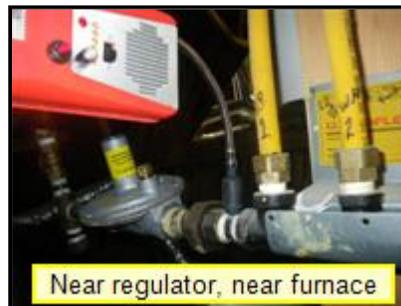
🔧 4.5 (1) A gas leak was detected in the attic. Service by a licensed plumbing contractor or the gas utility is recommended.

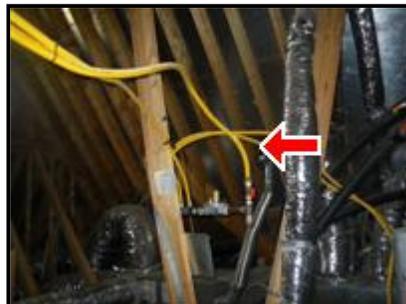
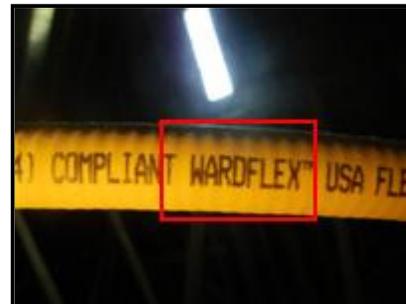
🔧 (2) A common gas piping system called Corrugated Stainless Steel Tubing or CSST is present in this home. OmegaFlex's product is known as "TRACPIPE" or "COUNTERSTRIKE," Titeflex's CSST product is known as "GASTITE," Ward's CSST product is known as "WARDFLEX," and Parker Hannifin's CSST product is known as "PARFLEX." A lawsuit in 2005 claimed that CSST poses an unreasonable risk of fire due to lightning strikes. The lawsuit was settled and the manufacturers agreed to require additional electrical bonding above the minimum requirements set by the National Electric Code. In most circumstances, the bonding is required to be connected to the house electrical system. We could not confirm that such bonding was present. We recommend a further evaluation and repair as deemed necessary by a competent, licensed electrician familiar with the requirements of this type of gas piping. More detailed information regarding the suit and this piping system is available at www.csstsettlement.com and on [our website](#).

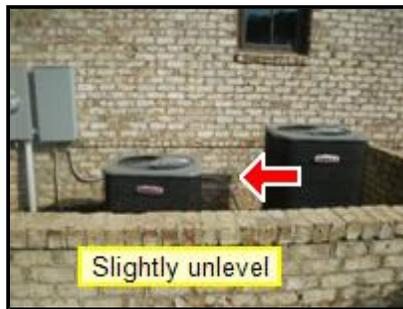
🔧 (3) The condensing coil was not level. A level support pad is recommended to prevent long-term damage to bearings, etc.

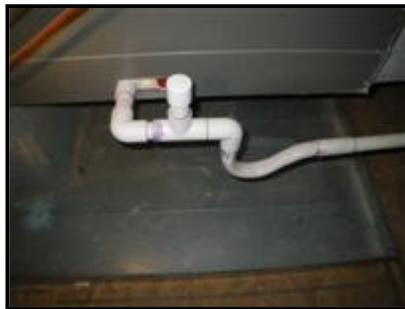
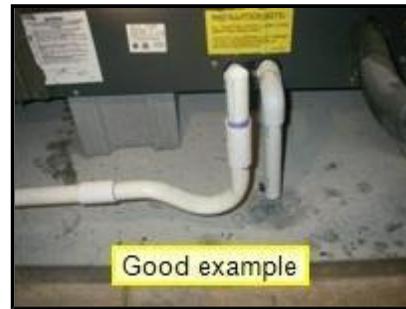
🔧 (4) The secondary condensate port was not plumbed to the drain pan. As a result, when the primary drain line becomes clogged, the condensate inside the air handler has no path to escape. It will rise in the air handler cabinet until it finds a seam in which to seep out, and may cause rust inside the cabinet. In the worst case scenario, the water may rise until it travels down a duct and will cause ceiling damage when it escapes out a duct seam. We recommend that the secondary port be plumbed to the bottom of the drain pan. Immediate service is not critical and can wait until the next scheduled maintenance.

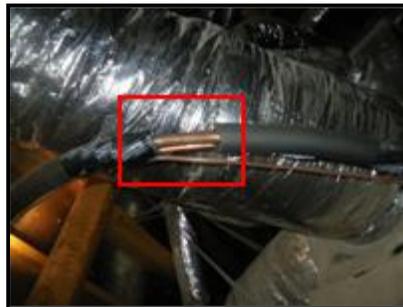
🔧 (5) Insulation is missing from the refrigerant line in the attic. The condition will allow condensation to form and drip, which may cause damage to the ceiling below. Insulation should be installed where missing and taped at the joints.

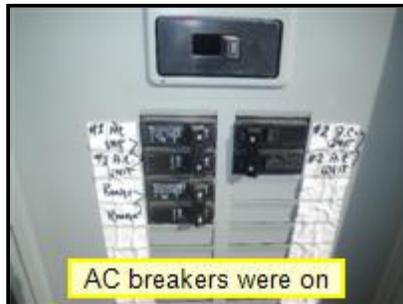
🔧 (6) Neither of the AC system condensers would respond to the thermostat, and should be serviced by an HVAC contractor. This service should be scheduled prior to the close of escrow because a specialist might reveal additional defects or recommend upgrades that could affect your evaluation of the systems.

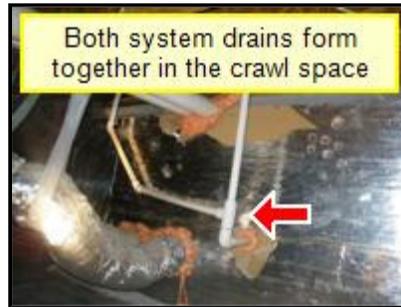
🔧 (7) The primary condensate drains should discharge to a conspicuous location. Both system drains are joined together in the crawl space and it will not be apparent when one system's drain becomes clogged. We recommend relocation so that each discharges to a conspicuous location, 3 to 6 inches above grade, where it can be routinely monitored to ensure it is not clogged.

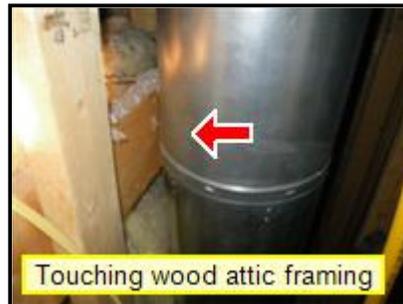
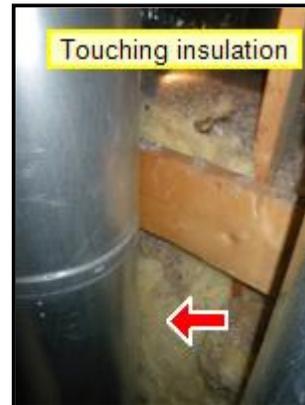
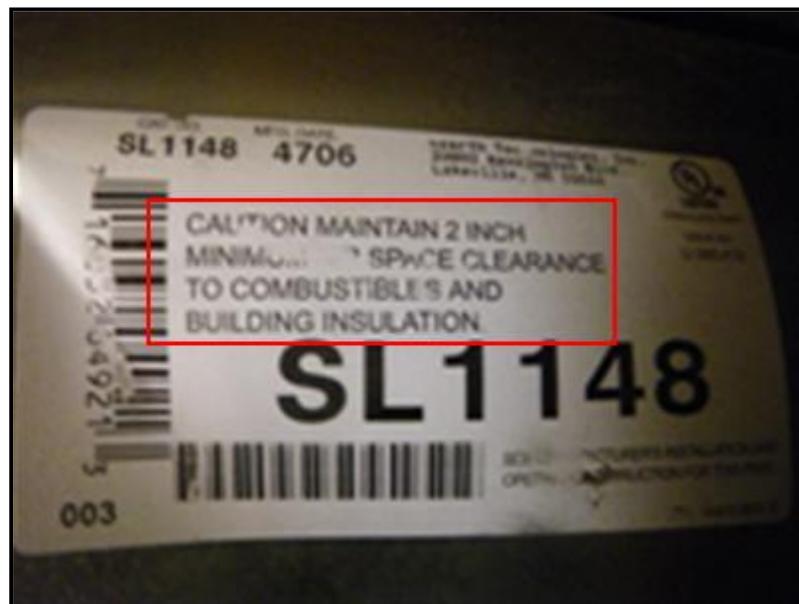
🔧 6.6 The fireplace exhaust flue was in contact with or too close to combustible materials. A single-walled flue should be six inches away from any combustible material, and a double-walled flue should be one or two inches away. This construction defect is considered a fire hazard. We recommend that repairs meeting the manufacturers specifications be conducted for fire safety reasons.

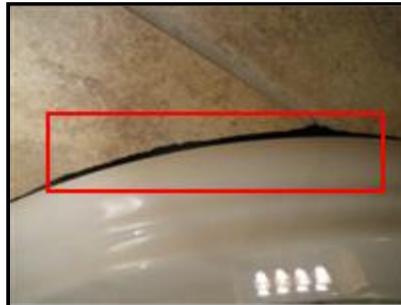
🔧 **7.1 (1)** The tile decking at the spa tub in the master bathroom needs grout or sealant in order to prevent water entry behind the tiles.

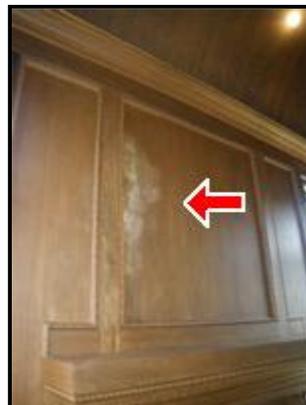
🔧 (2) There is a moisture stain on the library wall, which you should ask the sellers to explain or have explored further. The stain was dry at the time of the inspection. We could not confirm that repairs have been made.

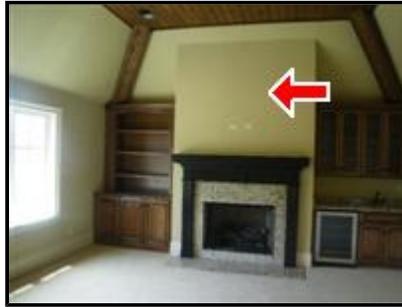
🔧 (3) There is a moisture stain on the 2nd level den wall, which you should ask the sellers to explain or have explored further. The stain was dry at the time of the inspection. We could not confirm that repairs have been

made.

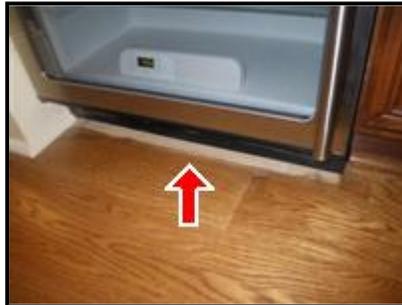
🔧 (2) A small section of the wood floor at the wet bar near the kitchen was not stained.

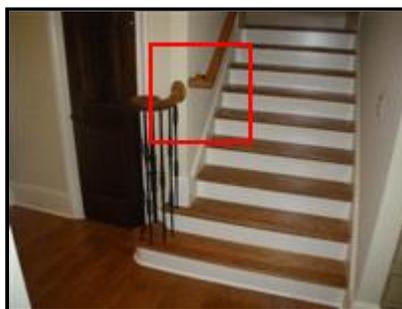
🔧 **7.3** The main stairs did not have a continuous handrail. Today's commonly accepted construction standards require a handrail for 4 or more risers. Additionally, "handrails for stairways shall be continuous for the full length of the flight, from a point directly above the top riser of the flight to a point directly above the lowest riser of the flight." Although this defect is quite common, for safety reasons a railing meeting the standard as quoted above is recommended. Information about proper stair rail construction and illustrations are available on [our website](#) (see page 9).

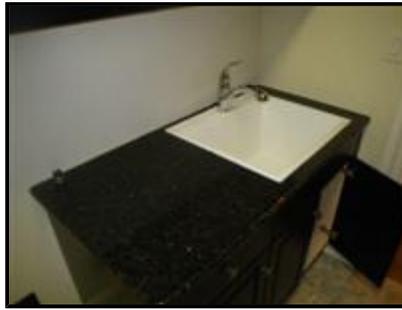
7.4 (1) No backsplash was preset at the laundry room cabinet. Cosmetic damage to the surrounding walls can be anticipated. FYI.

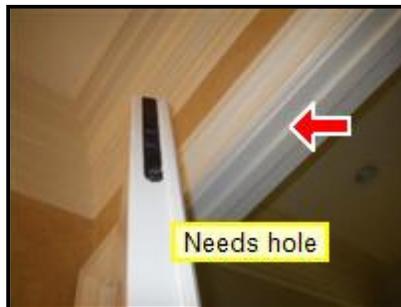
🔧 **7.5** (1) The fixed portion of the double master bathroom door could not be fixed. There is no hole provided for insertion of the door pin.

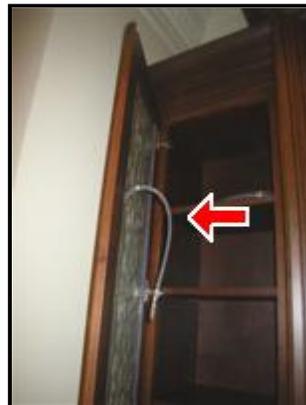
🔧 **7.6** (1) A plastic seal for a cabinet window at the wet bar was not fully installed or else was damaged. Service is recommended.

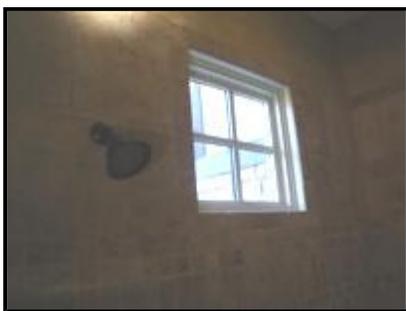
🔧 (2) The master bathroom custom shower contains a wood window, which we consider a poor design. Frequent maintenance will be necessary to prevent deterioration and decay. Replacement with a vinyl clad window is recommended.

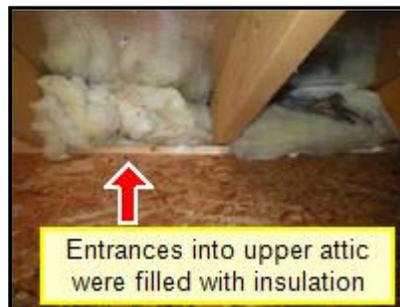
8.3 The small wall storage attic spaces were considered to have inadequate ventilation. Only soffit vents provide ventilation for the structure. For venting to be effective the air has to be able to move. It is recommended that the structure be ventilated with both: A) An air intake preferably located as close to the eaves as possible. (Most often this is done through soffit vents. Ensure the soffit vents are not obstructed by insulation.) B) An air exhaust preferably located as close to the ridge as possible. "The total net free ventilating area should not be less than 1 to 150 of the area of the space ventilated except that the total area is permitted to be reduced to 1 to 300..." provided mechanical ventilators are used. Area calculations were not conducted; it is recommended that a state licensed general contractor evaluate the adequacy of attic ventilation and add ventilation as deemed necessary.

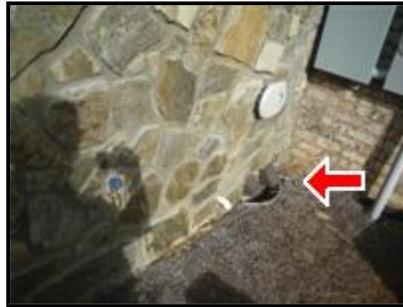
🔧 (6) The downstairs dryer vent is missing a back-draft damper or it was damaged at the exterior. Its absence will allow cold air, rain, snow, birds or other animals to enter the vent. Blockages can create a fire hazard. Service to repair or replace the backdraft damper is recommended.

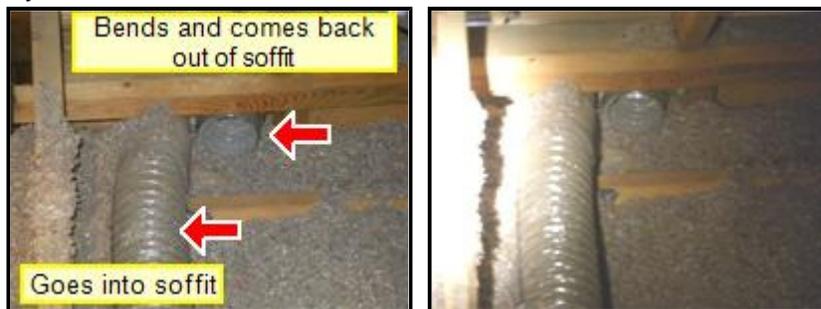
🔧 (7) One or more bathroom vents exhausts directly into the attic. The bathroom exhaust duct(s) should be extended to an exterior vent port to prevent moisture damage to structure or ceilings. They should all be verified to be installed correctly.

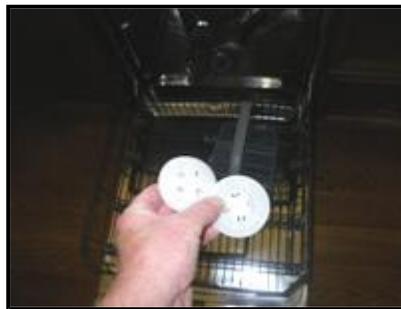
9.0 Two small components of the dishwasher were not installed. We could not determine their purpose or where they are supposed to be installed. Minor service is recommended.

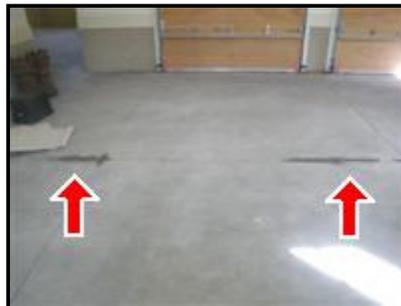
10.2 (1) The garage floor had two stains and we could not identify the source. You should ask the builder to explain it.

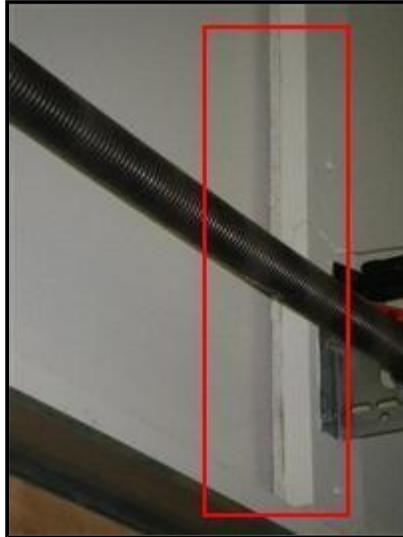
(2) One of the garage door frame supports that secures the springs and motor track was pulled loose from the wall 3/4". Service is recommended. Failure to service this door may result in door failure and possible injury.
