# **Alpha & Omega Home Inspections, LLC**

## Confidential Inspection Report

115 Anystreet  
MyTown SC

<b>Date:</b> 3/8/2010	<b>Time:</b> 02:00 PM	<b>Report ID:</b> Sample Report - New Construction
<b>Property:</b> 115 Anystreet MyTown SC	<b>Customer:</b>	<b>Real Estate Professional:</b>

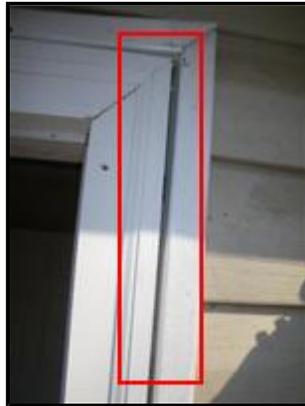
**1.2** The vinyl trim at the side entry door is not tight against the door trim. The potential for water entry around the door exists. Service by a qualified contractor is recommended.

- 🔧 The vinyl trim at the side entry door is not tight against the door trim. The potential for water entry around the door exists. Service by a qualified contractor is recommended.

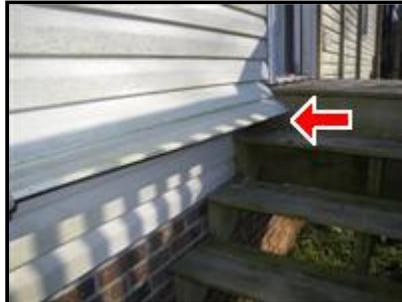
**1.3 (1)** The vinyl siding at the right side has one or more loose sections that may expose the sheathing to moisture. Repair or replacement of the affected sections is recommended.

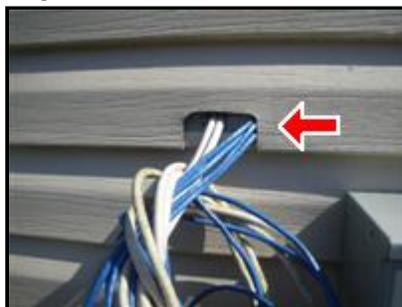
**(2)** A wall penetration near the electric meter were not adequately sealed. Service to seal the opening(s) is recommended. Failure to seal the opening could allow water to enter unintended areas.

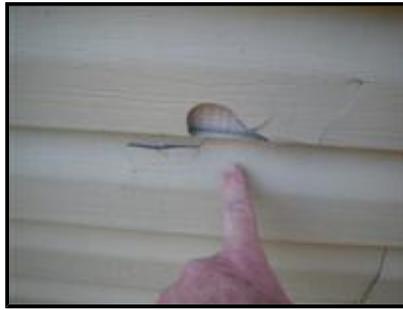
**(3)** The vinyl siding at the left side has one or more holes that may expose the sheathing to moisture. Repair or replacement of the affected sections is recommended.

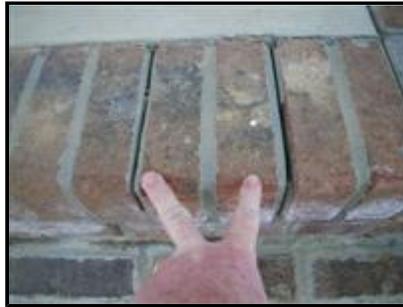
🔧 **1.5** Openings or cracks exist in the mortar between the brick steps at the front porch that should be re-pointed to prevent long-term deterioration of the steps during freeze-thaw cycles.

- 🔧 Openings or cracks exist in the mortar between the brick steps at the front porch that should be re-pointed to prevent long-term deterioration of the steps during freeze-thaw cycles.

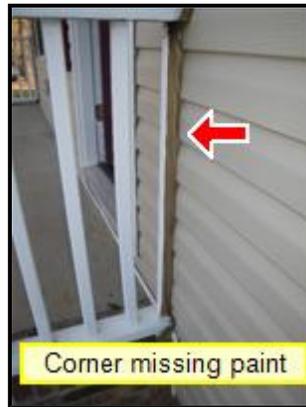
🔧 **1.6** Sections of the house trim need paint (porch rails, trim, etc.). Bare wood was exposed to the elements.

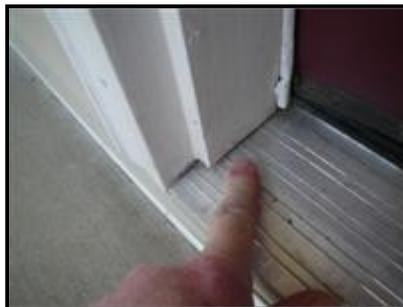
🔧 (2) The threshold is not caulked or sealed at the main and side entry doors. Sealant is recommended to prevent water from wicking up into the door frame resulting in deterioration to the wood door jambs.

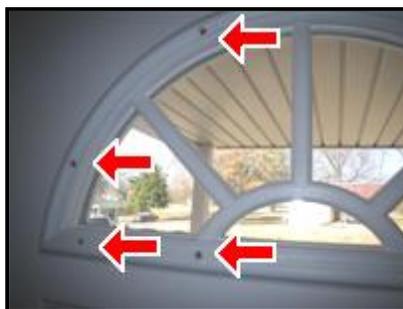
🔧 (3) The main entry and side entry door frame is missing caps over the screw holes.

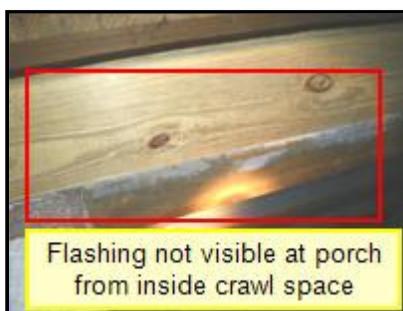
**1.11** (1) The flashing for the front of the home was not visible. The only material visible was "house wrap", which is not an approved flashing material. The potential for water to penetrate behind the front porch and siding may exist. We suggest that you have the installation method evaluated by a licensed general contractor.

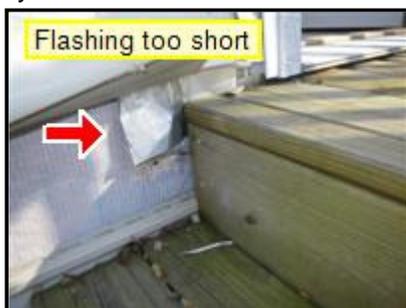
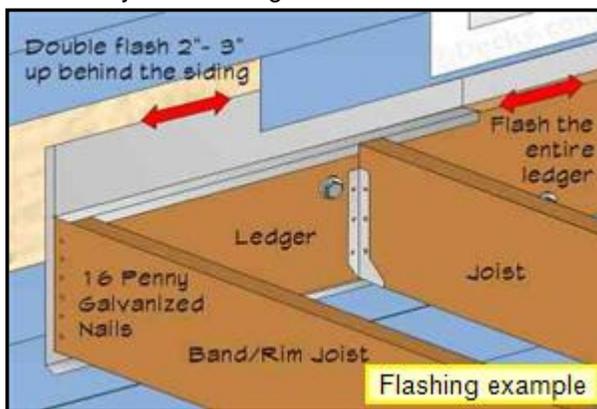
(2) The flashing for the side porch was sub-standard and may not be effective in preventing water entry against the house framing. The potential for water to penetrate behind the porch and siding may exist. We suggest that you have the installation method evaluated by a licensed general contractor.

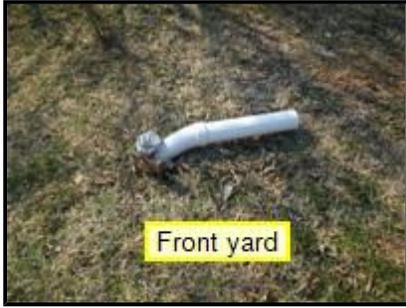
**1.15** One or more underground pipes exists on the property. As mentioned in our contract, we do not inspect any underground components. We offer this information as a courtesy and you may want to further investigate the pipe, and its purpose.

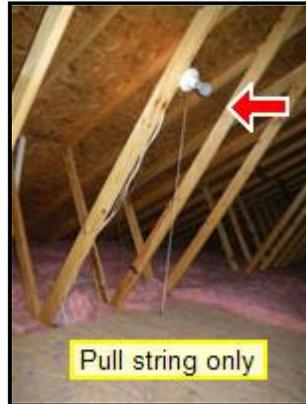
🔧 **3.6 (1)** No wall switch was provided for the light in the attic. One is required by today's commonly accepted construction standards whenever HVAC equipment is present or storage space is provided. A switch is recommended.

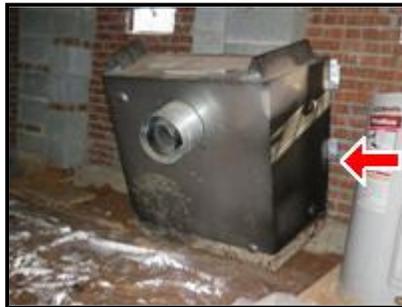
(2) An abandoned fireplace exists in the crawl space, which you may wish to have removed.

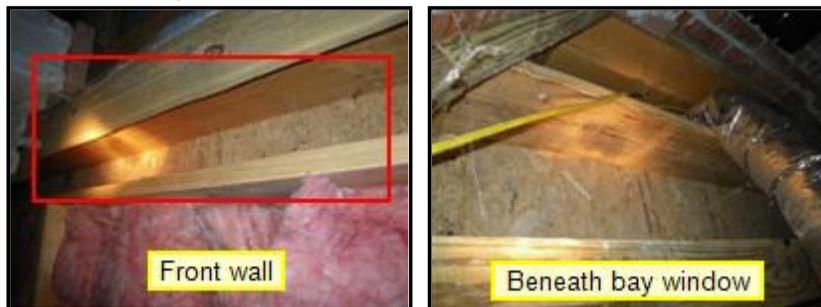
**4.4** (1) Large portions of the sub-floor are uninsulated. Insulating the sub-floor to a minimum level of R-19 is recommended for thermal efficiency.

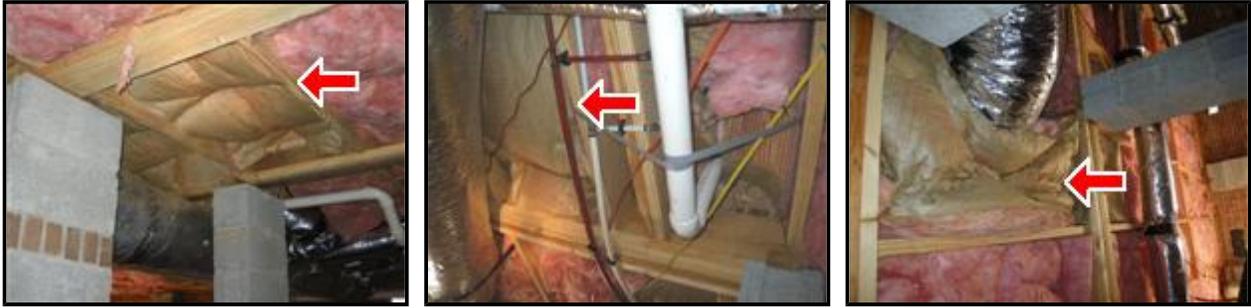
(2) Floor insulation has been installed up-side down. The vapor barrier should be installed against the sub-floor. Service to reverse the insulation is recommended. And since the improper installation of insulation can trap moisture against the floor framing and may result in decay, the floor structure should be thoroughly evaluated by a licensed contractor.

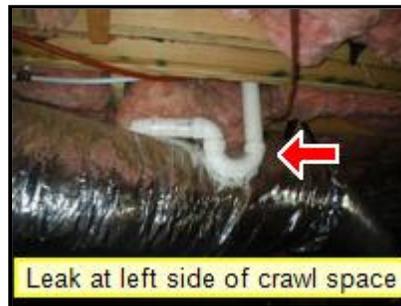
🔧 **5.1** There is a waste pipe leak in the crawl space beneath the bathroom, which should be repaired by a licensed plumber within the contingency period, or before the close of escrow. This is particularly important because leaks can lead to the growth of molds and fungi, which can have an adverse influence on health.

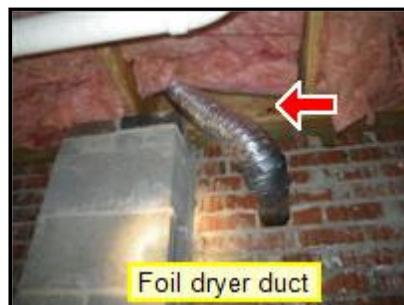
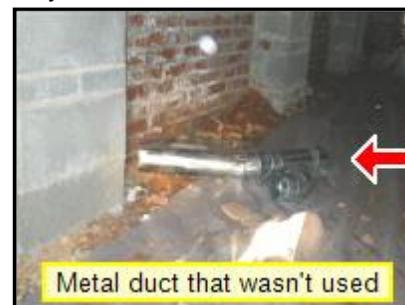
🔧 **5.11** The dryer vent in the crawlspace was corrugated, flexible ducting. Today's commonly accepted standards specify that corrugated ducts may be used only within the first 8 feet and may not be concealed within construction. The concealed ducts should be rigid metal ducts or equivalent, without screws, vented to the exterior of the home. This is recommended for fire safety reasons.

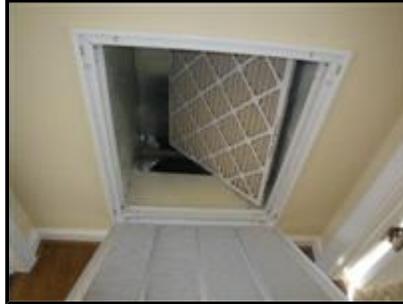
**6.4** The return air filter was displaced, which allows return air to bypass it. Missing or misplaced filters can

cause significant dust build-up on evaporator coils, circulating fans and inside ducts. Since none of these components were examined because it would require disassembly of the HVAC system or specialized equipment, you should have the system serviced by a licensed HVAC contractor prior to close of escrow. The filter should be re-positioned to capture all return air. The service should include a determination as to whether the ducts should be professionally cleaned.

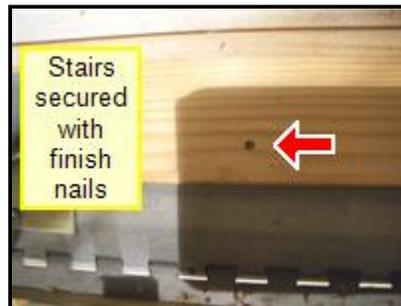
(2) The drop down stairs are not installed according to instructions, which specifies the use of 16D nails, not screws. Nails other than 16D were used. Service is recommended for safety reasons.

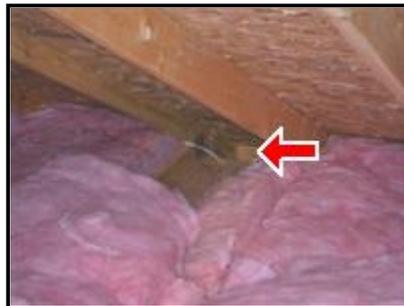
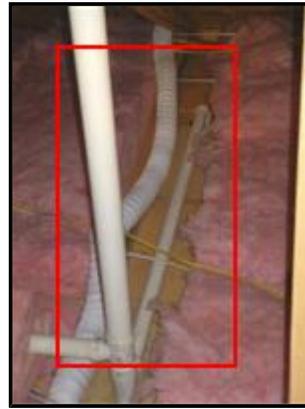
**7.1** Portions of the ceilings are uninsulated. For thermal efficiency, you may want to add insulation to bring the attic up to today's standard of R30. Note: R30 would be approximately 12 inches of fiberglass and 10 inches of cellulous.

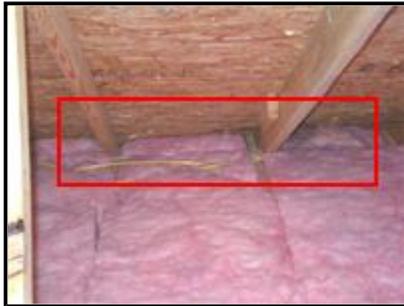
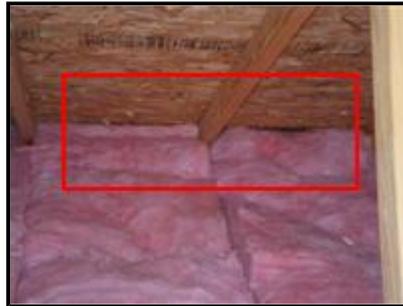
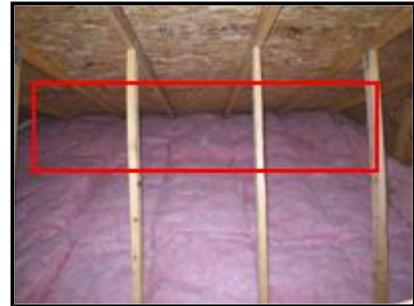
**7.4** Soffit vents have been obstructed by insulation. It is recommended that the insulation be sufficiently removed from soffit vents to provide adequate attic ventilation.

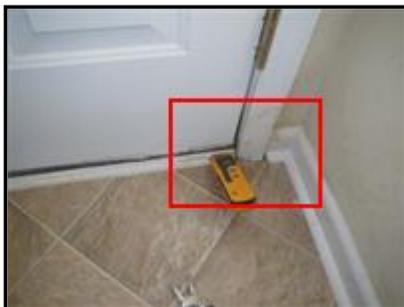
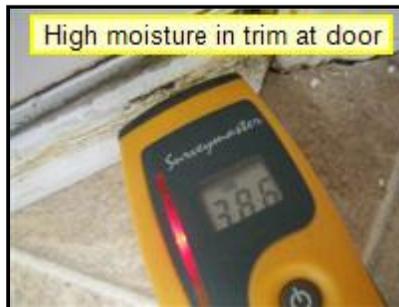
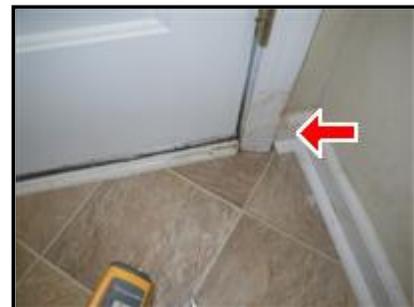
🔧 **8.0** (1) Evidence suggests that moisture intrusion is present on the wall trim at the side entry door. We did not determine the cause and you should have it evaluated and repaired by a competent licensed contractor prior to the close of escrow. *Note: the best way to prevent water entry around a door is by use of a storm door.*

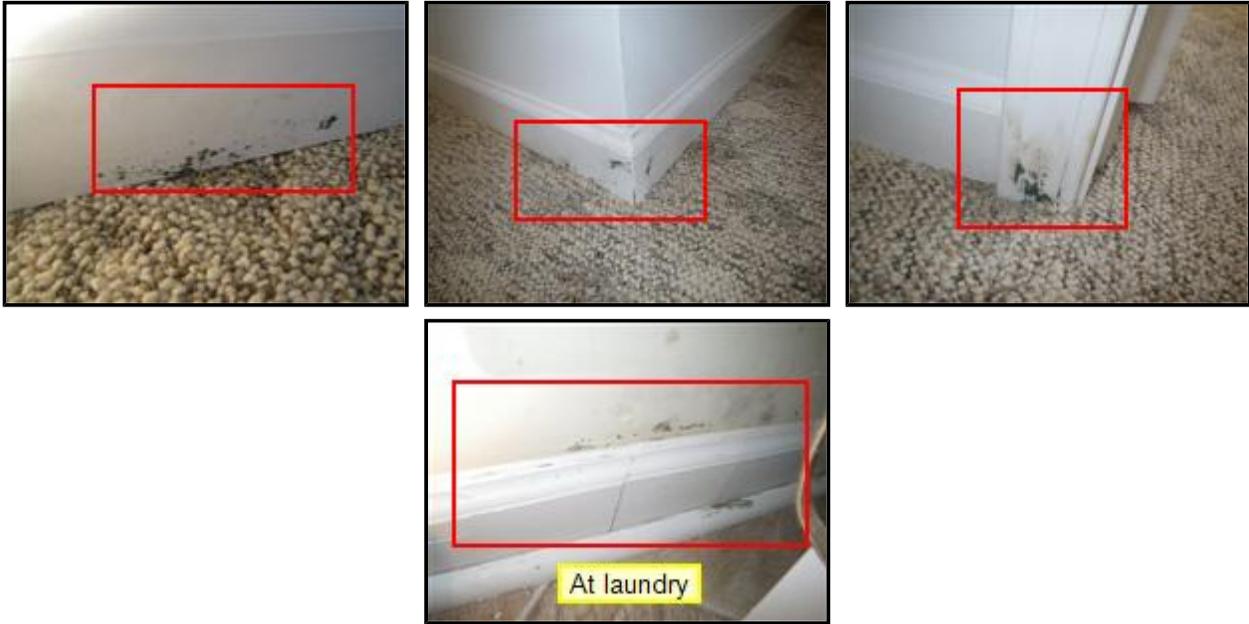
🔧 (2) We have detected a mold-like substance within the master bathroom closet and laundry room. You can learn more about mold from our web site [here](#). *Note: our company has mold certifications from the International Association of Certified Indoor Air Consultants, and we can assist you with mold sampling and identification if you desire. Note: the amount of material was very small and no moisture was detected. A simple cleanup by a*

qualified individual according to [EPA guidelines](#) is recommended.

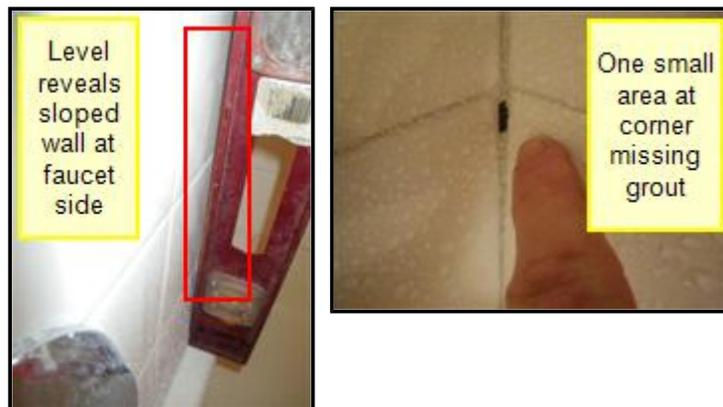
🔧 (4) The tile wall at the master bathroom is not flat. Our opinion is that it was not installed in a workman-like manner. You should evaluate it for yourself regarding acceptability.

The tile wall in the tub/shower area of the master bathroom needs grout or sealant in order to prevent water entry behind the tiles.

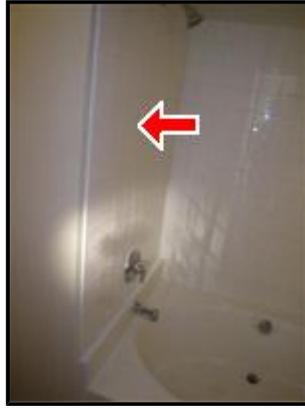
🔧 (5) The tile wall at the master bathroom appeared to be installed directly over sheetrock, and a cement wallboard base is called for to prevent water entry behind the tiles. If water enters behind the wall, structural damage may occur which may not reveal itself until years in the future. However, we cannot be certain of the construction method without destructive testing and you should therefore have it evaluated by a tile specialist or general contractor.

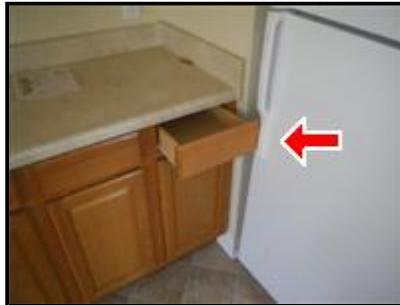
**9.0** (1) Not all drawers or cabinets were fully functional due to obstructions or poor design of the kitchen. You should view this condition for yourself.

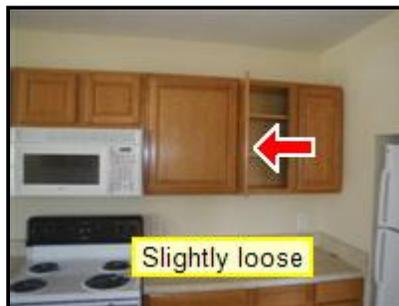
(2) One kitchen cabinet door hinge(s) was loose and needs minor service.
