Manufactured-Stone Nightmares

Without proper flashing, heavy-duty building paper, and weep holes, walls behind cast-stone veneer can get wet

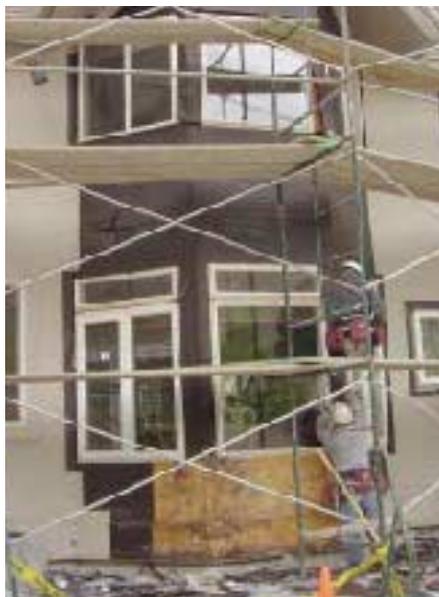
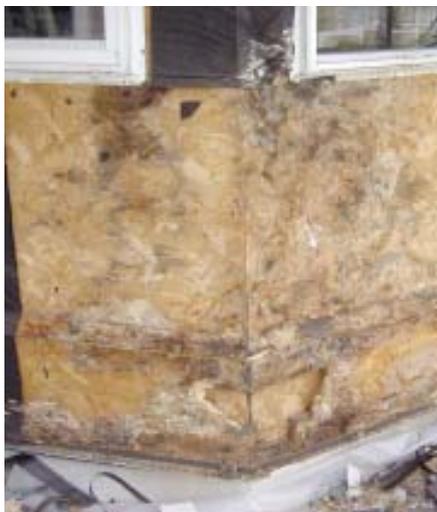
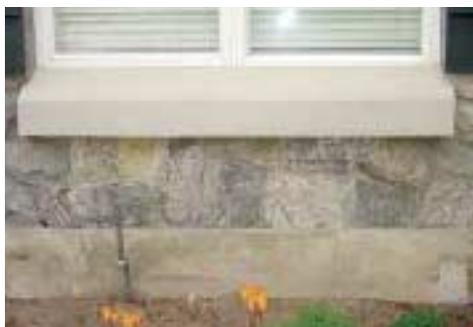
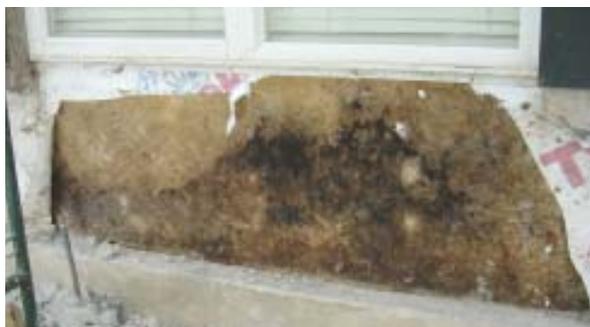
leaks and rot often show up sooner, progress more quickly, and cause more severe damage inside the wall (see Figure 1).

Figure 1. Where stucco (top photos) and cast stone (bottom) have been installed on the same home, the author frequently finds more severe moisture and rot damage under the cast-stone portions of the exterior. One reason is that the stucco terminates at the bottom with a weep screed, while the cast stone sits in a bed of mortar and grout, directly on a foundation ledge, with no weeps or flashings.

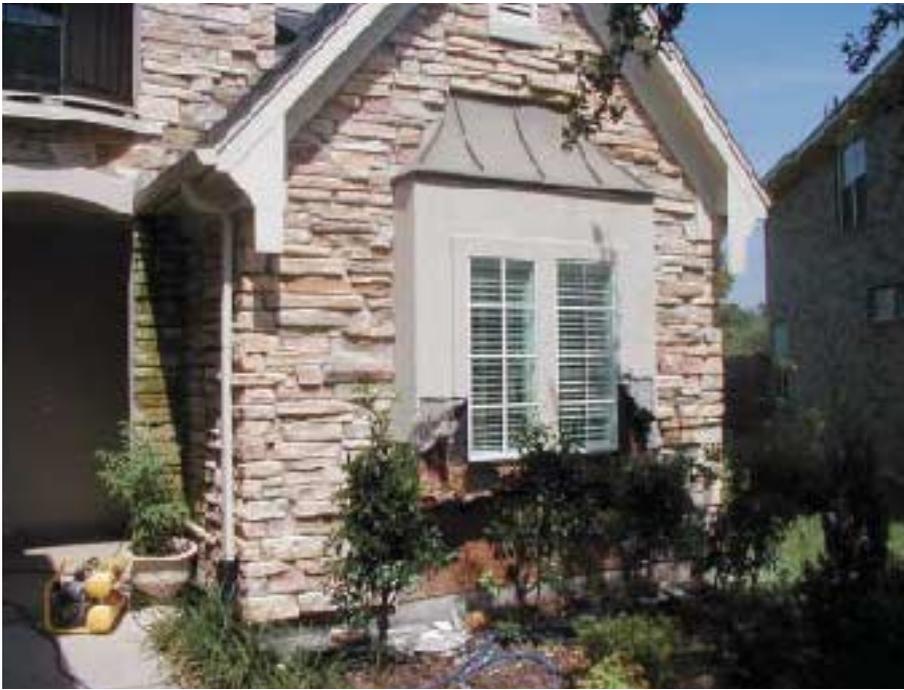
For one thing, manufactured stone is a cement-based product that absorbs and holds water like stucco, but cast stone is thicker than stucco and can thus store more moisture. Also, most of the cast-stone brands now have "ledge-stone" versions of the product, which have a long, horizontal shape; the long, flat, shelflike ledges are often sloped toward the framing when installed, which provides a place for rain water

to puddle up and soak into the wall (Figure 2, next page).

Figure 2. Long, flat “ledgestone” pieces like this create many horizontal shelves where water can stand and soak into grout joints.

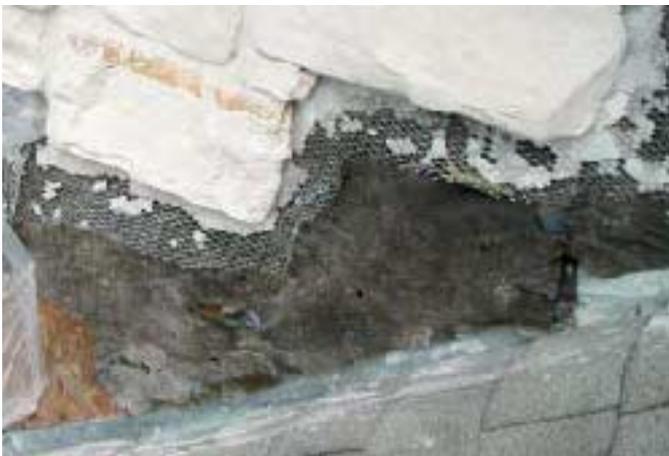
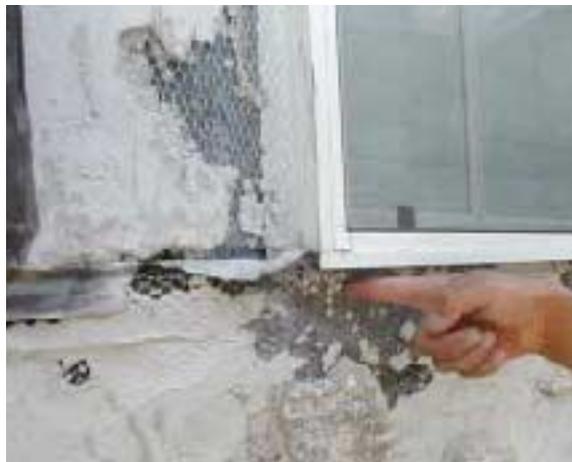
The greater thickness of cast stone also complicates the task of fabricating and installing practical flashing components. The kickout or diverter flashing required where a roofline butts into a wall is a good example. On job after job, my company gets paid good money to go in after the fact, tear cast-stone veneer off a wall, and retrofit a larger kickout flashing to the wall because the original roofer's kickout flashing was too small to push water out beyond the plane of the cladding. If the diverter flashing is too small, it may as well not be there: All the water flowing and blowing against that spot will just get dumped into the wall system below (Figure 3, next page).

Figure 3. Undersized or omitted diverter — or kickout — flashings allow water to flow beneath the cast-stone facade (above). Window flanges that lap under instead of over building paper can bring rain water into direct contact with the sheathing (right).

idea in a manufactured-stone job. However, we are more likely to see a reverse-lap flashing error, with building paper run to the window edge in such a way that the window flange directs water beneath the paper instead of on top of it (Figure 3). And, as with stucco, brick, or any other cladding, a cast-stone veneer should be equipped with weeps of some kind at any bottom termination, whether at the foundation sill or above a window or abutting roof. Otherwise, water will pool longest at the lowest points, and those areas may stay continuously wet.

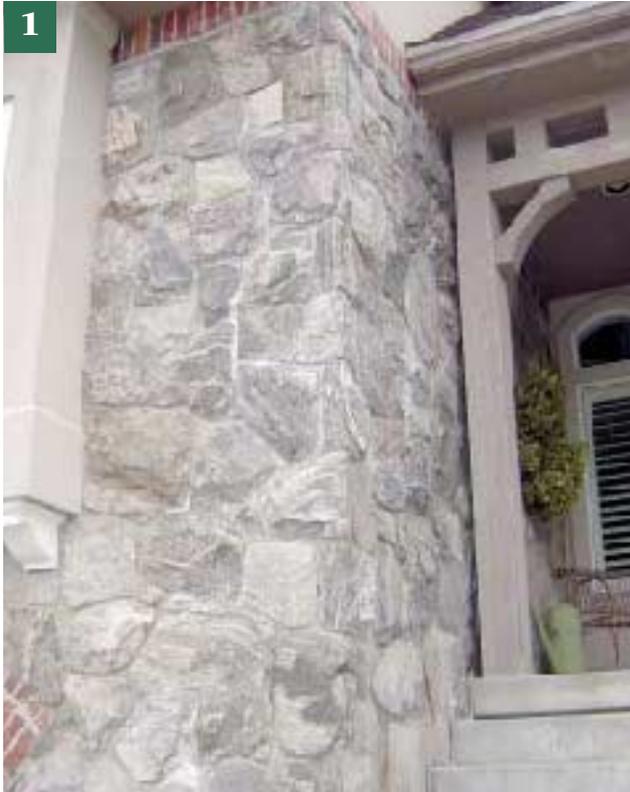
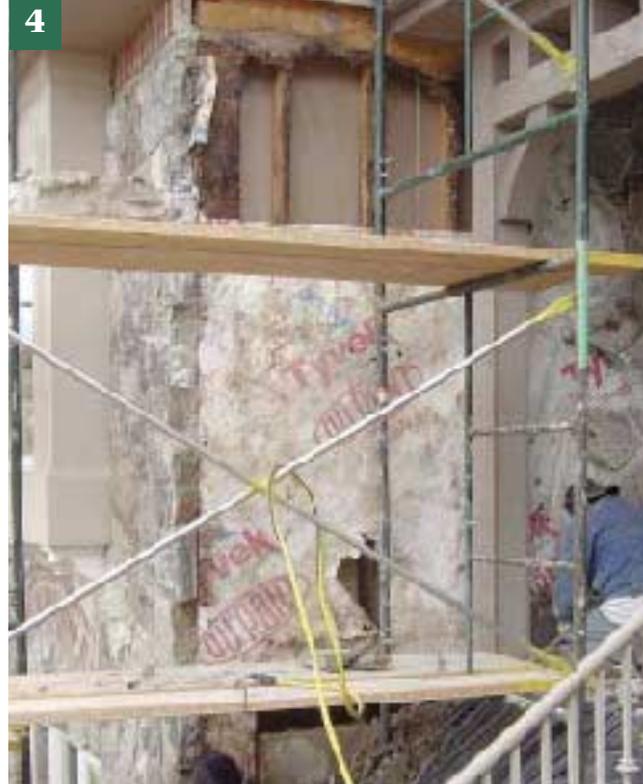
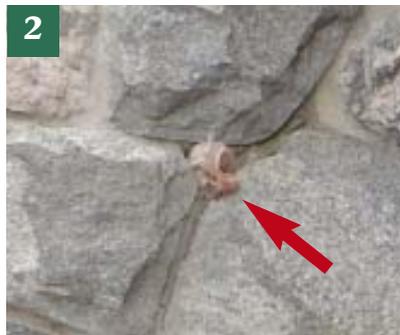
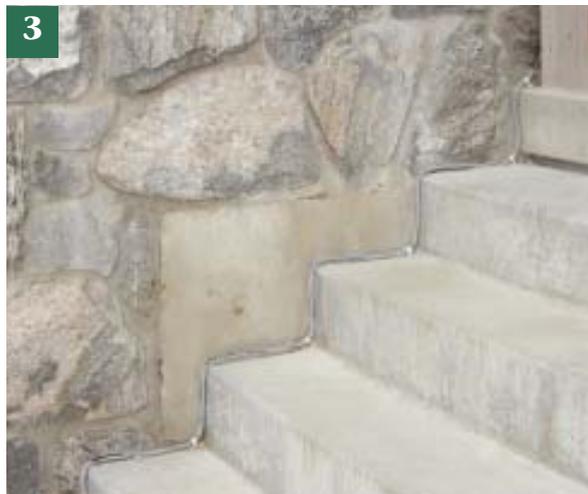
The owners of this one-year-old custom home **1** reported moldy smells behind the drywall; a mushroom growing from the cast-stone veneer face was the only visible sign of trouble on the exterior **2**. The gutter butting into the top of the wall seemed a likely source of moisture, while the bottom of the wall provided no way for moisture to escape **3**.

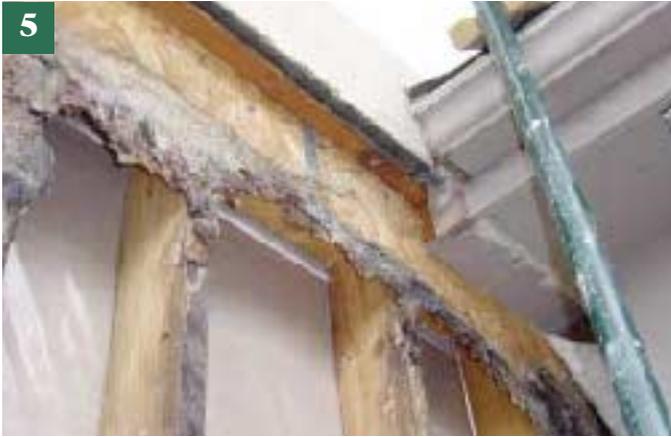
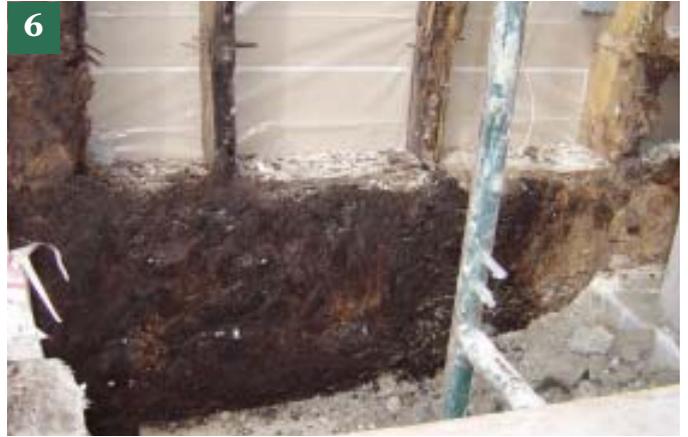
Opening the wall [4](#) revealed severely rotted OSB sheathing and damage to the framing. While the row of soldier bricks at fascia height provided some protection [5](#), the water coming off the roof saturated the cast stone and soaked through the housewrap beneath, turning the sheathing at the base of the wall to compost in less than two years [6](#).

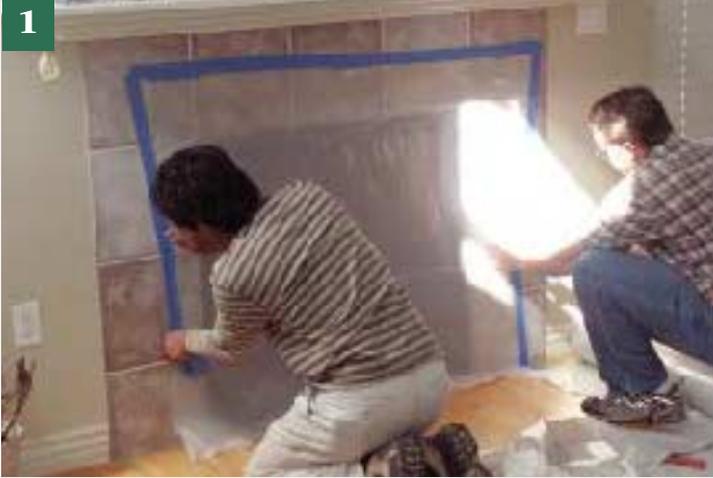
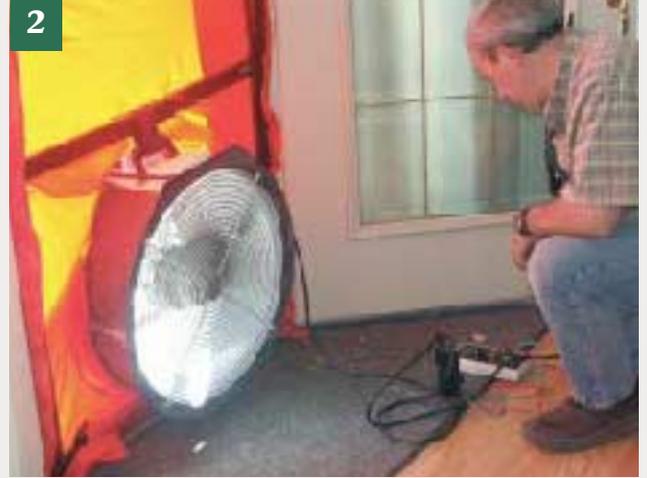
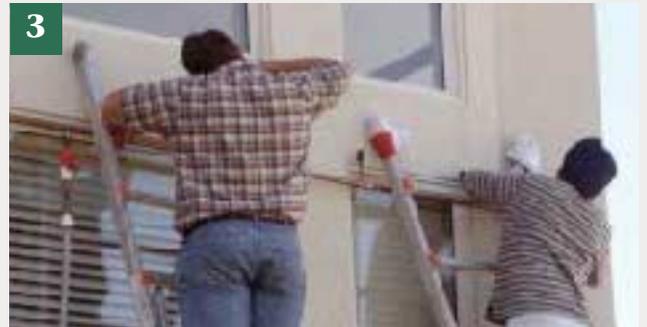
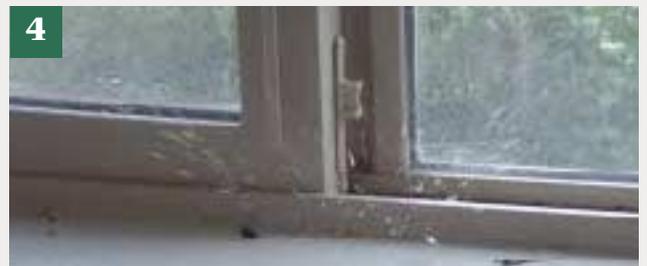
On this job, the original installer of the cast-stone veneer wall had tried unsuccessfully to stop leaks by spraying a clear sealer onto the stone and by removing the lowest courses to apply a membrane flashing where the wall meets the foundation. To assess the problem, the Ram Builders team first seals large openings inside the home **1** and sets up a blower door **2**. With the blower door running to depressurize the house, the crew turns on a water-spray apparatus **3**, thus simulating the effect of a 15-mph wind-driven rain. Within a short time, water finds its way into the house **4**.

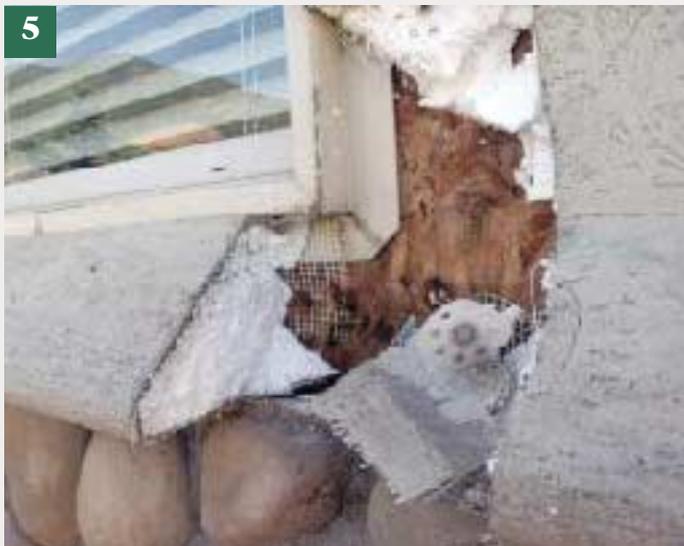
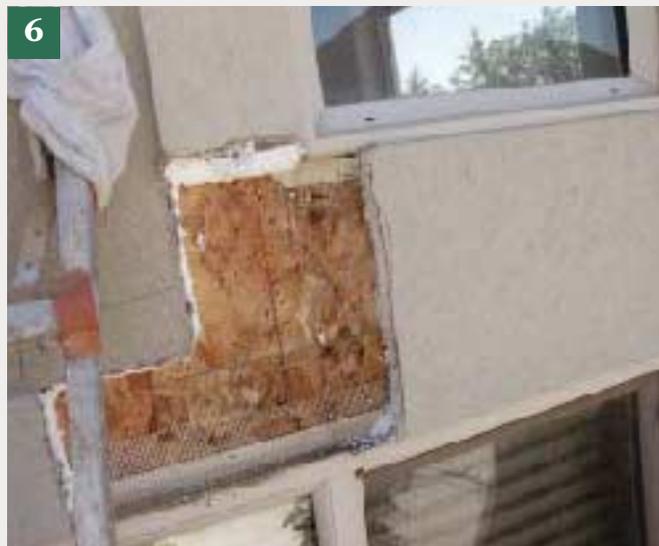
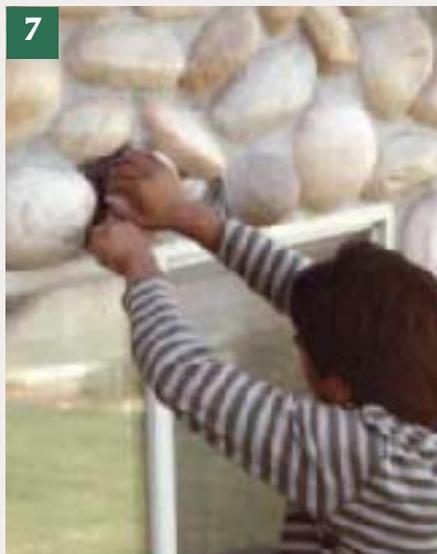
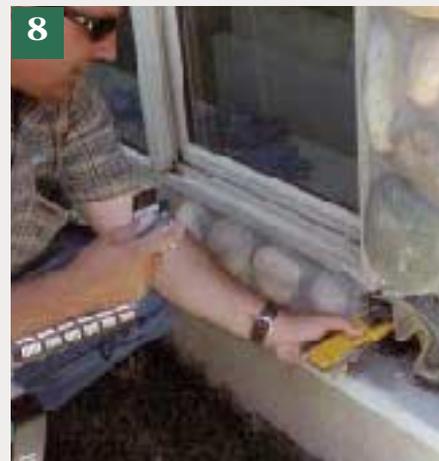
After verifying that the cladding leaks, the team digs under the surface to find out why. Tearing off small areas of EIFS on the upper wall reveals that there is no building paper or window flashing installed where the EIFS meet the cast stone **5**, or between upper and lower windows in the EIFS wall **6**. Tearing off cast stone near a window **7**, the team learns that water has wet the OSB sheathing. The author measures high moisture content even at the bottom of the wall, where no direct stream was applied **8**. The retrofit flashing repair has proven ineffective because flaws higher in the wall dump water behind it.
