**Alpha & Omega
Home Inspections, LLC**
"A wise man builds his house upon the Rock" Mat. 7:24

Confidential Inspection Report

Property Address: 328 Elm St. York, SC 29745

Inspection Date: 4/7/2016
Report ID: Worst new Home Sample

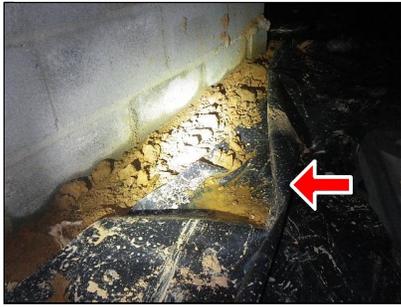
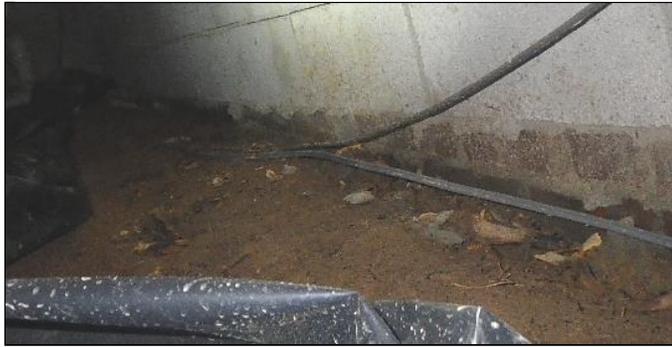
(2) The soils in the crawlspace are moist, which could indicate a chronic drainage problem. Moisture can adversely affect the house foundation and can facilitate the growth of a variety of molds that can promote unhealthy conditions. Therefore, you should consult a grading and drainage contractor or a licensed general contractor with experience in

crawl space drainage and moisture to determine the extent of the concerns and necessary repairs. We also recommend that you observe the crawl space during a period of heavy or prolonged rain prior to the close of escrow.

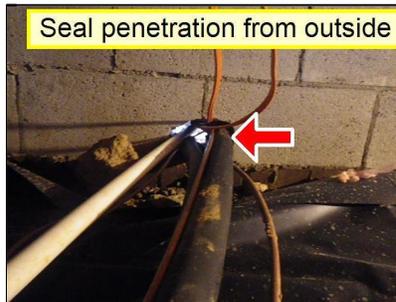
- (3) Evidence suggests that the crawl space is not rodent or animal proof. Rodents have collapsible rib cages and can enter the home through small and narrow spaces. A competent person should ensure that the house is not accessible to rodents, snakes or other wildlife because they are a nuisance and health hazard.

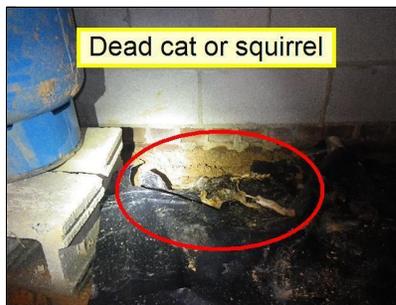
- (4) The crawlspace has been contaminated by animals, which is a significant health hazard, and should be evaluated by an exterminator or wildlife specialist as soon as possible. Animals can compromise not only the crawlspace and its various components, such as ducts and insulation, but can eventually compromise the living space as well. Consequently, we disclaim any further responsibility for evaluating the crawl space and its components.

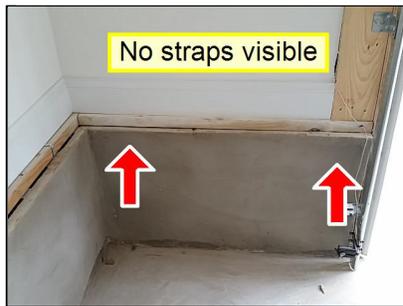
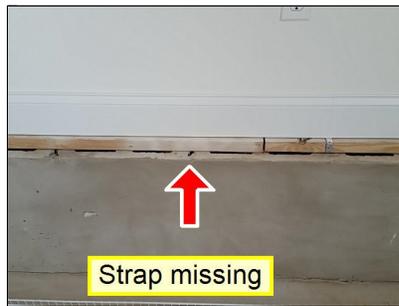
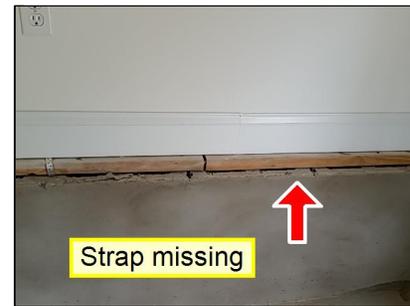
- (1) Today's commonly accepted construction standards require that the structure framing be bolted or strapped to the foundation walls not more than 6 feet apart and not more than 12 inches from each board's end to prevent the house from moving off its foundation during high wind or seismic events. Bolts or straps were not visible and their absence is considered a deficiency. A further evaluation by a licensed general contractor and repair as deemed necessary is recommended. Note that any repair or retrofit will be expensive, likely prohibitively expensive. You may wish to consult with a licensed general contractor about the potential consequences of missing anchors.

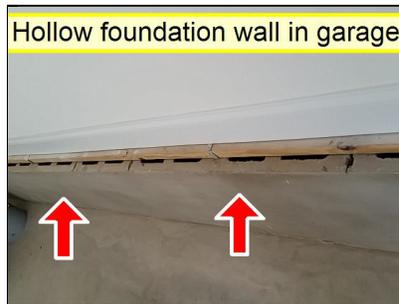
- (2) The tops of every portion of the foundation wall was not filled with grout. Hollow masonry units allow paths for termites to access the wood structure and their presence can be concealed. Repair may be cost prohibitive and you should consult with a licensed general contractor and/or a licensed pest contractor about the costs and the likelihood of termite infestation.

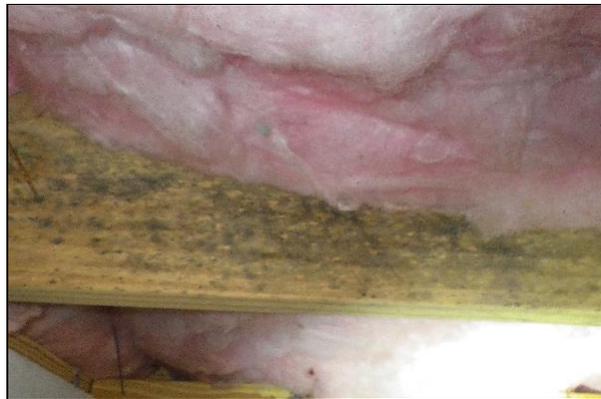
- Moisture content in wood structures was measured at < 20%. No decay as a result of humidity was observed, but apparent fungi was noted on floor framing. Wood will decay at moisture levels > 28% and will support fungi growth at levels in the low-20s. It is recommended that a qualified individual take appropriate measures to eliminate the environment conducive to fungi growth. The services of a certified mold specialist and/or a crawl space specialist should be considered to achieve the desired results. Options to reduce the moisture levels include, but are not limited to, elimination of water intrusion into the crawl space, increasing ventilation, installation of a vapor barrier or installation of a humidistat controlled fan. Here's useful information [on our website](#) about mold.

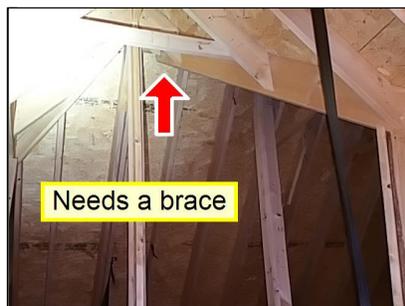
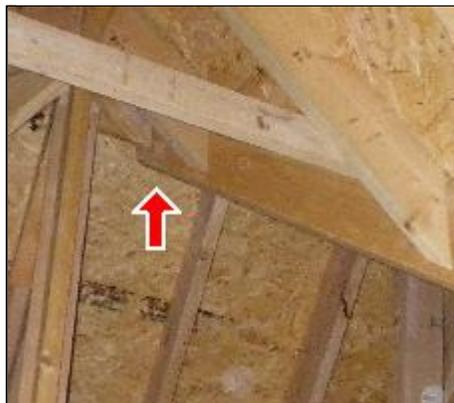
- (1) All valley rafters were not posted (supported at each end) to provide support. Valley rafters are essentially beams and carry significant loads and should be posted at each end. The result of improper support may be sagging or failure of that structural member. Service to post the rafter(s) by a licensed general contractor is recommended.

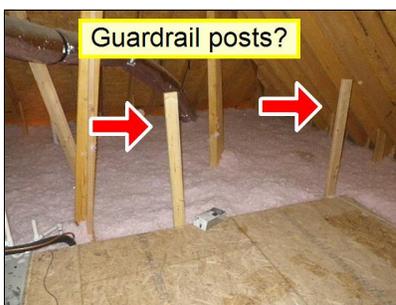
- 🔧 (2) Guardrails for personnel protection while on the attic deck were not provided. They normally are present. It appears the project was started but not finished. We recommend guardrails for safety reasons.

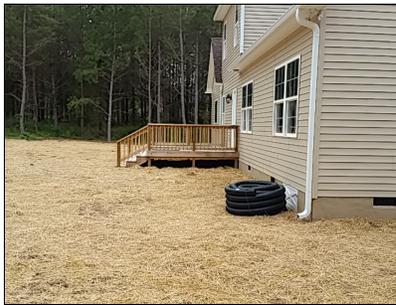
- 🔧 (2) Grading and drainage is either negative or neutral adjacent to the residence at the rear of the home, and moisture intrusion and/or foundation deterioration will remain a possibility. The soil or the hard surfaces should slope away from the residence to a distance of at least ten feet to keep moisture away from the footings. We can elaborate on this issue, but you should seek a second opinion from a grading and drainage contractor prior to close of escrow. At a minimum, you should observe the crawl space conditions prior to the close of escrow during a period of heavy or prolonged rain.

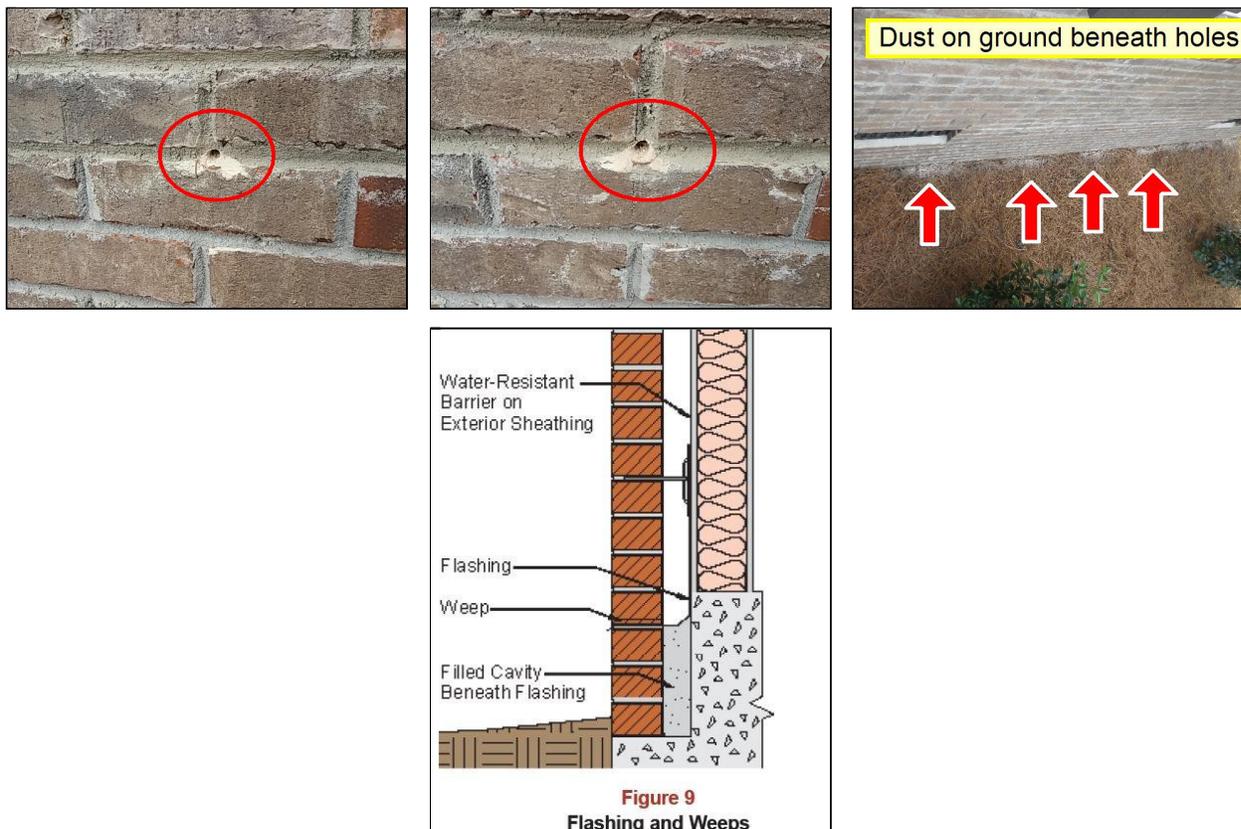
- 🔧 (1) It is our opinion that weep holes were not provided in the masonry veneer siding at the base of the foundation when the wall was built. Evidence suggests that weep holes were drilled after construction of the wall as evidenced by chipped brick and brick dust observed beneath the holes. Today's commonly accepted construction standards require weep holes (not less than 3/16" in diameter) every 33 inches at the the foundation, above windows and doors. Flashing is required to direct water toward the weep holes. No evidence of flashing was observed. Installation of weep holes after construction may cause more damage than benefit (if the flashing is not present it may be inconsequential and if the flashing is present, it may have been damaged by drilling into the wall). You should consult with the county building inspector to ascertain his observations during his routine inspection. We also recommend consulting with a licensed and competent masonry contractor about this apparent construction defect, its consequences, and the options (if any) for correction. A guidance document is attached at the end of this report for your information.

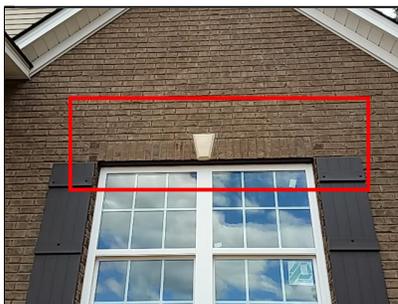
- (2) Weep holes were not visible above windows and doors in the masonry veneer siding. Today's commonly accepted construction standards require weep holes (not less than 3/16" in diameter) every 33 inches at the foundation and above doors and windows. Flashing is required to direct water toward the weep holes. However, installation of weep holes after construction may cause more damage than benefit (if the flashing is not present it may be inconsequential and if the flashing is present, it may be damaged by drilling into the mortar). You should consult with a licensed and competent masonry contractor about this construction defect, its consequences, and the options (if any) for correction. An attachment with more information and diagrams is included at the end of this report.

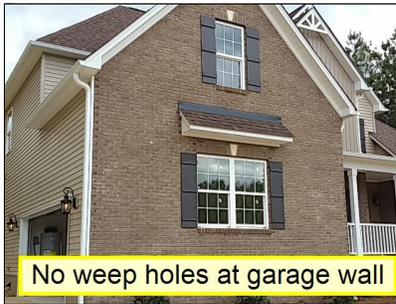
- (3) An inadequate number of weep holes were provided in the masonry veneer siding. Today's commonly accepted construction standards require weep holes (not less than 3/16" in diameter) every 33 inches at the base of wood framed walls, above windows and doors. Flashing is required to direct water toward the weep holes. However, installation of weep holes after construction may cause more damage than benefit (if the flashing is not present it may be inconsequential and if the flashing is present, it may be damaged by drilling into the mortar). You should consult with a licensed and competent general contractor or professional engineer about this construction defect, its consequences, and the options (if any) for correction.

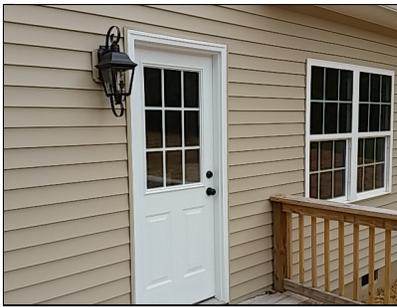
One or more exterior doors is unsheltered by a porch or significant roof overhang. Such exterior doors are prone to leaks and deterioration from the weather over time. Although weather stripping should be present at exterior doors, the weather stripping is primarily designed to minimize air infiltration and a house door may not be effective in keeping out moisture under extreme weather conditions, especially wind driven rain. Consideration should be given to construction of a porch, overhang or installation of a storm door(s) to protect the door from deterioration and to prevent moisture intrusion.

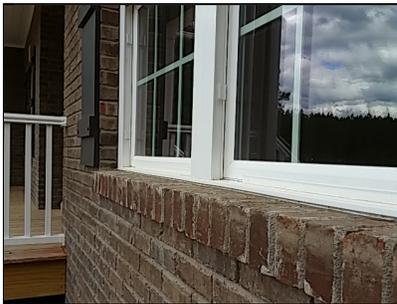
The brick window ledge is flat or may even slope toward the house. It should have been built with a slope to shed water, ice and snow. Failure to shed moisture could lead to long term decay of window trim or even water entry into the wall system. FYI.

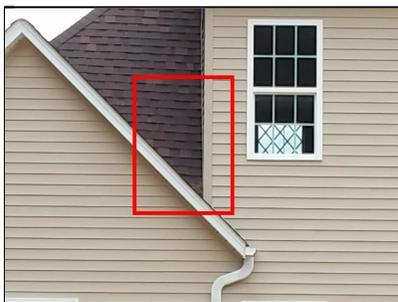
(1) A section of the roof's design channels water toward a wall and will easily trap debris. Moisture laden debris can cause shingle deterioration. This section may be prone to leaks and should be frequently monitored and kept clean.

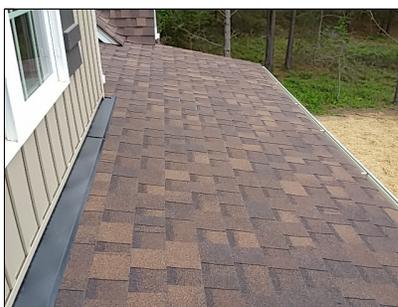
(2) The roof at the front of the home is classified as a low sloped roof, meaning that the pitch or slope of it is less than 4 in 12. Asphalt shingle can be installed on roofs less than 4 in 12 but special underlayment is required. Shingles should never be installed on roofs sloped less than 2 in 12: standing snow or ice could leak past the singles and cause water damage to the home interior. You may wish to have the roof evaluated by a competent roofing contractor prior to the close of escrow to ensure its proper installation if you are especially concerned.

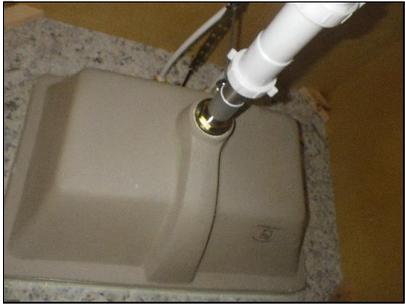
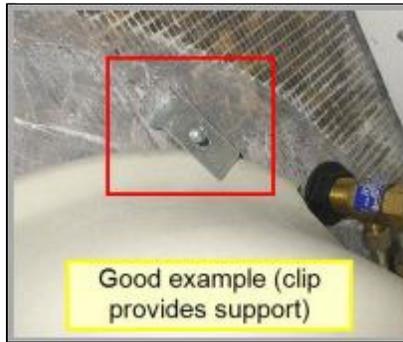
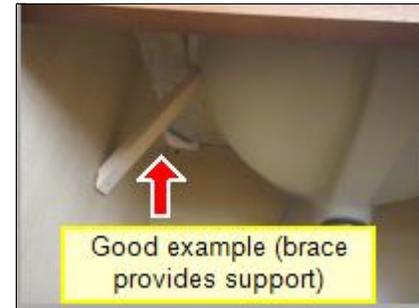
(1) The under-mounted 1st level hall bathroom sink is inadequately supported in our opinion. Sinks should not rely totally on adhesive in our judgement and two braces, one on each side, attached to beneath the cabinet is standard. Installation of braces by a competent person is a common practice and recommended.

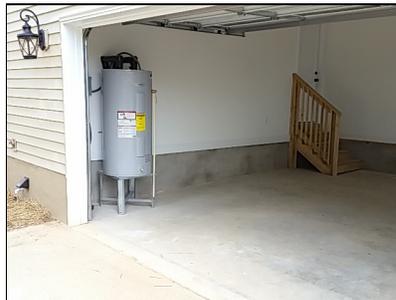
- (1) Water heater estimated date of manufacture: 2015.
- ✎ (2) The water heater in the garage is not adequately protected from vehicle impact, which is required by the manufacturer's installation instructions. We recommend suitable protection to prevent vehicles from striking the unit and damaging it. Rupture of the tank due to a vehicle impact may result in scalding to anyone exposed to the pressurized release of hot water. Note: a concrete filled metal bollard, anchored to the floor, is a typical and commonly accepted method of protection.

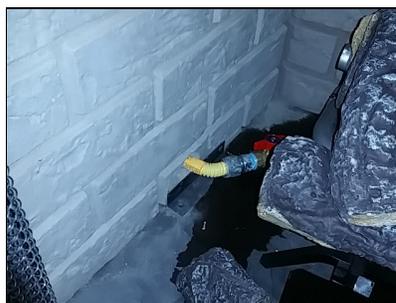
- ✎ A gas appliance connector passes through the fireplace cabinet; a practice which the manufacturer prohibits. The manufacturer of these devices states: "Do not conceal connector or run connector through enclosed outdoor BBQ pits, walls, partitions, floors or appliance panels." Service by a licensed plumbing or mechanical contractor is recommended.

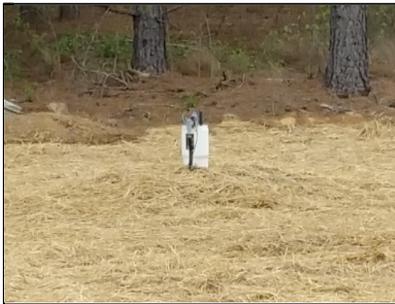
🔧 (3) We recommend insulating or weather-proofing the structure providing shelter to the well and/or pressure tank to prevent freezing and bursting pipes.

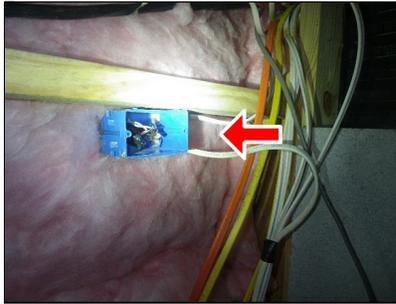
- ⚡ (1) The electrical system does not include arc-fault circuit interrupters (AFCIs) for 15 and 20 amp branch circuits protecting rooms such as family rooms, living rooms, dining rooms, offices, libraries, dens, sun rooms, recreation rooms, closets, hallways, or similar rooms which effective with the adoption of the 2012 International Residential Code were mandated for those areas. Note that we consider AFCIs an important safety feature and consideration should be given to upgrading the circuits regardless of the regulatory requirements in effect at the time of construction. Area missing AFCI: dining room, dinette area, family room, downstairs hallway, master bedroom closets, stairway, 2nd level hallway, 2nd level recreation room.
- ⚡ (2) One open electrical junction box(s) were observed in the crawlspace which should be sealed to contain any arcing or sparking that might occur.

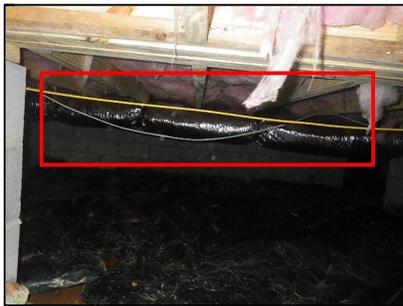
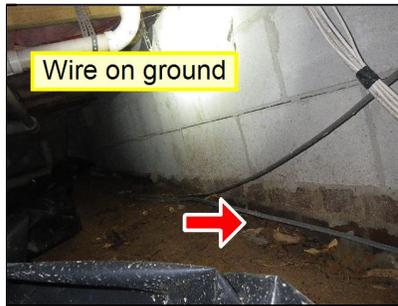
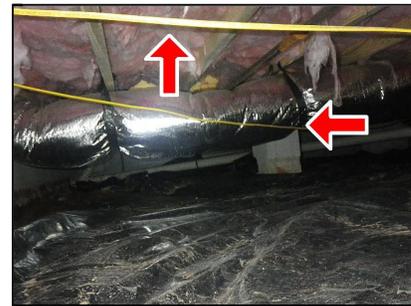
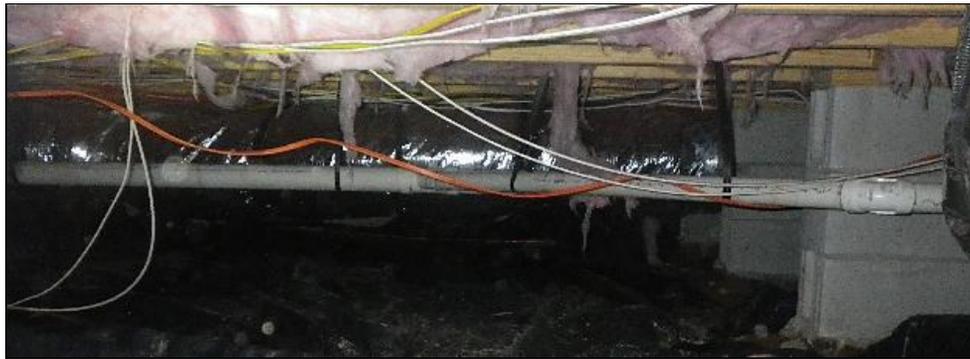
- (3) In the crawl space, one or more electric cables was on the ground or dangled overhead. Electric cables are required to be supported overhead every 4.5 feet for personnel safety reasons.

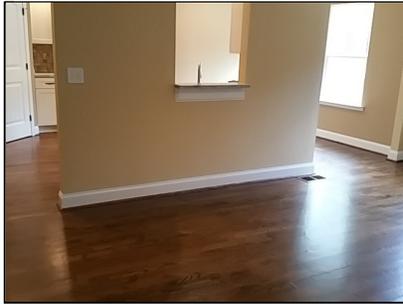
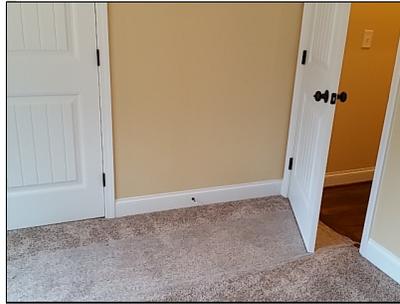
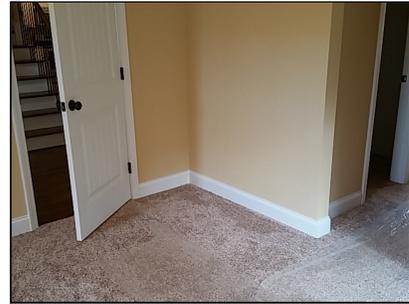
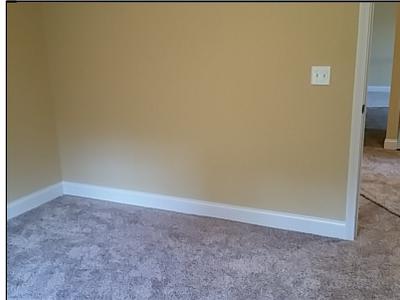
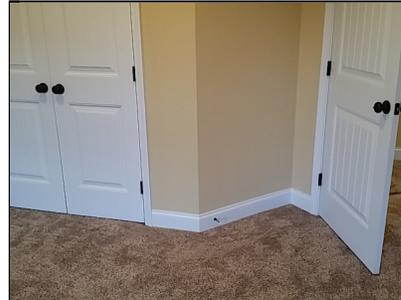
- (1) No doorbell was provided. They are not required but are generally present on a new home. FYI.
- (2) Today's commonly accepted electrical standards require that outlets be spaced so that no point along a wall is more than 6 feet from an outlet. Generally speaking, any wall more than 2 feet wide requires an outlet. The spacing exceeded that in the family room, 1st level rear left bedroom, master bedroom, 2nd level rear left bedroom, and bonus room. Service by a licensed electrician is recommended.

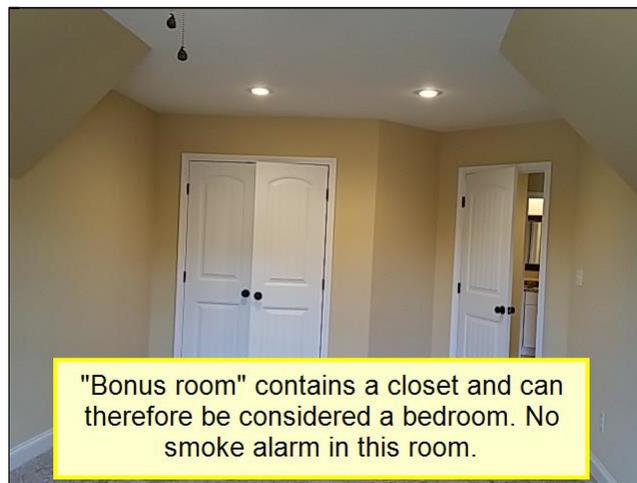
- 🔧 One or more smoke alarms were missing and should be replaced. Failure to install a working smoke alarm could cause death or serious injury.

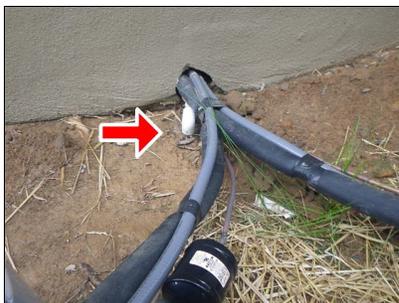
- 🔧 (2) The condensate drain(s) do not discharge sufficiently above grade. It is clogged or will likely become clogged by debris, soil, mulch or insects. Service to raise the condensate drain or lower the grade is recommended.

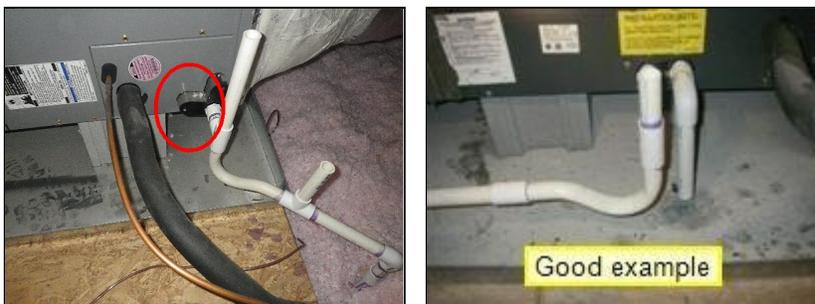
- 🔧 (3) The secondary condensate port was not plumbed to the drain pan. As a result, when the primary drain line becomes clogged, the condensate inside the air handler has no path to escape. It will rise in the air handler cabinet

until it finds a seam in which to seep out, and may cause rust inside the cabinet. In the worst case scenario, the water may rise until it travels down a duct and will cause ceiling damage when it escapes out a duct seam. We recommend that the secondary port be plumbed to the bottom of the drain pan. Immediate service is not critical and can wait until the next scheduled maintenance.

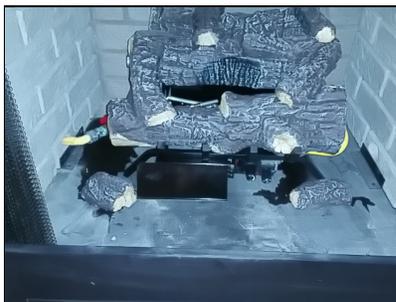
The fireplace or log installation was incomplete. You should ensure their completion and have the homeowner/builder demonstrate its operation and transfer any operating manuals to you.

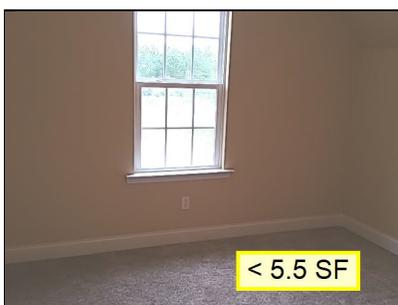
- 🔧 (1) A 2nd level front left bedroom window opening area (the opening created by opening one sash) is less than today's commonly accepted construction standards (a minimum opening of 5.5 sq. ft. for upstairs bedrooms and 5.0 sq. ft. for downstairs bedrooms). The minimum acceptable opening width today is 20 inches and the minimum acceptable opening height is 24 inches. You are advised of this fact and the possibility that large individuals may not be able to exit through the windows safely in the event of a fire.

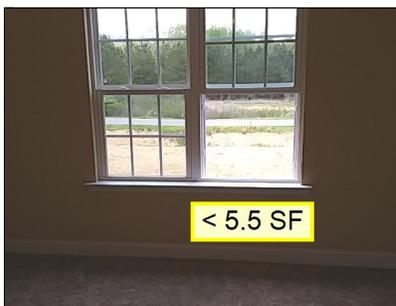
- 🔧 (2) A 2nd level front center bedroom window opening area (the opening created by opening one sash) is less than today's commonly accepted construction standards (a minimum opening of 5.5 sq. ft. for upstairs bedrooms and 5.0 sq. ft. for downstairs bedrooms). The minimum acceptable opening width today is 20 inches and the minimum acceptable opening height is 24 inches. You are advised of this fact and the possibility that large individuals may not be able to exit through the windows safely in the event of a fire.

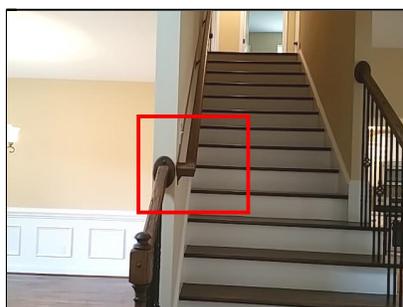
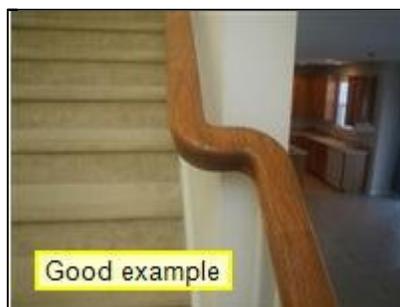
- 🔧 The main stairs did not have a continuous handrail. Today's commonly accepted construction standards require a handrail for 4 or more risers. Additionally, "handrails for stairways shall be continuous for the full length of the flight, from a point directly above the top riser of the flight to a point directly above the lowest riser of the flight." Although this defect is quite common, for safety reasons a railing meeting the standard as quoted above is recommended. Information about proper stair rail construction and illustrations are available on [our website](#) (see page 9).

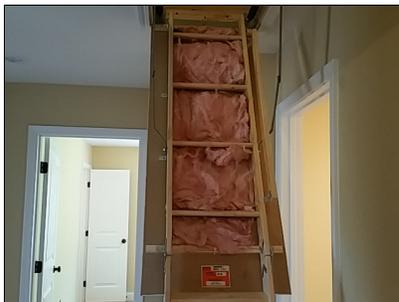
- 🔧 (1) No weather stripping was provided at the interior of the attic opening. We recommend that you seal the access openings for maximum thermal efficiency. Weather stripping is required by today's commonly accepted construction standards.
- 🔧 (2) Today's commonly accepted construction standards require attic openings to be weather stripped and insulated to a minimum of R30. The insulation provided was less than R30, which is the level we recommend at a minimum for thermal efficiency reasons.

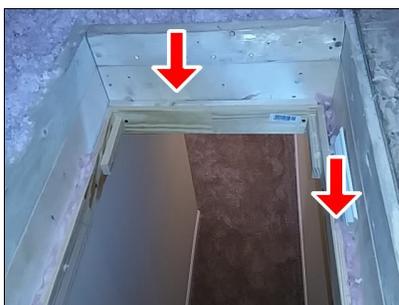
- 🔧 (3) Today's commonly accepted construction standards require foam sealant at penetrations into the building from unconditioned spaces or the outdoors. No foam sealant was provided at the attic entrance. Service by a competent person is recommended.

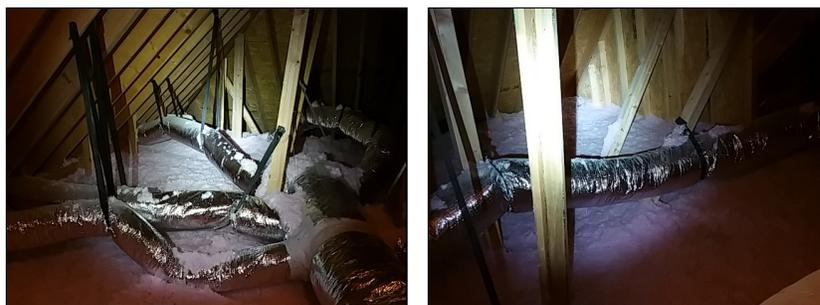
- 🔧 (4) No depth markers were evident in the attic space. Without insulation markers, the insulation installer cannot be assured that the proper level of insulation was provided. Service to install the marker and ensure that the proper amount of insulation is installed is recommended for thermal efficiency reasons.

2012 IECC " R303.1.1.1 Blown or sprayed roof/ceiling insulation.

The thickness of blown-in or sprayed roof/ceiling insulation (fiberglass or cellulose) shall be written in inches (mm) on markers that are installed at least one for every 300 square feet (28 m²) throughout the attic space. The markers shall be affixed to the trusses or joists and marked with the minimum initial installed thickness with numbers a minimum of 1 inch (25 mm) in height. Each marker shall face the attic access opening."

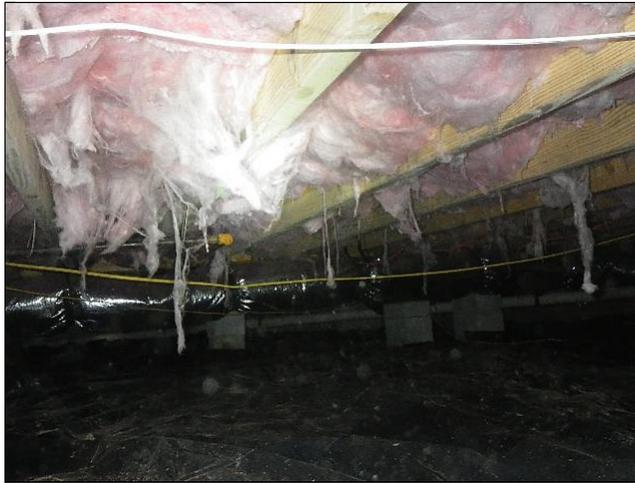
wood will decay at moisture levels > 28% and will support fungi growth at levels in the low-20s. Monitoring of the sub-floor moisture content during the humid summer months is recommended.

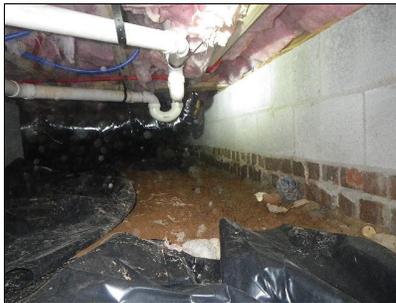
- 🔧 Moderate portions of the moisture barrier are displaced. To be fully effective, the plastic sheeting should be spread out. Stapling to the ground is also recommended.

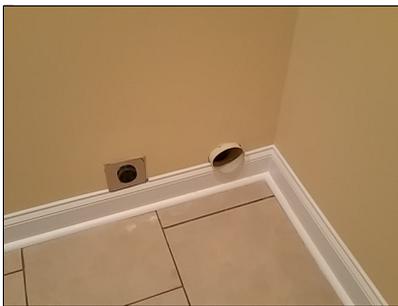
- 🔧 (2) The dryer vent is covered with a screen or grill, which can trap lint and create a clog which would be a fire hazard. Today's commonly accepted construction standards specify a back-draft damper and no screen, and that is what we recommend.
- 🔧 (3) Today's commonly accepted construction standards require that when the dryer duct is concealed in building construction, the dryer duct length should be identified within six feet of the dryer on a permanent label or tag. This is important so that the occupant can ensure that the dryer manufacturer's installation recommendations are followed.

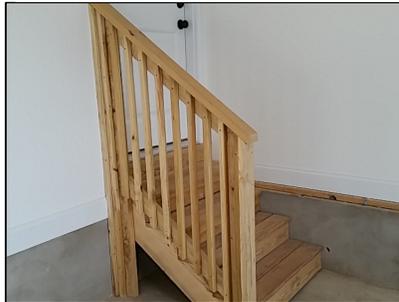
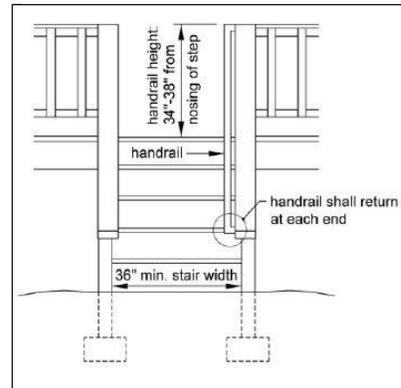
A common defect exists in that the stairs at the garage entry door did not have a graspable handrail meeting today's commonly accepted construction standards. Information about proper stair railing and illustrations can be obtained at our website (www.aohomeinspection.com/pdf/IRC_interpretation.pdf). (See page 9). You may wish to have a graspable handrail installed, particularly for elderly residents or guests.
