**Alpha & Omega
Home Inspections, LLC**

CONFIDENTIAL INSPECTION REPORT

2 Faith Lane, Indian Trail, NC

5/18/2007 9:00 am to 12:17 pm

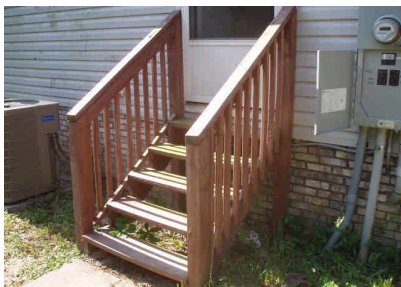
- 1.6 - An exterior door(s) opens over a step, or has no landing, and poses a fall hazard. According to today's standards for new construction, such doors are required to open over a platform that is at least the width of the door.

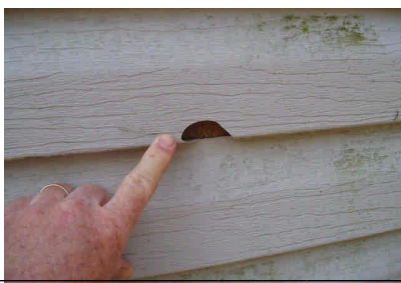
- 1.12 - The vinyl siding has one or more holes that may expose the sheathing to moisture. Repair or replacement of the affected sections is recommended.

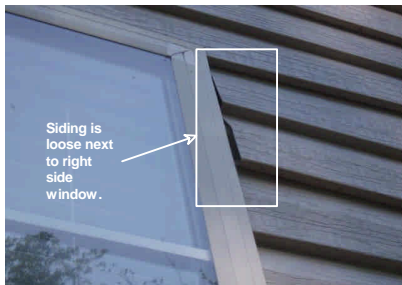
1.13 - The vinyl siding has one or more loose sections that may expose the sheathing to moisture. Repair or replacement of the affected sections is recommended.

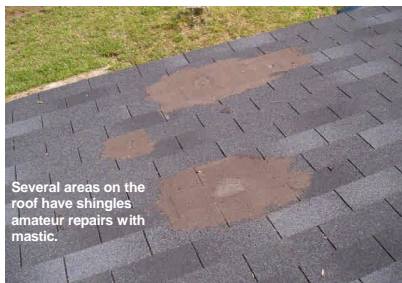
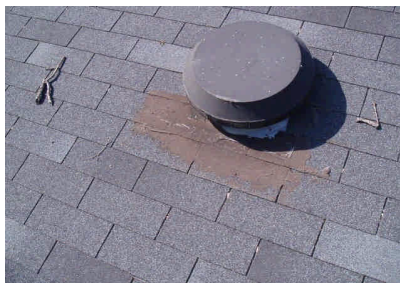
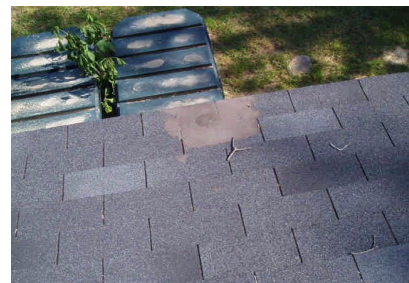
2.2 - Broken, cracked, or otherwise damaged shingles were observed. An evaluation of all the shingles and repair as deemed necessary by a licensed roofing contractor is recommended.

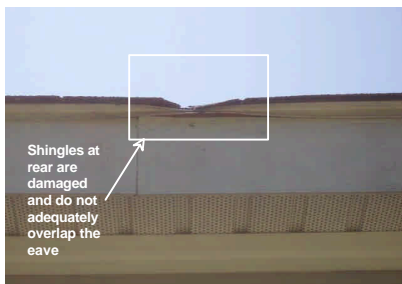
2.4 - The shingles do not adequately overlap the roof eave or rake at one or more areas.

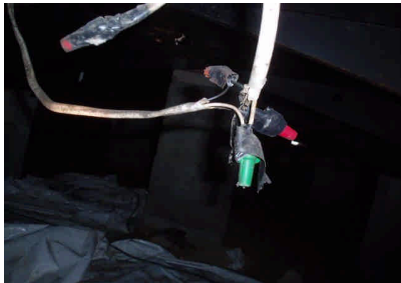
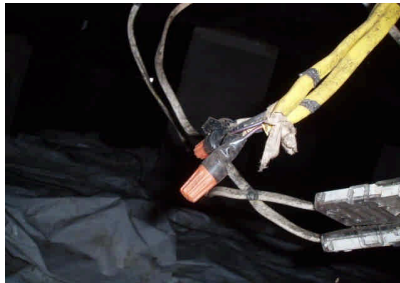
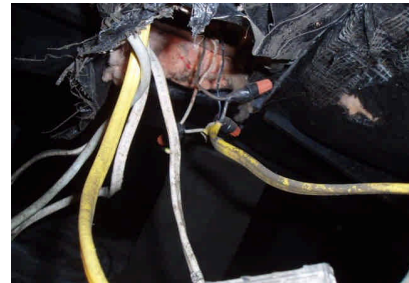
3.2 - One or more electrical connections within the crawlspace have been incorrectly made outside of a junction box, which is a potential fire-hazard. All such connections should be made inside a junction box, in order to contain any arcing or sparking within the box.

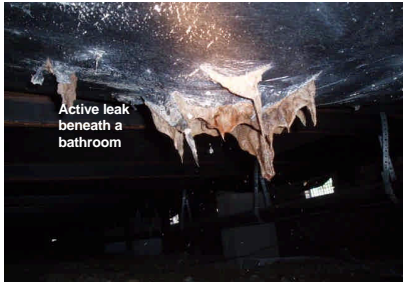
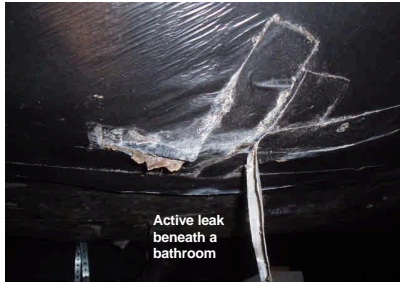
6.2 - The sub-floor structure of the home is sealed with black plastic that prevents any examination of the sub-floors, plumbing systems, ventilation systems, etc. Nevertheless, we observed areas of the plastic that were sagging and were filled with water (beneath the kitchen and possibly the laundry room, beneath a bathroom at the left front of the home, and beneath the master bathroom). We punctured the plastic and confirmed the presence of water on the top side of the plastic (beneath the sub-floors) and wet sub-floor insulation. No further disassembly of the floor system was preformed because to do so would

be destructive. We were therefore unable to determine the source of the water, but it is assumed to be either a drain line or supply line leak. We recommend that a licensed general contractor and/or plumbing contractor remove the plastic and determine the source of the leak(s), repair the leak(s), and determine the severity of damage to the floor systems. Repairs should be performed as deemed necessary and within the contingency period because moisture can cause fungi growth which is a health concern, and significant and costly structural damage that may affect your evaluation of the property.

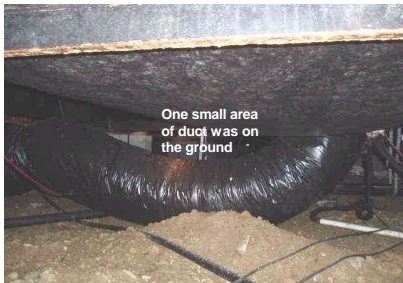
8.1 - One or more HVAC ducts in the crawl space were on the ground. Ducts are required to be a minimum of 4 inches above ground. We recommend service by a state licensed HVAC contractor.

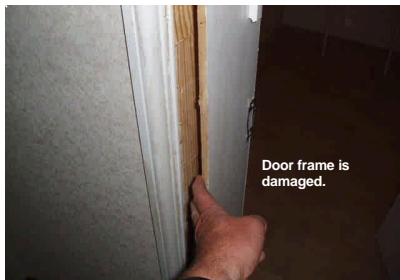
12.5 - The closet door does not function as intended and needs repair.
