**Alpha & Omega
Home Inspections, LLC**

CONFIDENTIAL INSPECTION REPORT

2 Faith Lane, Indian Trail, NC

5/18/2007 9:00 am to 12:17 pm

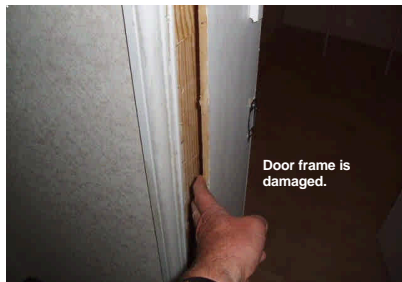
12.5 - The closet door does not function as intended and needs repair.
