**Alpha & Omega
Home Inspections, LLC**

CONFIDENTIAL INSPECTION REPORT

1 Plantation Hills Dr., Rock Hill, SC

SUMMARY SECTION

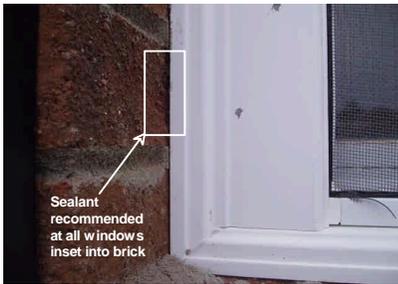
- 1.1 - One or more windows were not adequately sealed to prevent water intrusion. All the windows should be evaluated and sealed where necessary.

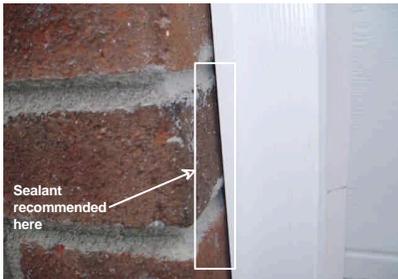
1.2 - The house trim at the garage needs sealant to prevent moisture intrusion.

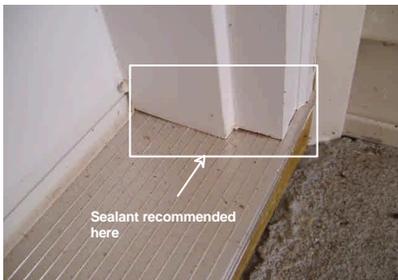
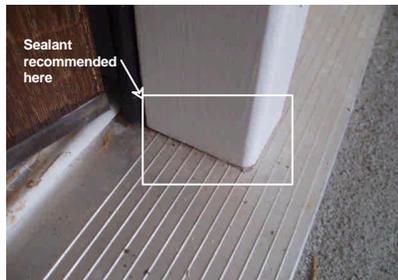
1.3 - The threshold is not caulked or sealed at the front door. Sealant is recommended to prevent water from wicking up into the door frame resulting in deterioration to the wood door jambs.

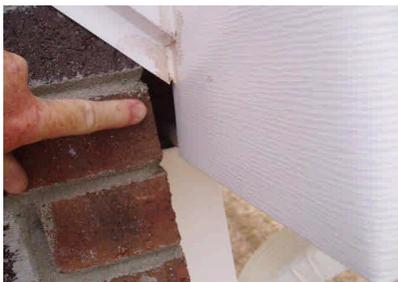
1.4 - The fascia trim did not totally cover wood structures.

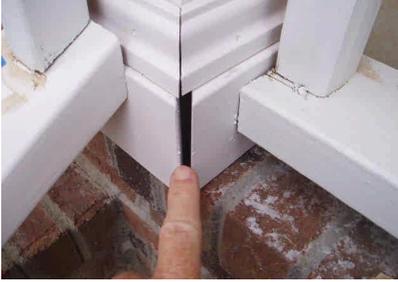
1.5 - One or more posts needs sealant to prevent deterioration to the wood.

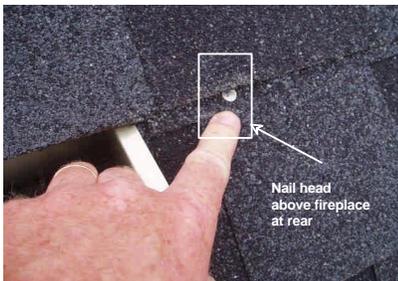
2.1 - One or more fasteners were observed unprotected by overlapping shingles. Improper fastening of the shingles may result in leaks. A thorough evaluation of the roof installation is recommended by a licensed roofing contractor.

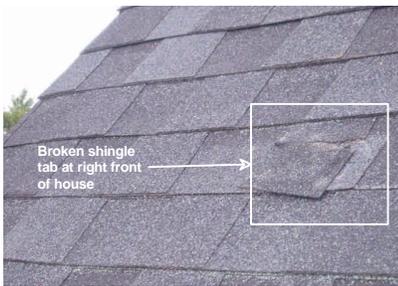
2.2 - Broken, cracked, or otherwise damaged shingles were observed. An evaluation of all the shingles and repair as deemed necessary by a licensed roofing contractor is recommended.

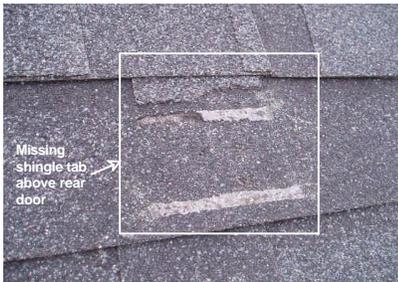
2.3 - One or more shingles or shingle tabs were missing or damaged. A thorough evaluation of the roof and repair by a licensed roofing contractor is recommended.

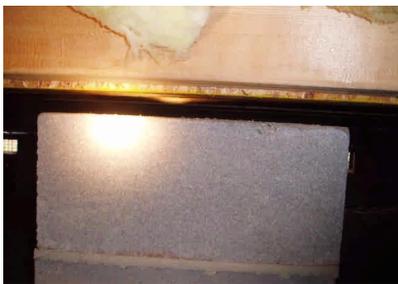
3.1 - A pier was not adequately shimmed to support the floor girder.

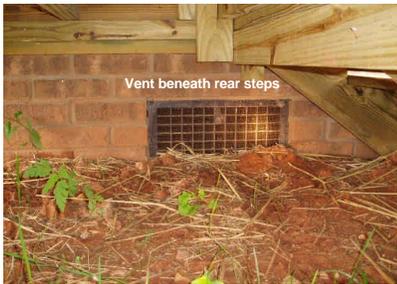
3.2 - One or more foundation vents was at or below grade level. Water likely enters the crawl space through these vents. It is recommended that vent wells be installed to prevent water from entering the crawl space.

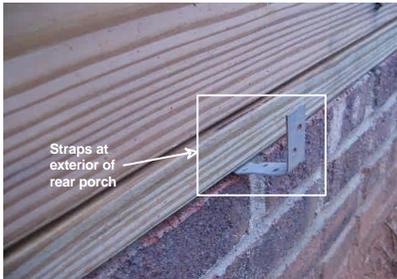
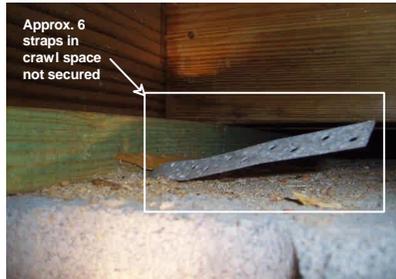
3.4 - One or more foundation straps were not secured.

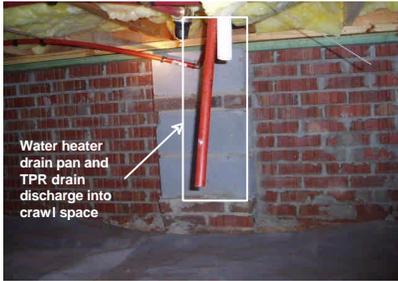
6.1 - The discharge pipe from the temperature-pressure relief valve discharges into the crawl space, where any leaks would not be noticed. It should be plumbed to the exterior and terminate no more than twenty-four inches above grade and no closer than six inches to it, or it should discharge to a concrete floor in a

conspicuous area where no damage would result.

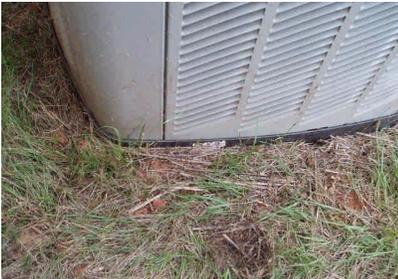
8.1 - The condensing coil was not elevated above the soil. Most manufacturers recommend an elevation of three inches above the surrounding soil to prevent corrosion.

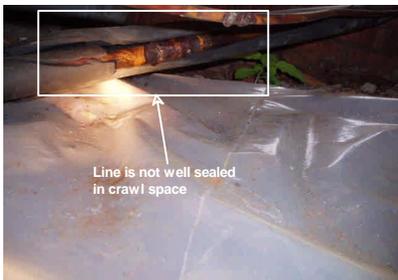
8.3 - Insulation is missing from the refrigerant line in the crawl space, which reduces the system efficiency. The condition will allow condensation to form and drip, and moisture in the crawl space should be avoided.

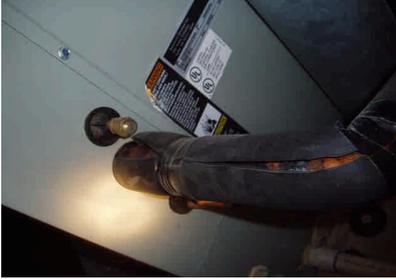
- 8.4 - Insulation is not sealed at the refrigerant line at the evaporator coil. The condition will allow condensation to form and drip, which may cause corrosion to the furnace, drip pan or damage to the ceiling below. Insulation should be installed where missing.

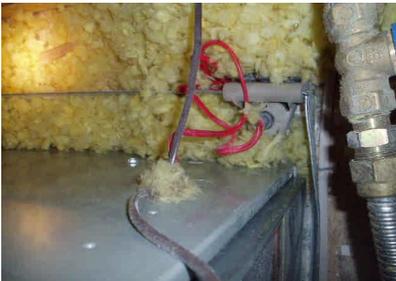
- 8.7 - The drip pan contains insulation that should be removed so that it will function effectively. Failure to clean insulation from the drip pan may result in a clogged auxiliary condensate drain or malfunctioning float switch, which would cause subsequent damage to the ceilings when the pan overflows.

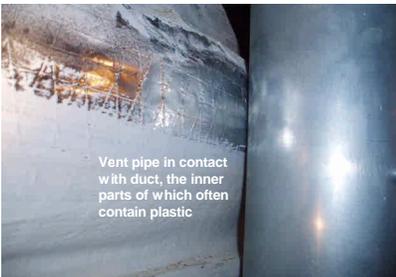
- 8.8 - The furnace exhaust flue was in contact with or too close to combustible materials. The manufacturer of the vent (a "B-vent") recommends a minimum 1" clearance from combustible materials. This construction defect is considered a fire hazard. We recommend that repairs meeting the manufacturers specifications be conducted for fire safety reasons.

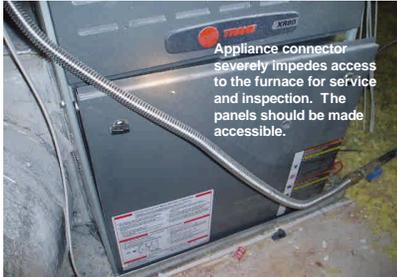
- 8.9 - A gas appliance connector passes through one or more HVAC cabinets; a practice which the manufacturer prohibits. The manufacturer of these devices states: "Do not conceal connector or run connector through enclosed outdoor BBQ pits, walls, partitions, floors or appliance panels."

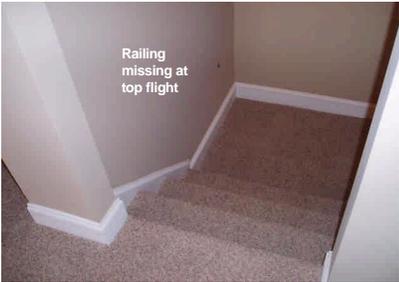
16.1 - The handrail on the stairs does not extend the full distance. Today's standards for new construction require a handrail for 4 or more risers. Additionally, "handrails for stairways shall be continuous for the full length of the flight, from a point directly above the top riser of the flight to a point directly above the lowest riser of the flight." For safety reasons, a railing meeting the standard as quoted above is recommended. Information about proper stair railing and illustrations can be obtained here: www.aohomeinspection.com/pdf/IRC_interpretation.pdf.
