# **Alpha & Omega Home Inspections, LLC**

## Confidential Inspection Report

**Property Address:**  
136 Anystreet St.  
MyTown SC

<b>Date:</b> 6/3/2010	<b>Time:</b> 02:15 PM	<b>Report ID:</b> 1912 House Sample
<b>Property:</b> 136 Anystreet St. MyTown SC	<b>Customer:</b>	<b>Real Estate Professional:</b>

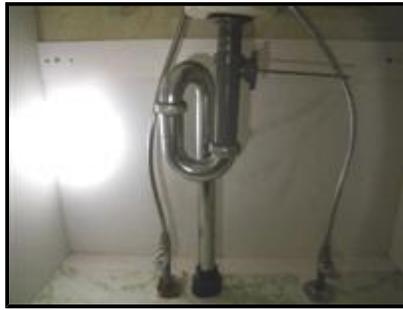
🔧 (3) The 2nd level hall bathroom sink drain employs an obsolete, or suspect, s-trap. Such traps are not approved because their water seals can be easily siphoned away, which would allow sewer gases to contaminate the residence.

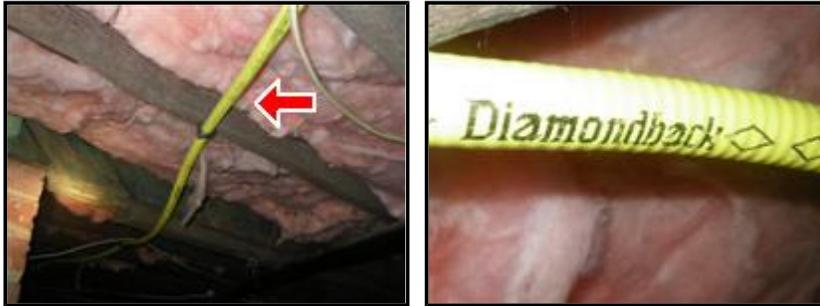
🔧 **5.11** A common gas piping system called Corrugated Stainless Steel Tubing or CSST is present in this home (*installed at the new furnace only*). OmegaFlex's product is known as "TRACPIPE" or "COUNTERSTRIKE," Titeflex's CSST product is known as "GASTITE," Ward's CSST product is known as "WARDFLEX," and Parker Hannifin's CSST product is known as "PARFLEX." A lawsuit in 2005 claimed that CSST poses an unreasonable risk of fire due to lightning strikes. The lawsuit was settled and the manufacturers agreed to require additional electrical bonding above the minimum requirements set by the National Electric Code. In most circumstances, the bonding is required to be connected to the house electrical system. We could not confirm that such bonding was present. We recommend a further evaluation and repair as deemed necessary by a competent, licensed electrician familiar with the requirements of this type of gas piping. More

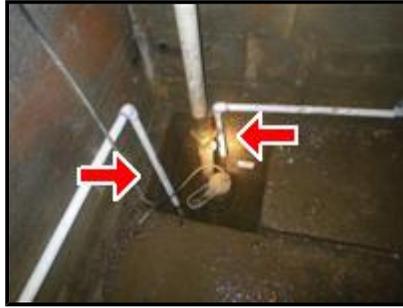
(3) The condensate pipe discharges into the crawl space sump. While we can think of no rule against it, generally accepted practice is to limit the amount of moisture present in a crawl space. Discharging outside the crawl space would also allow for routine observation of its function. We therefore recommend that it should be extended to discharge outside the residence.

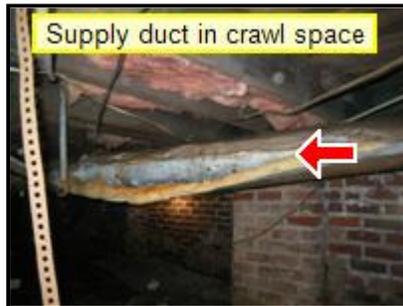
🔧 (2) Portions of the metal supply ducts were uninsulated or had deteriorated insulation, which will have an impact on thermal efficiency and condensation. We suggest that you consult with a licensed HVAC contractor about the ramifications of using the ducts in their current condition. *(Note that the return air ducts were completely uninsulated, which is contrary to today's modern installation practices.)*

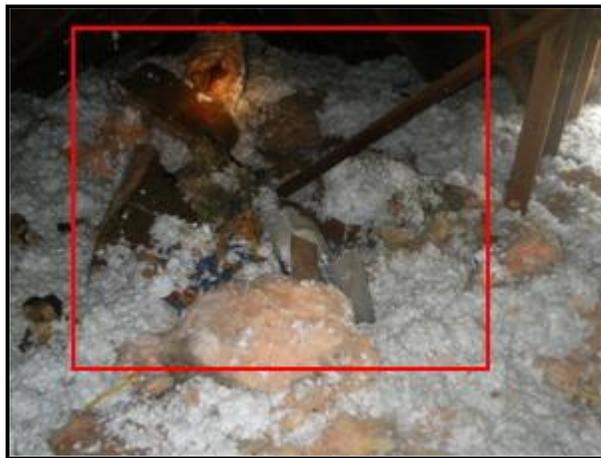
🔧 (2) There is a 'mess' of insulation in one area of the attic that may make traversing and servicing of the attic difficult. We recommend removal of the unnecessary insulation or evenly distributing it.

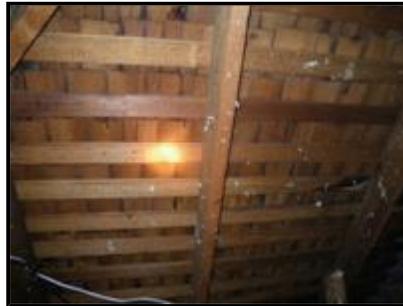
**7.5** (1) The composition shingles have been installed over an existing wood shingle roof. There is no other roof sheathing, which means that when the current layer of shingles is removed, the roof structure will likely have to be totally re-sheathed with plywood or oriented strand board (OSB), which will significantly affect the cost of re-roofing the house. We suggest that you have the roof and attic structure evaluated by a licensed roofing contractor prior to close of escrow because the cost of re-roofing could affect your budget.

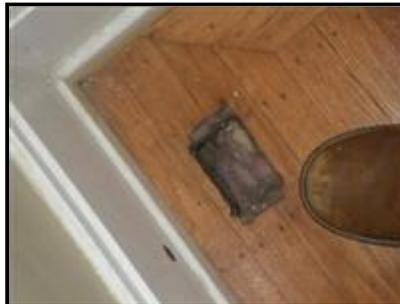
🔧 **8.2 (1)** There is a small hole in the living room floor that should be covered, closed, or sealed.

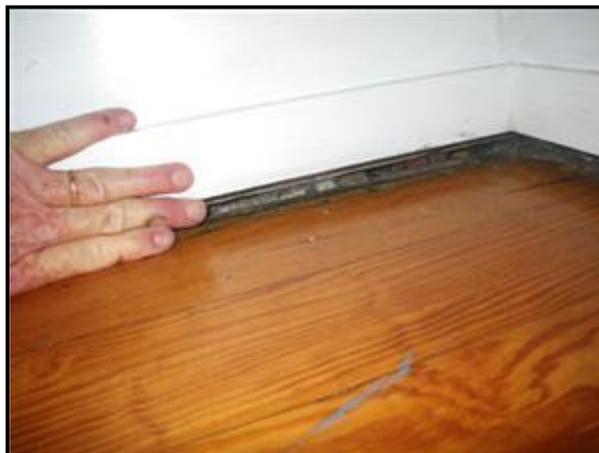
🔧 (2) The floor in the 1st level den has apparently dropped about one inch. We can elaborate, but you should consider an evaluation by a licensed general contractor or structural engineer.

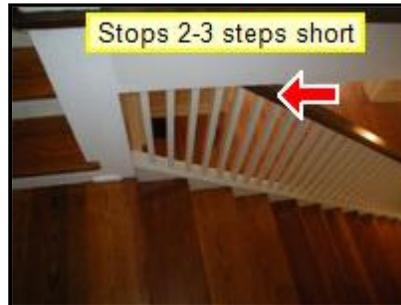
🔧 (2) The main stairs did not have a continuous handrail. Today's commonly accepted construction standards require a handrail for 4 or more risers. Additionally, "handrails for stairways shall be continuous for the full length of the flight, from a point directly above the top riser of the flight to a point directly above the lowest riser of the flight." Although this defect is quite common, for safety reasons a railing meeting the standard as quoted above is recommended. Information about proper stair rail construction and illustrations are available on [our website](#) (see page 9).

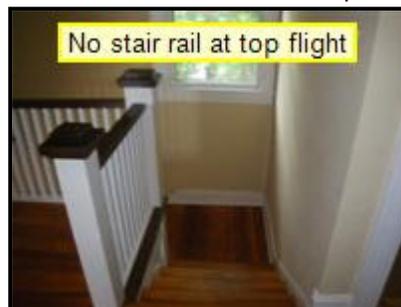
🔧 (3) No handrail is provided at the main stairs. Today's commonly accepted construction standards require a handrail for 4 or more risers. Additionally, "handrails for stairways shall be continuous for the full length of the flight, from a point directly above the top riser of the flight to a point directly above the lowest riser of the flight." For safety reasons, a railing meeting the standard as quoted above is recommended. Information about proper stair railing and illustrations can be obtained here: [www.aohomeinspection.com/pdf/IRC\\_interpretation.pdf](http://www.aohomeinspection.com/pdf/IRC_interpretation.pdf).

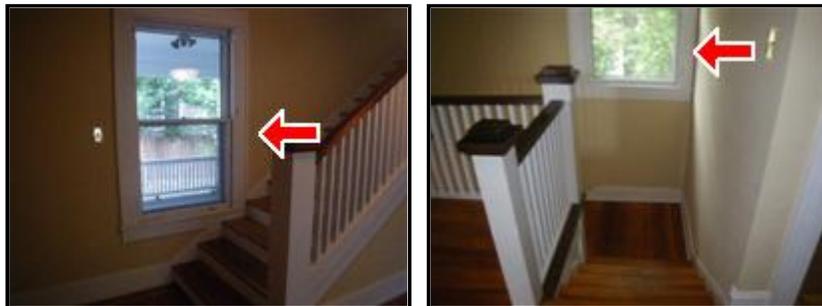
🔧 (8) Two windows within sixty inches of the stair surface could not be verified as being tempered or safety-glazed, which is required by today's commonly accepted construction standards. Replacement with tempered glass or safety glass is recommended for safety reasons.
