Alpha & Omega Home Inspections, LLC

Confidential Inspection Report

634 Anystreet
MyTown SC

Date: 5/12/2010	Time: 04:40 PM	Report ID: Sample Report - 75 YO Home
Property: 634 Anystreet MyTown SC	Customer:	Real Estate Professional:

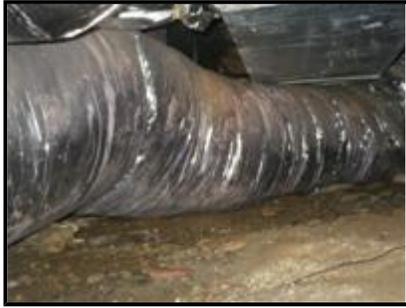
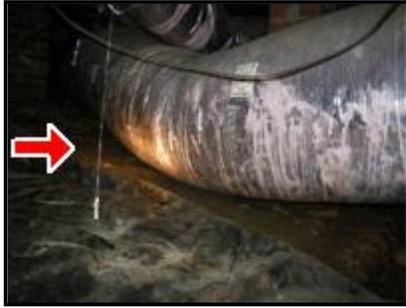
**6.2** HVAC ducts in the crawl space were on the ground. Ducts are required to be a minimum of 4 inches above ground. If this isn't possible due to height restrictions, then a sheet of plastic between the duct and the ground would be prudent.

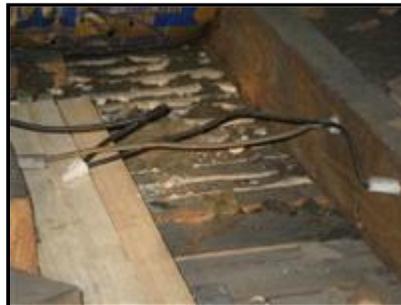
7.1 (1) All of the attic was under-insulated. This attic had approximately 6 inches of rock wool insulation, which is less than R30. Today's standards call for R30 levels of insulation in the attic and this is what we recommend. Note: R30 would be approximately 10 inches of fiberglass and 8.2 inches of cellulous.

7.1 (2) Portions of the ceilings are uninsulated. For thermal efficiency, you may want to add insulation to bring the attic up to today's standard of R30. Note: R30 would be approximately 12 inches of fiberglass and 10 inches of cellulous.

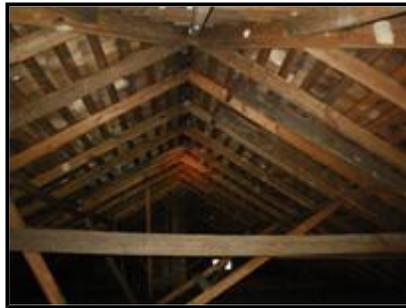
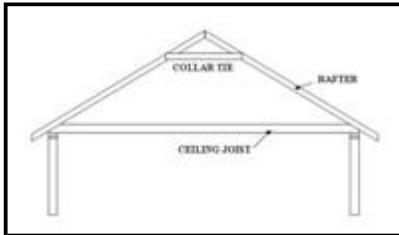
🔧 (2) The attic framing was not framed with collar ties, which serve to prevent the rafters from spreading. This was an accepted practice at the time of construction but we saw evidence of rafter sagging and separation. We therefore recommend an evaluation by a competent and licensed general contractor.

(3) A 'jumble' of miscellaneous, loose braces is all that provides support to the attic. The rafters have spread at the roof peak. An evaluation and service by a licensed and competent general contractor is recommended.
